94 Tail light or front indicator in bumper is cracked, broken, leaks, or does not work

94 20 19 2058420/1 February 3, 2020.

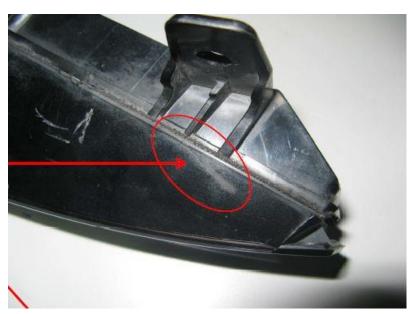
Figure 1. Turn signal in front bumper cracked.

Before replacing any components inspect the vehicle body and lamp(s) for damage that relates to outside influence (Figures 1 -5).

- 2. If damage relating to outside influence or force is found, this is not a warranty concern as it is considered consequential damage. In these cases, please explain the situation to the customer.
- 3. If there are no signs of outside influence, carry out standard diagnosis.

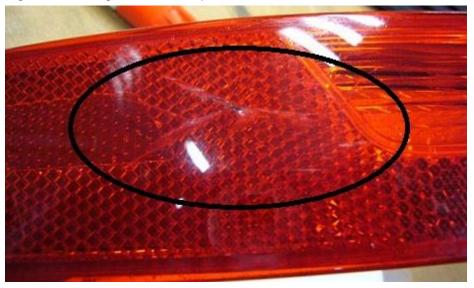
Figure 4. Turn signal in rear bumper scratched or cracked.

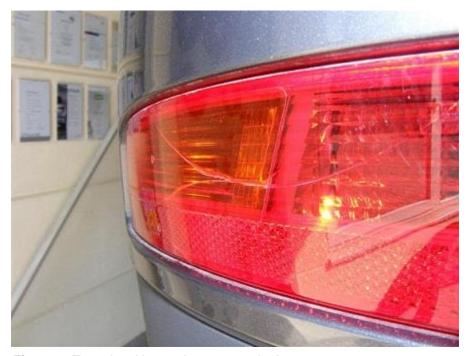
Figure 5. Turn signal in rear bumper cracked.
