February 2020  
SF597A

## Subject: Freightliner Cascadia Passenger-Side Dome Light

**Models Affected: Specific Freightliner Cascadia model vehicles,  
manufactured September 9, 2019, through October 25, 2019.**

### SF597A - Dome Light Inspection/Wiring Harness Repair

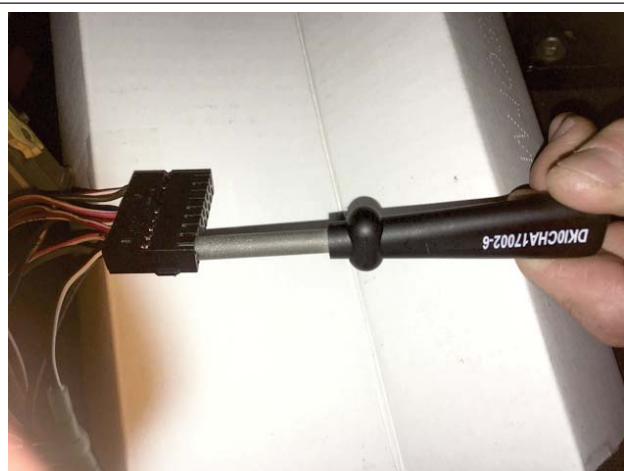
**Fig. 6, Removing the Purple/White Wire**

9. Remove the purple/white wire from pin 1 using tool # DKIOCHA17002-6. See [Fig. 6](#)

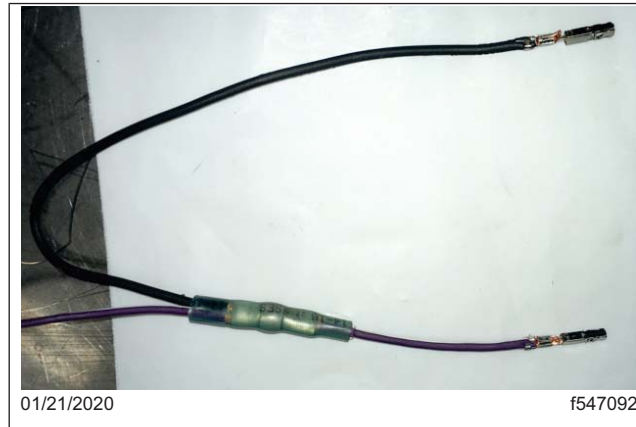
**Fig. 10, Completed Splice**

12. Insert the folded section of wire into the empty end of butt connector; then crimp using tool DKIOCHA17003-3. See [Fig. 10](#) for a representative image of the butt-spliced wires.

10. Splice 8 inches (20 cm) of black 18 gauge wire onto the purple/white wire:
  - 10.1 Cut the purple/white wire approximately 3 inches (8 cm) from the pin 1 terminal, and retain this 3-inch piece.
  - 10.2 Strip approximately 1/2 inch (1 cm) of wire insulation from the dash harness side of purple/white wire.
  - 10.3 Strip approximately 1/2 inch (1 cm) of wire insulation from an 8-inch piece of black 18 gauge wire.
  - 10.4 Twist the dash harness side purple/white wire and the black wire together. See [Fig. 7](#). Then insert the twisted wires into the butt connector (p/n PHM 1 1862), and crimp using tool DKIOCHA17003-3. See the left side of [Fig. 10](#).

13. Using a heat gun, carefully heat shrink the butt connector.
14. Strip approximately 1/4 inch (.5 cm) of wire insulation from end of black wire opposite the butt connector.
15. Crimp the terminal (p/n 23-13209-730) on the black wire using tool DKIOCHA17003-2; then insert the black wire terminal into sSAM X8 pin 2.
