Technical Service Bulletin	Transaction No:	2049039/6
87-18-08 - Air Conditioning, Cleaning of the R1234yf Refrigerant Circuit (U.S. Only)		Release date:	2/5/2020

Debris can be dispersed throughout the refrigerant circuit after A/C component damage. In order to maintain A/C operating efficiency, it is important to flush the refrigerant circuit after A/C component repairs.

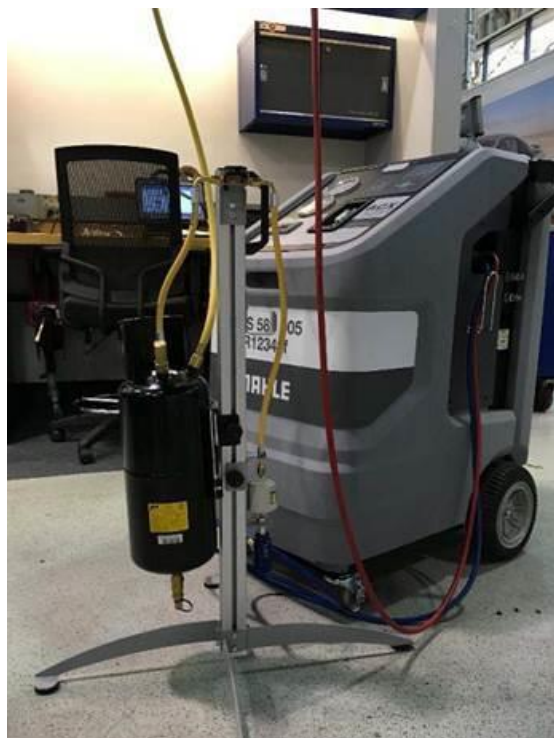
Figure 1. The VAS581005 Air Conditioning Service System with Flushing Device.

Use the MAHLE R1234yf A/C Service Unit VAS581005 and the R1234yf Flush Kit RTI360831040 (Figure 1).

Used for effective refrigerant handling and air conditioning circuit flushing after air conditioning component failure.

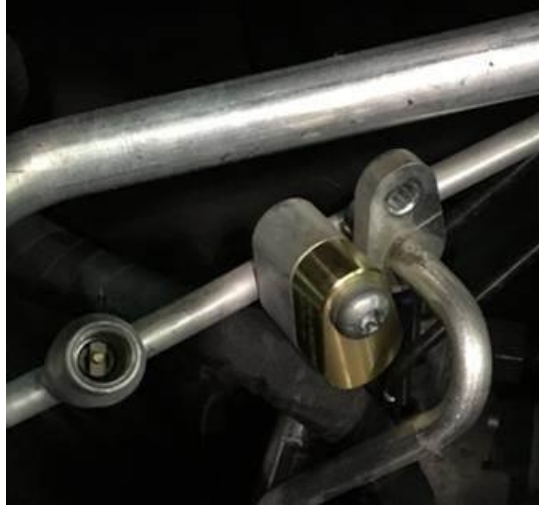
Figure 4a. Installation of high side rear A/C Line connection block adaptor VAS 6338/63

(Atlas Only) The rear A/C unit refrigerant lines must be disconnected and replaced with block off adaptors VAS 6338/5 and VAS 6338/63 before performing the front A/C unit flush procedure.

8. (Atlas Only) Disconnect rear refrigerant lines and install adaptors VAS 6338/5 and VAS 6338/63 as shown. (Figure 4a, 4b)

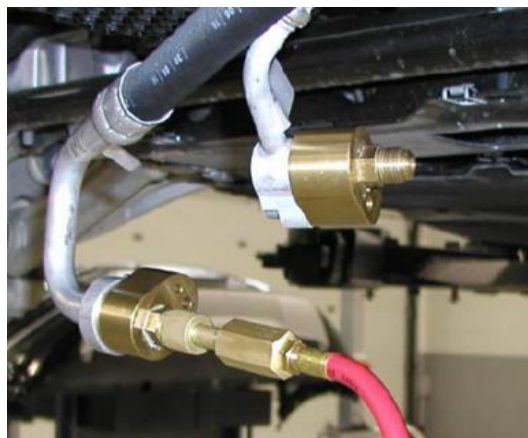
Figure 7.

This connection strategy allows for a system flush *in the opposite* direction of the normal refrigerant flow.

11. Attach high side A/C Recovery machine hose with VAS 6338/48 fitting to low side compressor hose adaptor VAS 6338/12. (Figure 7)
