# Instrument Panel (Dashboard) and Door Panels Sticky/Cracked

**Service Category** Vehicle Interior

**Section** Interior Panels/Trim

The information contained in this bulletin supersedes Service Bulletin No. L-SB-0041-15.

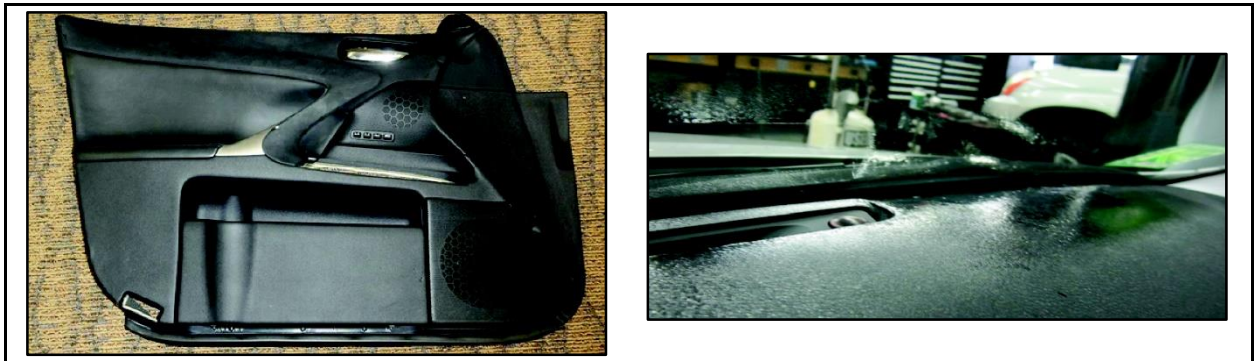
Does the dashboard and/or door panel(s) exhibit a sticky and/or cracked appearance?  
(See Figures 1 – 4 for examples of these conditions.)

**Figure 1. Example of Sticky Condition**

- When a vehicle with sticky interior panels is parked out of heat and humidity for more than a few hours, the panel surface may become chalky. Once the vehicle is exposed to heat again, the sticky condition may return.
- Interior panels can become sticky over time for a variety of reasons and circumstances. Most vehicles subject to repair under this Service Bulletin have more than likely been operated for extended periods in areas of high temperatures and high humidity.
- In some cases, the interior panels may appear shiny due to aftermarket interior dressing.

2. Remove the affected panel(s).

3. Install the NEW panels.

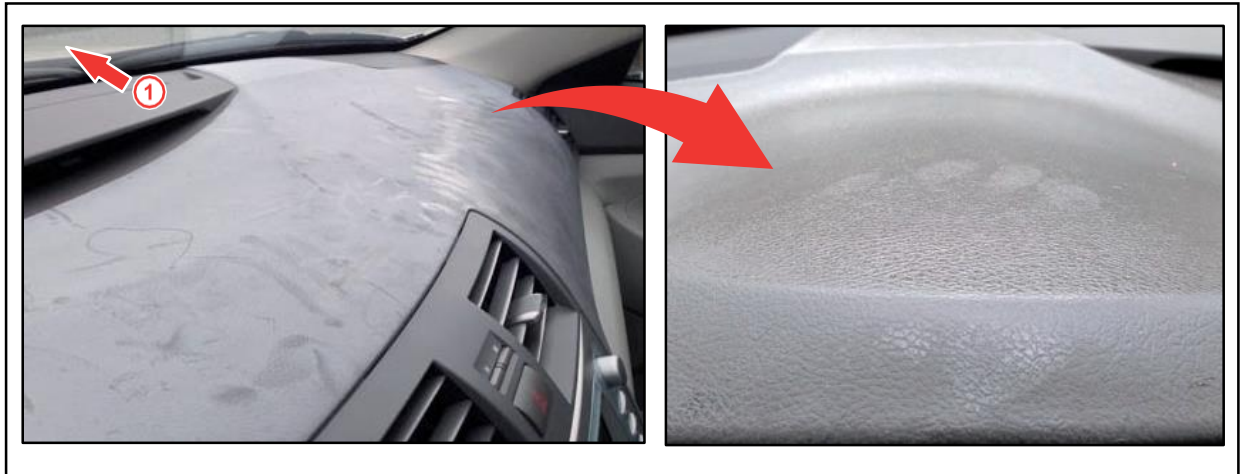
**Figure 3. Example of Chalky Condition (Becomes Sticky in Heat)**

<b>1</b>	Front of Vehicle
----------	------------------
