Seat Noise During Forward/Rearward Operation

Service Category Vehicle Interior

Section Seat

YEAR(S)	MODEL(S)	ADDITIONAL INFORMATION
2020	Supra

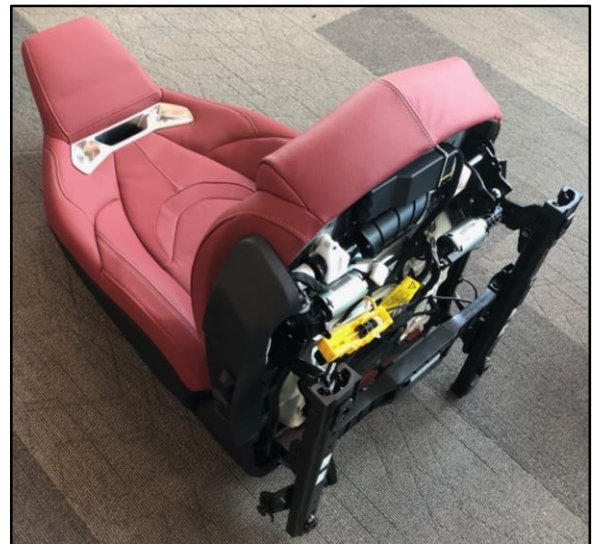
Figure 1.

2. Lie the seat on its back cushion to access the seat motor and driveshafts.

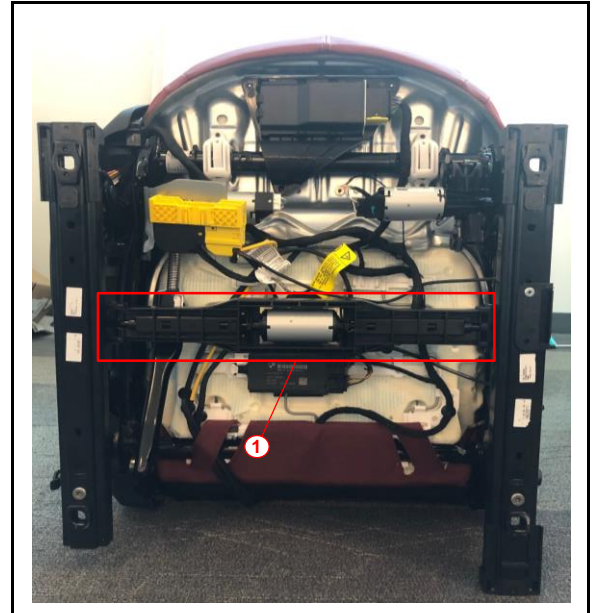
Figure 2.

3. Locate the seat motor drive carrier controlling forward/rearward motion on the bottom of the seat.

1	Seat Motor Drive Carrier
----------	---------------------------------

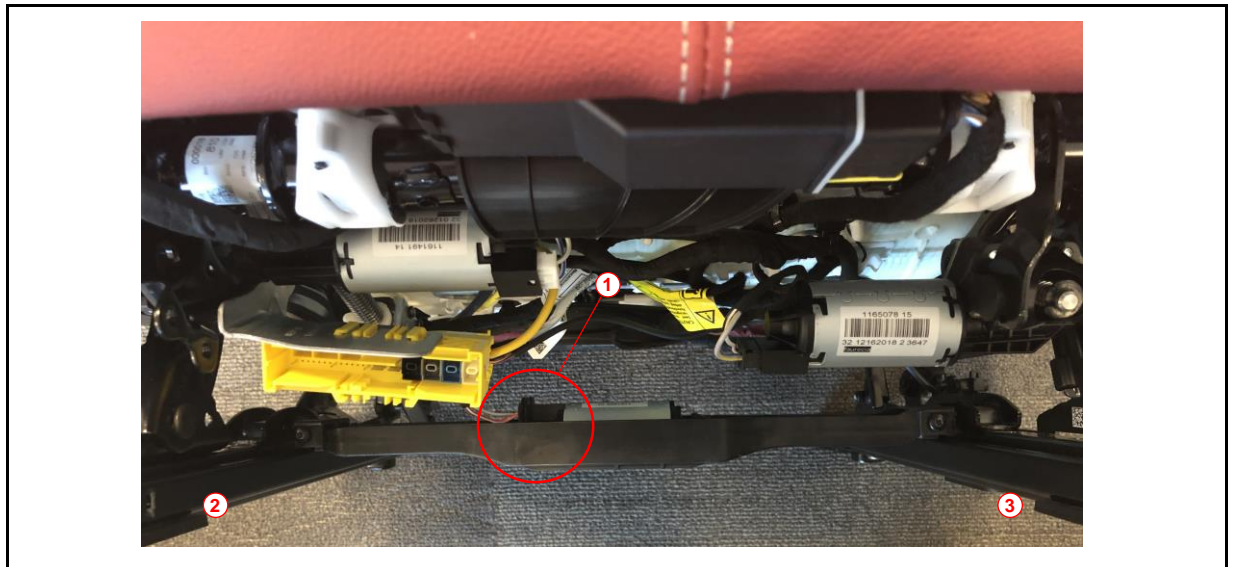
Figure 3.

4. On the top of the carrier, locate and disconnect the drive motor wire harness connector on the left-hand side of the motor.

1	Seat Motor Wire Harness Connector
2	Left-hand Side
3	Right-hand Side

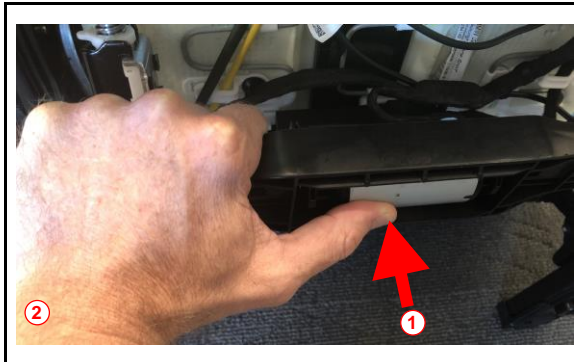
Figure 4.

- Remove the motor from the carrier by pushing upward on the motor from the bottom side on the left-hand side first, then the right-hand side. Refer to Figures 4 and 5 for removal detail. Figure 5 also shows the motor COMPLETELY unclipped from the housing.

1	Pushing Direction
2	Left-hand Side

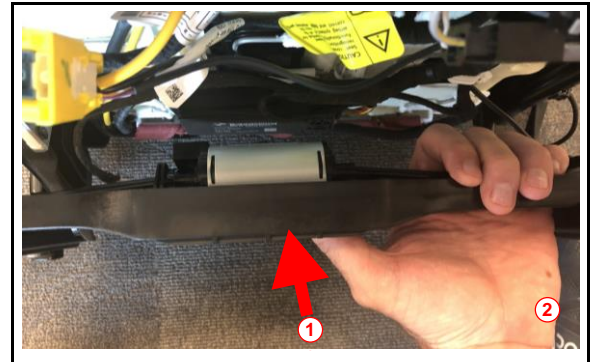
Figure 5.

1	Pushing Direction
2	Right-hand Side

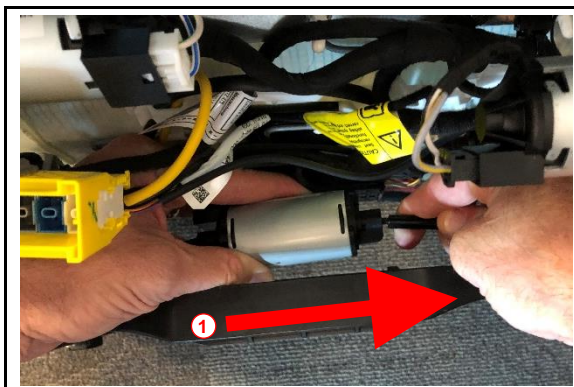
Figure 6.

- Remove the motor driveshaft (right-hand or left-hand side, ANY order is OK) from the motor by pulling outward, and remove the motor from the opposite driveshaft to remove the motor from the carrier.

1	Pulling Direction
---	-------------------

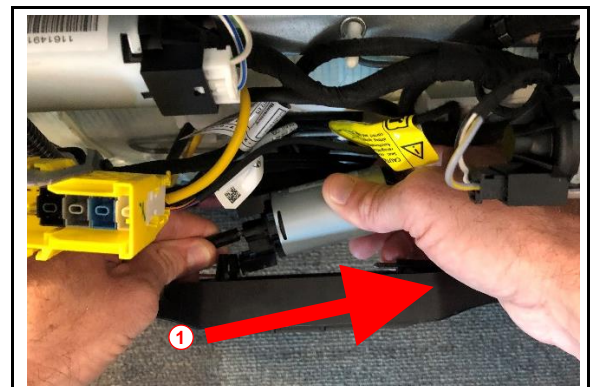
Figure 7.

1	Pulling Direction
---	-------------------

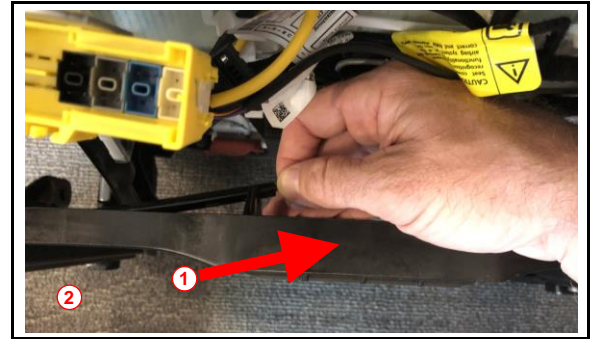
Figure 8.

7. Remove the driveshafts from the carrier by pulling inboard relative to the seat. Figure 8 shows the left-hand side removal, right-hand side removal pulling direction opposite to the left-hand.

1	Pulling Direction
2	Left-hand Side

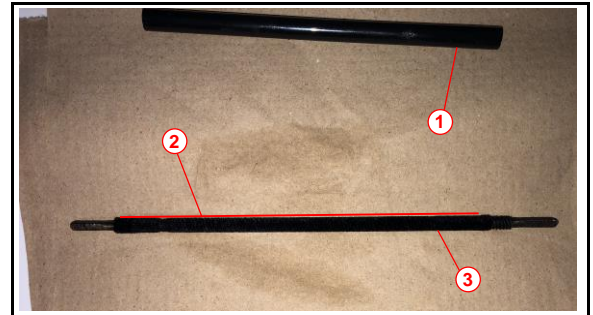
Figure 9.

8. Remove the driveshaft from the plastic sleeve and apply an even bead of 3-IN-ONE® Telescoping Spout Multi-Purpose Oil along the profile line shown (along the felt coating).
 - A. Use a paper towel or clean rag to apply the oil evenly over the felt and remove excess oil from the driveshaft. The oil should NOT drip AFTER application.
 - B. Reinsert the driveshaft to sleeve immediately AFTER oiling to prevent contamination to the driveshaft friction surface. Oil both right-hand and left-hand driveshafts, using the same process for BOTH sides.

1	Sleeve
2	Oil Application Line
3	Driveshaft

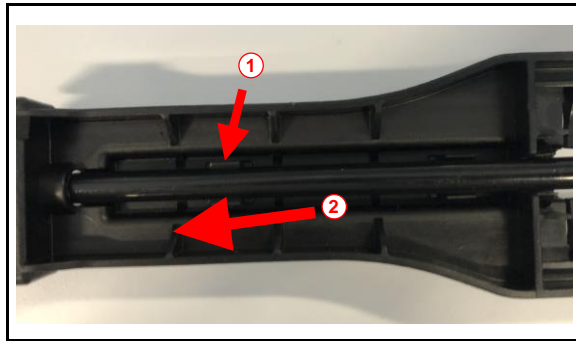
Figure 10.

9. Insert the driveshaft into the motor drive carrier by clipping the outboard clip first and sliding the driveshaft into the seat drive gear (Figure 10 shows the top of the motor carrier clip locations). Follow this same procedure for the opposite side. You will know when the driveshaft and sleeve are fully installed by the position(s) shown in Figure 11. Driveshafts are interchangeable between left-hand and right-hand.

1	Outboard Clip Location
2	Insertion Direction

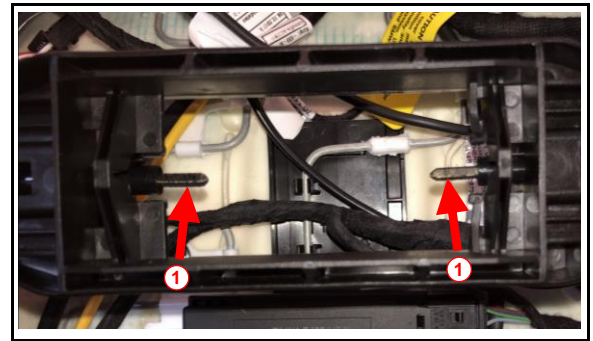
Figure 11.

1	Driveshaft Locations After Full Insertion
----------	--

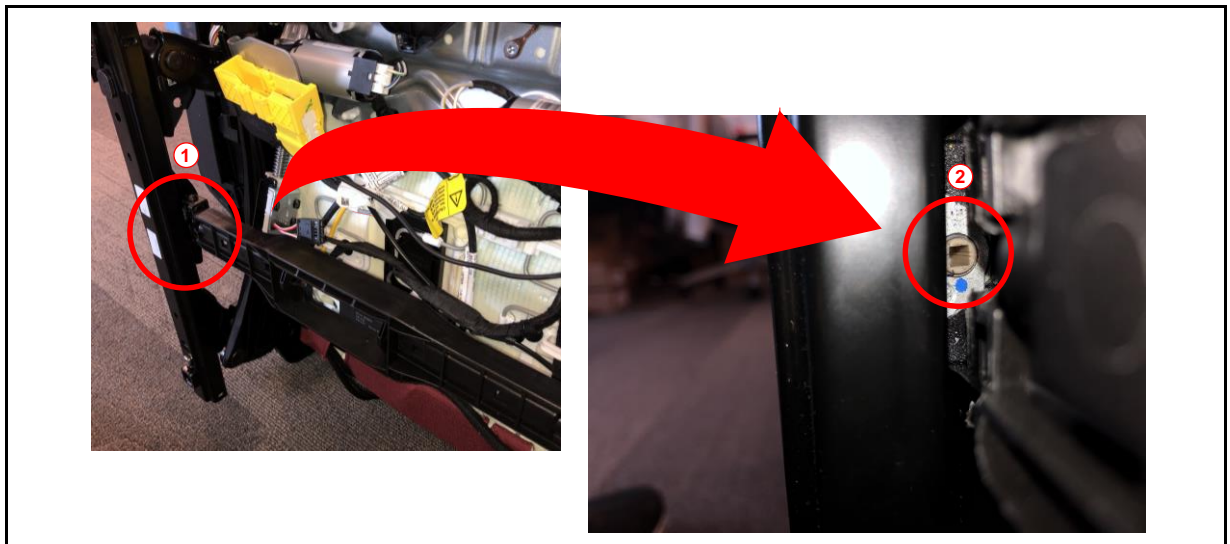
Figure 12.

Driveshaft alignment to seat drive gear is a square shape. You may need to rotate the driveshaft in the seat drive gear to fully insert the driveshaft. You can view the driveshaft insertion point to drive gear through a small view hole in the area highlighted below.

1	Seat Drive Gear Location
2	Seat Drive Gear Insertion Point

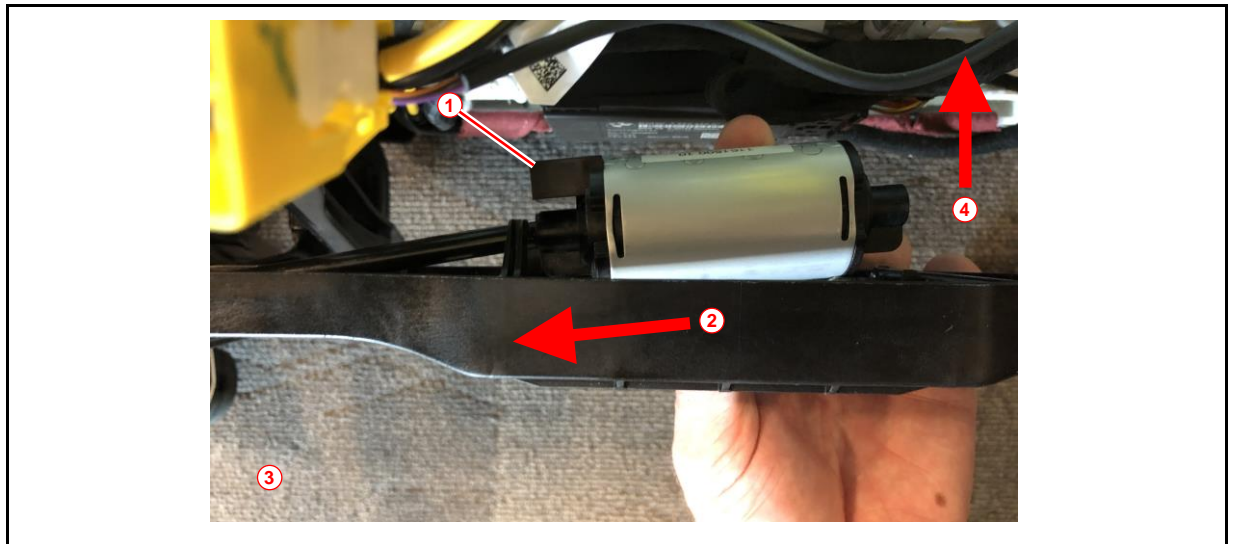
Figure 13.

10. Install the motor to one driveshaft. Ensure motor alignment to carrier by confirming the wire harness connector is facing the left-hand side in an upward direction.

1	W/H Connector
2	Insertion Direction
3	Left-hand Side
4	Upward Direction

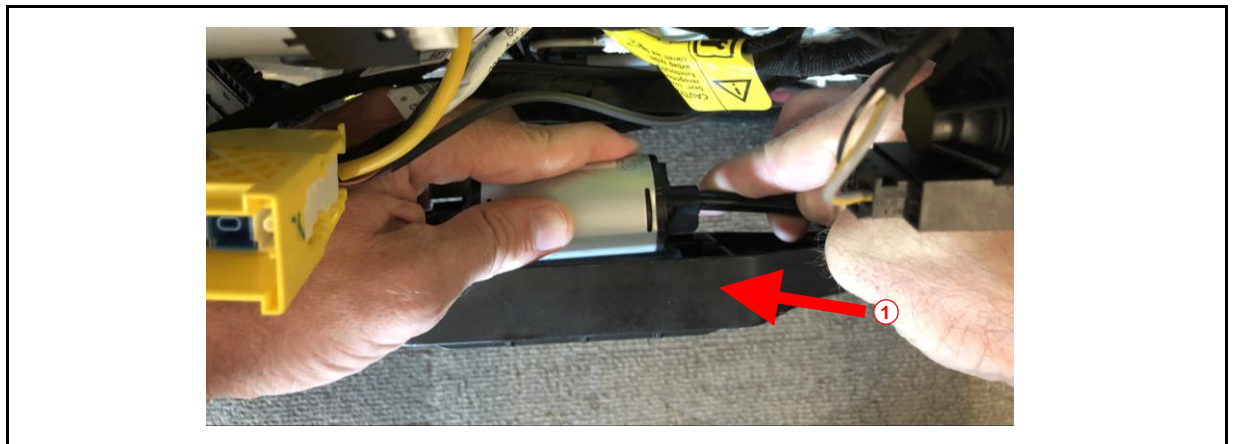
Figure 14.

11. While holding the motor installed to the first driveshaft, install the second driveshaft to the motor. Some bending of the second driveshaft may be needed to fully install to the motor.

1	Insertion Direction
---	---------------------

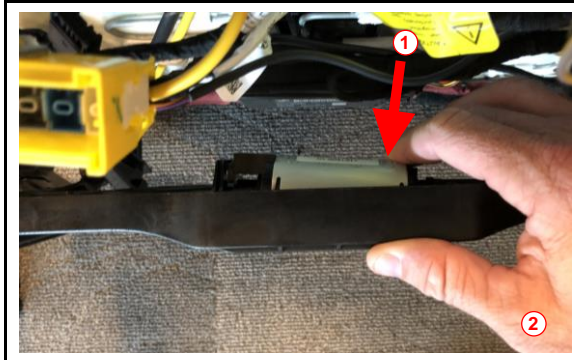
Figure 15.

12. With BOTH driveshafts installed to the motor, clip the motor into the carrier by pressing DOWN on the top of the motor right-hand side first, then left-hand side. Ensure driveshafts are fully seated on the two right-hand and left-hand side carrier clips.

1	Pushing Direction
2	Right-hand Side

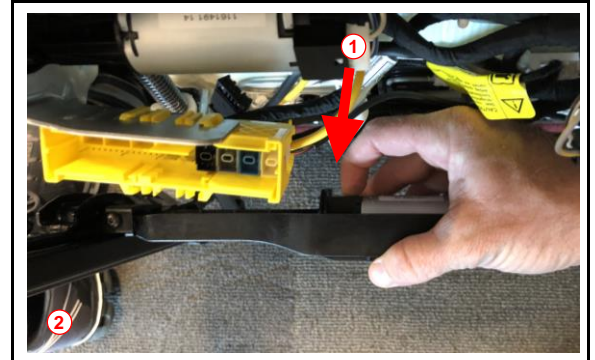
Figure 16.

1	Pushing Direction
2	Left-hand Side

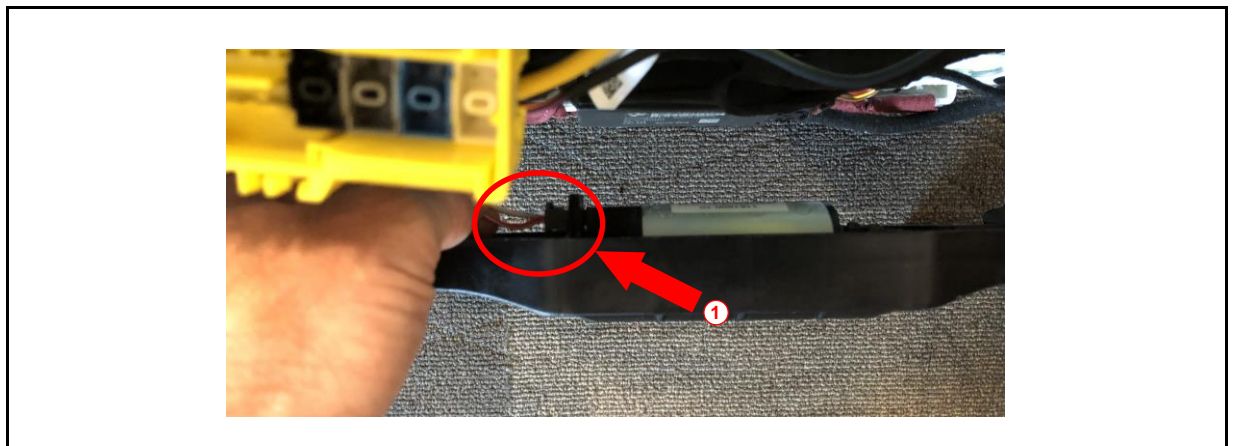
Figure 17.

13. Install the wire harness to the seat motor wire harness clip.

1	Seat Motor Wire Harness Connector
----------	--
