SIB 66 20 17 DISPLAY KEY IS NON-FUNCTIONAL

2020-01-24

This Service Information Bulletin (Revision 3) replaces SI B66 20 17 **dated October 2019**.

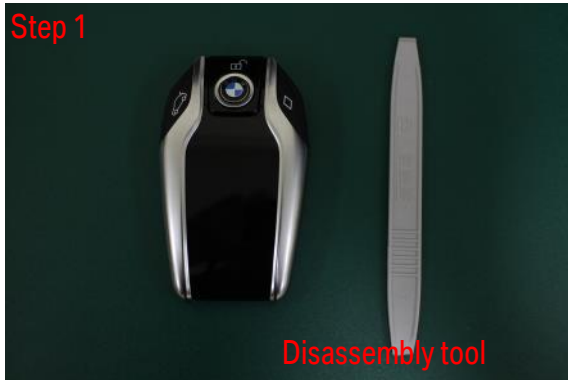
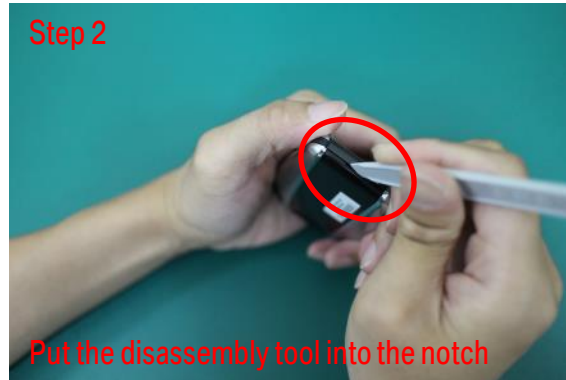
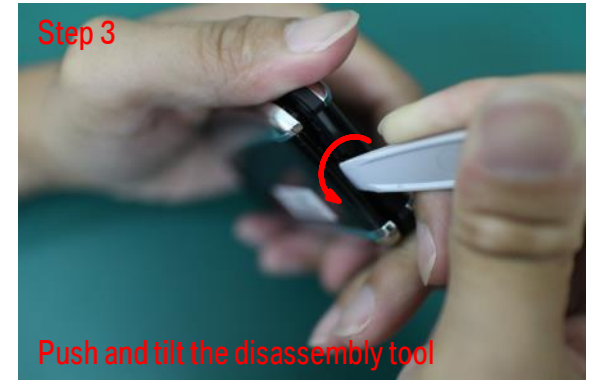
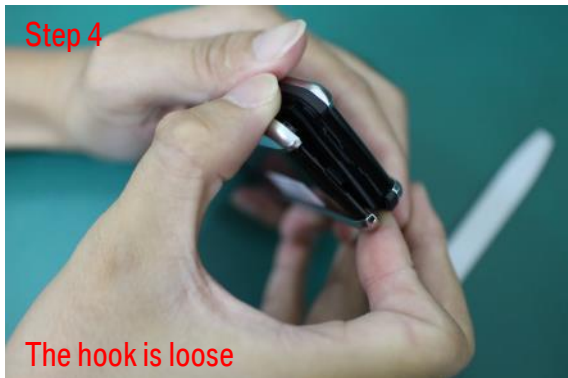
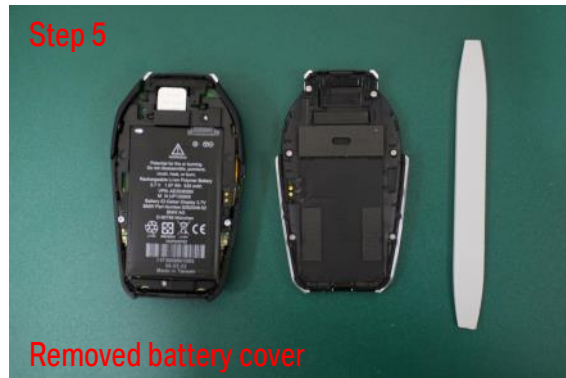
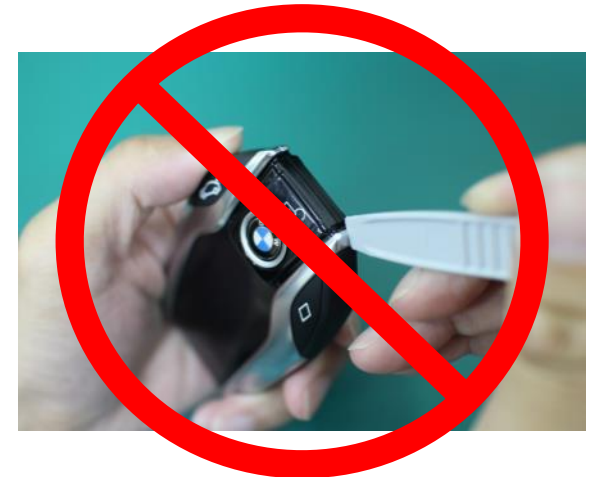
How to remove the battery cover?

DISPLAYKEY BATTERY RESET/EXCHANGE

DO NOT disassemble battery cover from top side.

3. Remove the battery from the display key (as per instructions in attachment) and then reinsert the battery.

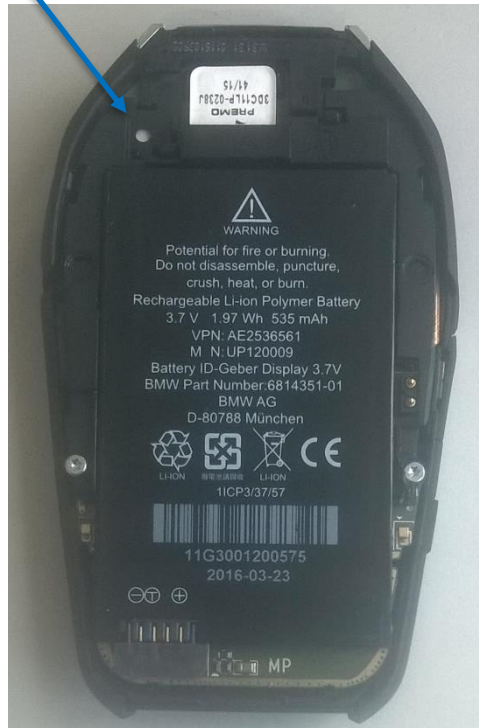
white color: no water ingress

4. Examine the moisture indicator above the battery (as per instructions in attachment).

NO – if the indicator is still white, the display key warranty has not been voided by excess moisture exposure. Go to next step.

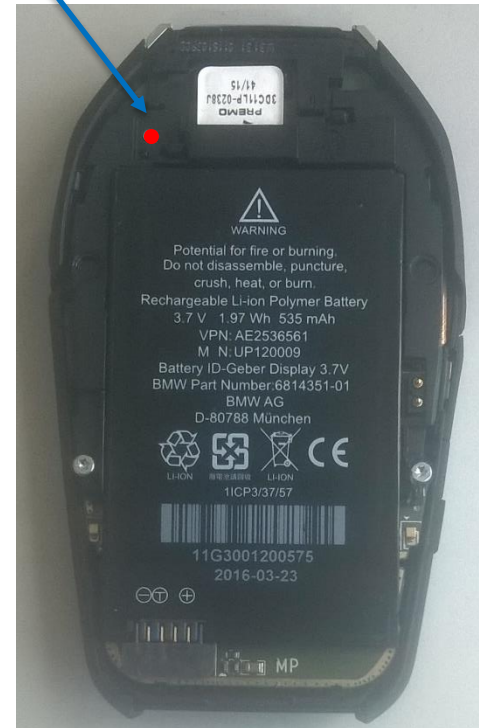
red color: water was in the key!

YES – the display key has been subjected to excess moisture and is NOT replaceable under warranty.

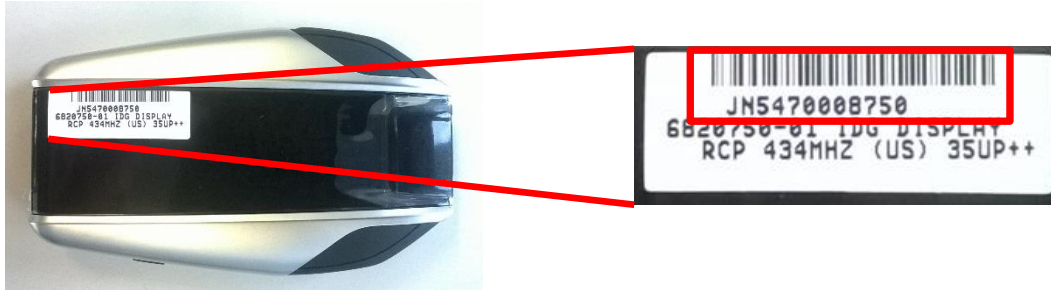
Serial-No on housing-label (probably already removed by dealer/customer):

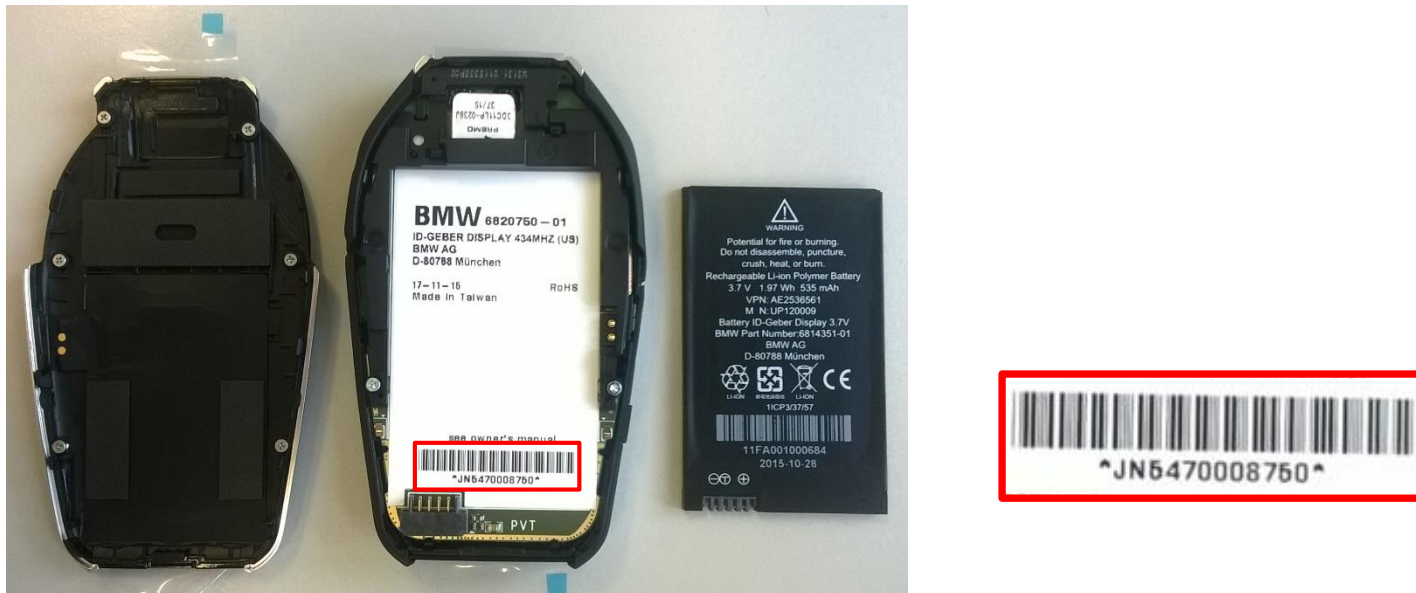
Serial-No on inside label below the battery:
