Power Sliding Door Reverses Direction When Closing

Supersedes 19-028, dated April 9, 2019, to revise the information highlighted in **yellow**.

Year	Model	Trim	VIN Range
2018	Odyssey	ALL except LX	ALL
2019	Odyssey	ALL except LX	From VIN 5FNRL6H..KB000001 thru 5FNRL6H..KB022148

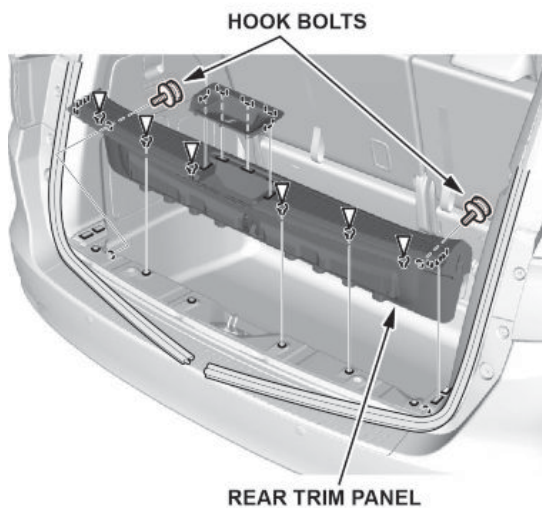
1. Check for debris or damage on the sliding door rails, rollers, or along the pathway of the power sliding door that would prevent it from operating properly.
 - If damage or debris is found, this bulletin does not apply. Repair the damage or clear the debris per normal repair procedures.
 - If no damage or debris is found, go to step 2.
2. Remove the rear trim panel.
 - 2.1. **Set the third row seats upright.**

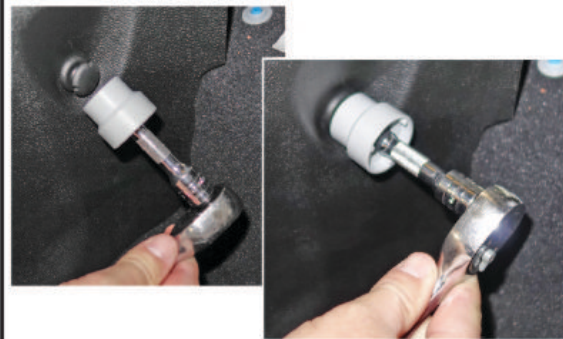
If necessary, use Special Tool 07AAA-SEPA100 to loosen the hook bolts.

- 2.2. **Remove the weatherstrip as needed.**
- 2.3. **Remove the rear trim panel. If necessary, use special tool 07AAA-SEPA100 to remove the hook bolts.**
- 2.4. **Fold down and stow the third row seats.**

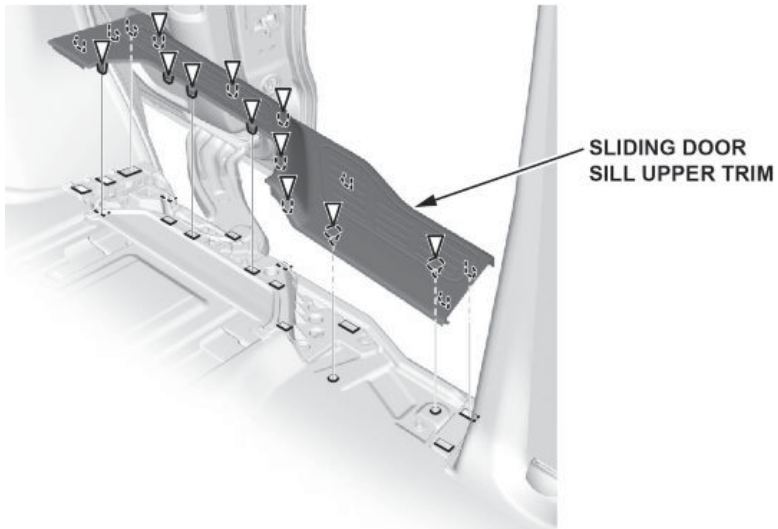
3. Remove the left sliding door sill upper trim.

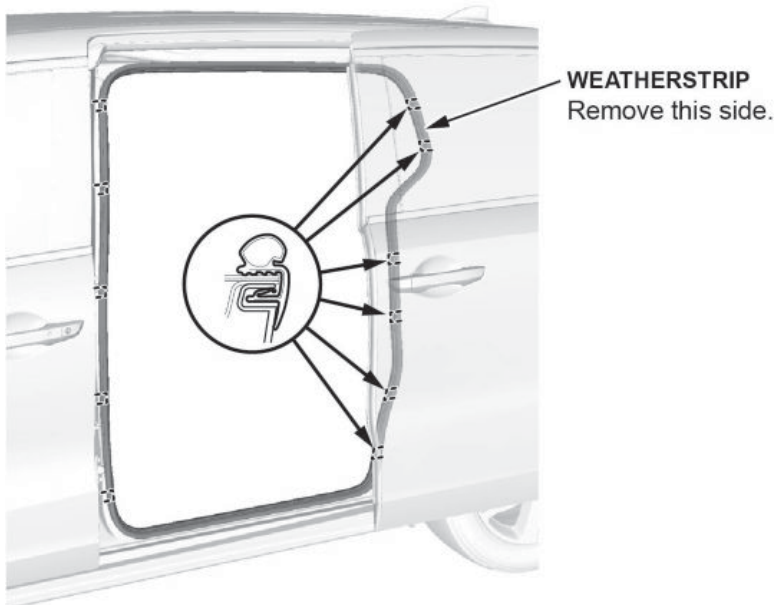
4. Remove the weatherstrip along the left rear side trim panel as needed.

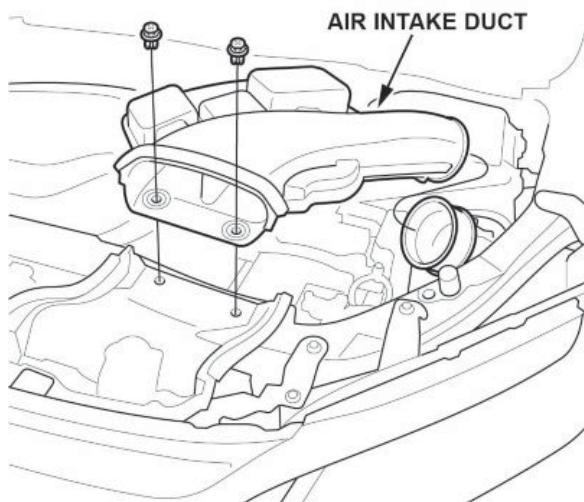
5. Remove the air intake duct.

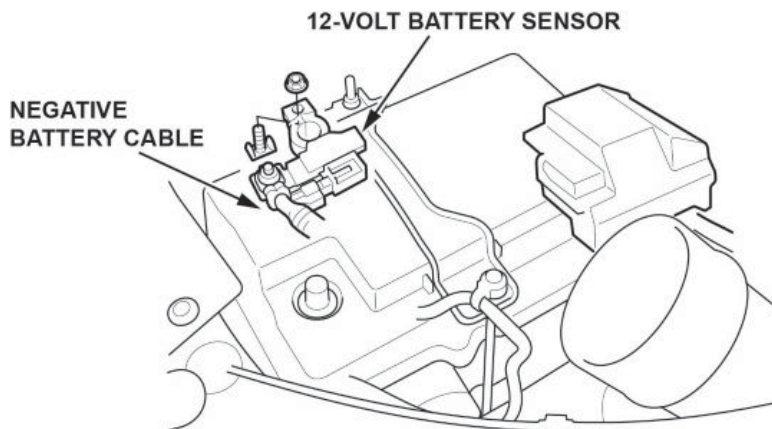
6. Disconnect the 12-volt battery.

6.2. Disconnect and isolate the negative battery cable with the 12-volt battery sensor from the 12-volt battery.

- Always disconnect the negative terminal first.
- To protect the battery sensor connector from damage, do not hold it when removing the terminal.
- Do not disconnect the 12-volt battery sensor from the cable.

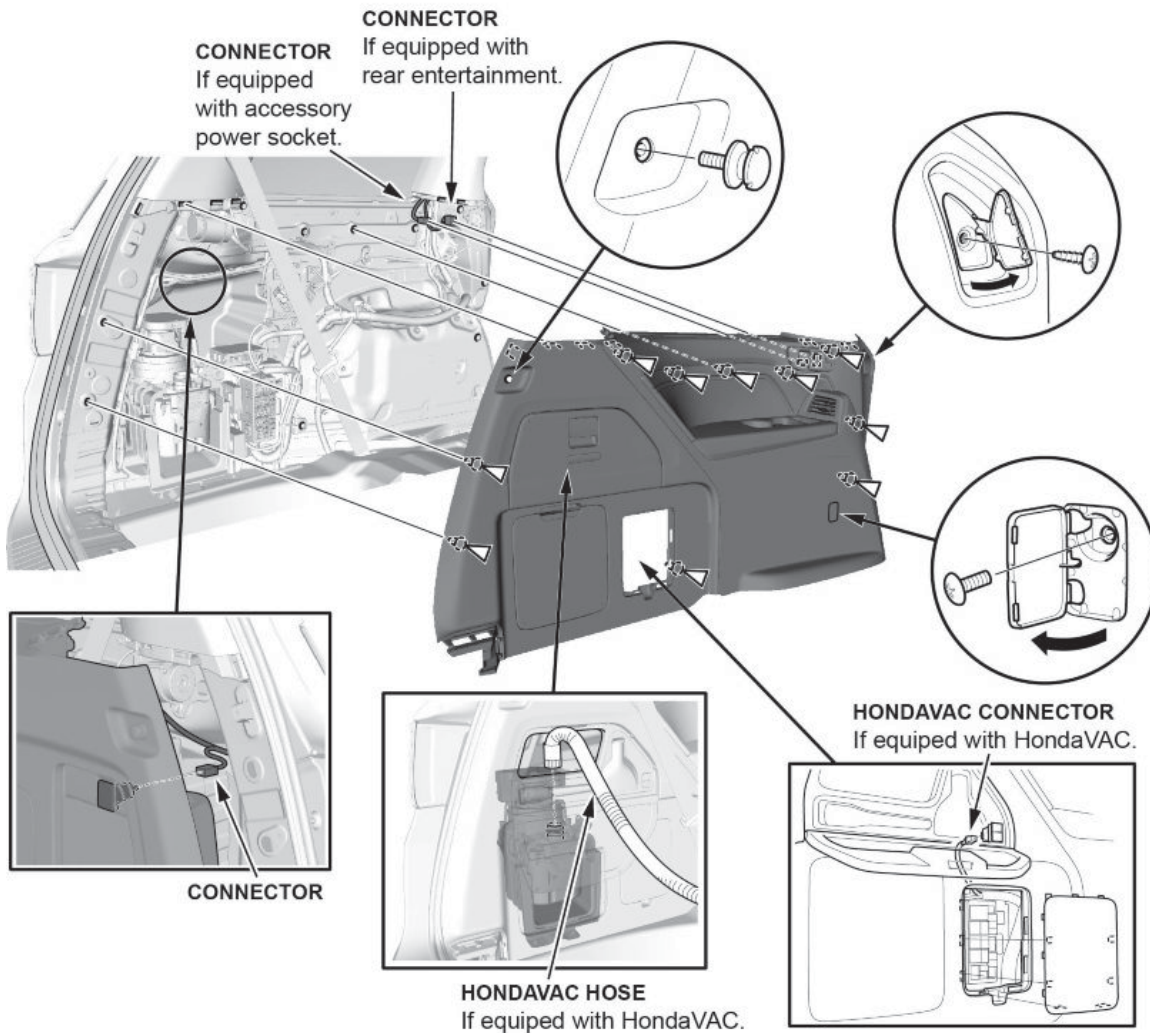
7. *Left side PCB module replacement:* Remove the left side rear trim panel. In addition to removing the panel, do the following if it applies to the vehicle:

- Remove the shop vacuum hose from the vacuum, and disconnect the connector.
- Disconnect the rear entertainment connector.
- Disconnect the rear accessory power socket.

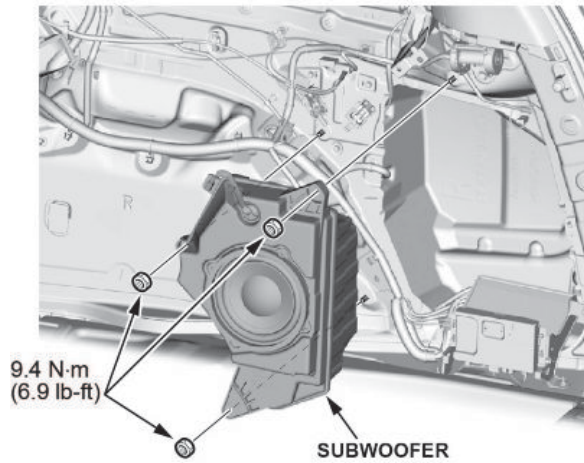
Right side only

9. *Right side PCB module replacement:* Remove the subwoofer.

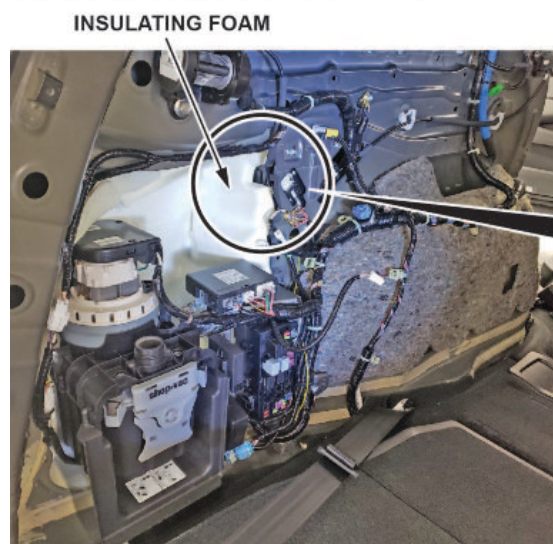
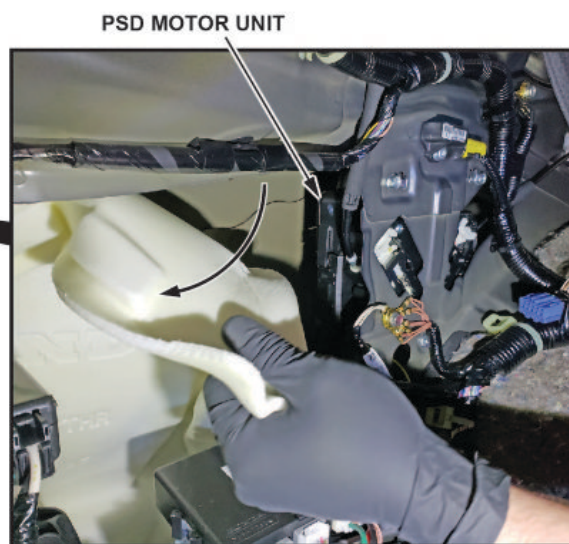
Left side shown; Right side is similar

10. Fold the insulating foam out of the way so you can access the PSD motor.

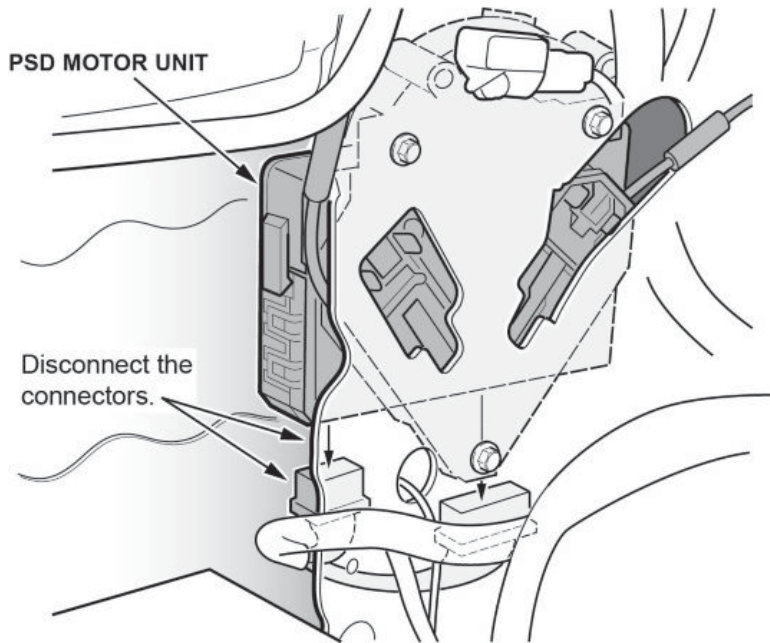
11. Disconnect the PSD motor unit connectors.

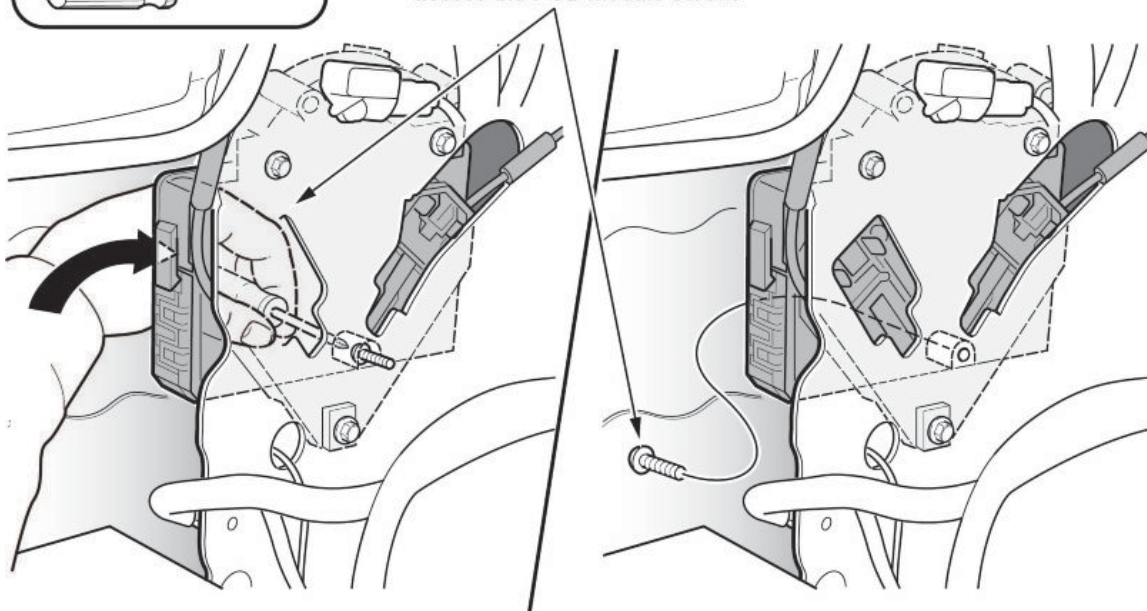
12. Remove the screw holding the PCB module.

- Use a small #1 screwdriver that is less than 4.9 in. (12.5 cm) long. You will not be able to fit a larger screwdriver in the opening.
- You may need to use a mirror to locate the screw because it is located between the body and the motor unit.
- **Be very careful when removing the screw so that it is not lost** between the body and the fenderwell. A replacement screw is included in the kit in case you lose the original.

Reach inside the cavity to access the PCB module screw.

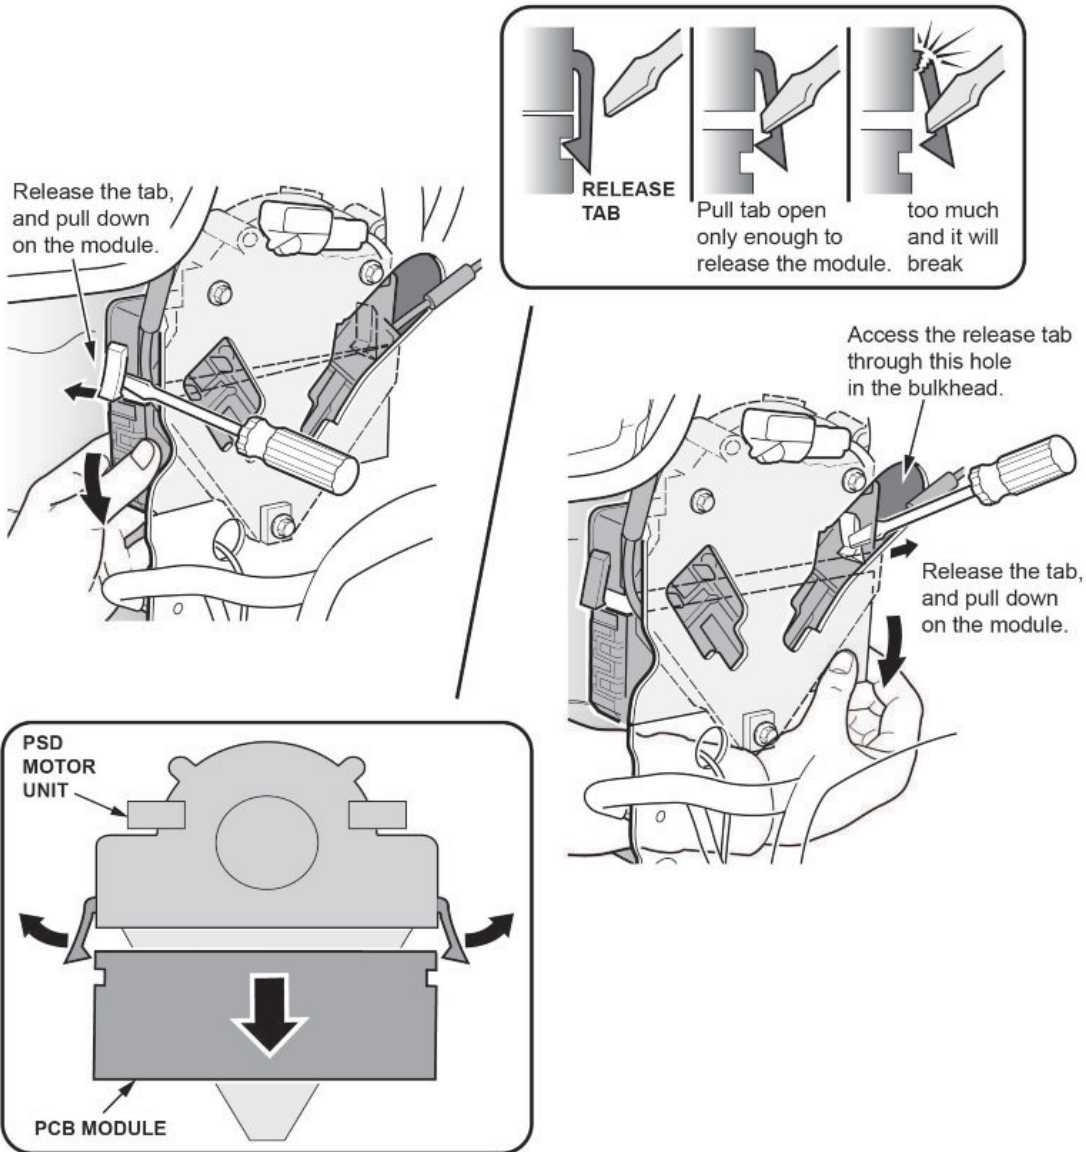
13. Release the PCB module from the motor unit by pulling the PCB module down while releasing the two tabs.

- **Be very careful releasing the tabs.** They are fragile and should not be opened more than a few millimeters because they may break.
- The PCB module is firmly installed in the motor unit and requires significant force to pull it out. Do not assume that the tabs are not open far enough because the tabs may break.

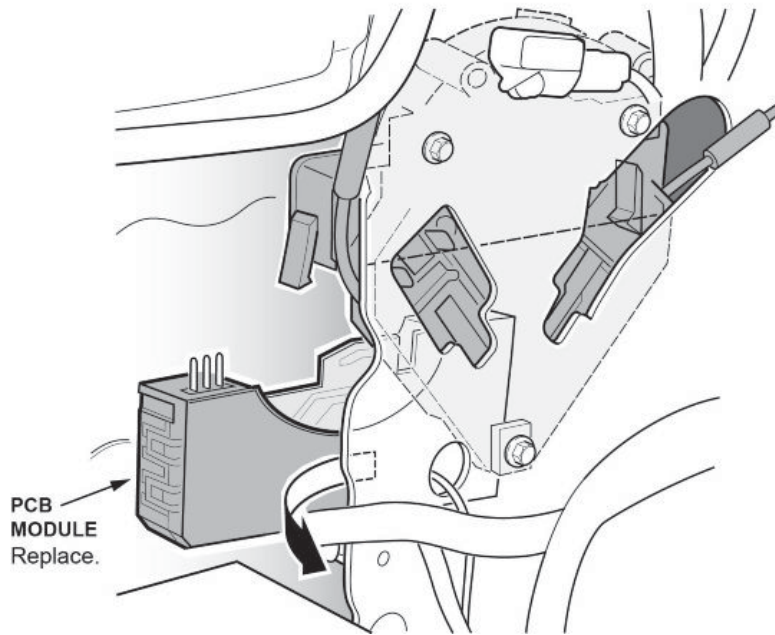
14. Remove the PCB module.

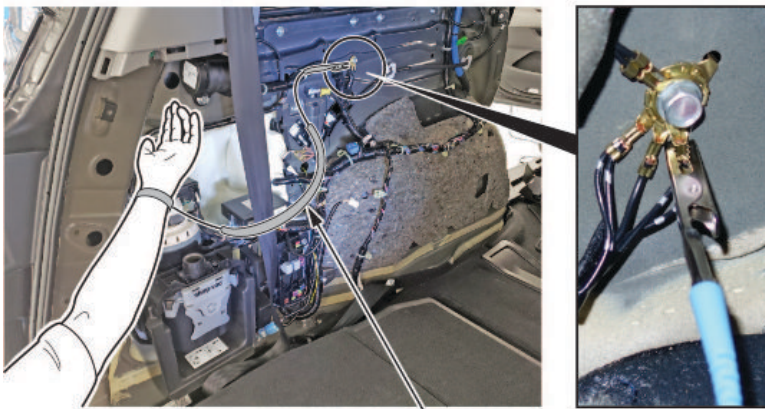
ESD WRIST STRAP

15. Place the anti-static (ESD) wrist strap included in the PCB kit on your bare arm, and attach it to a grounding screw before touching the new PCB.

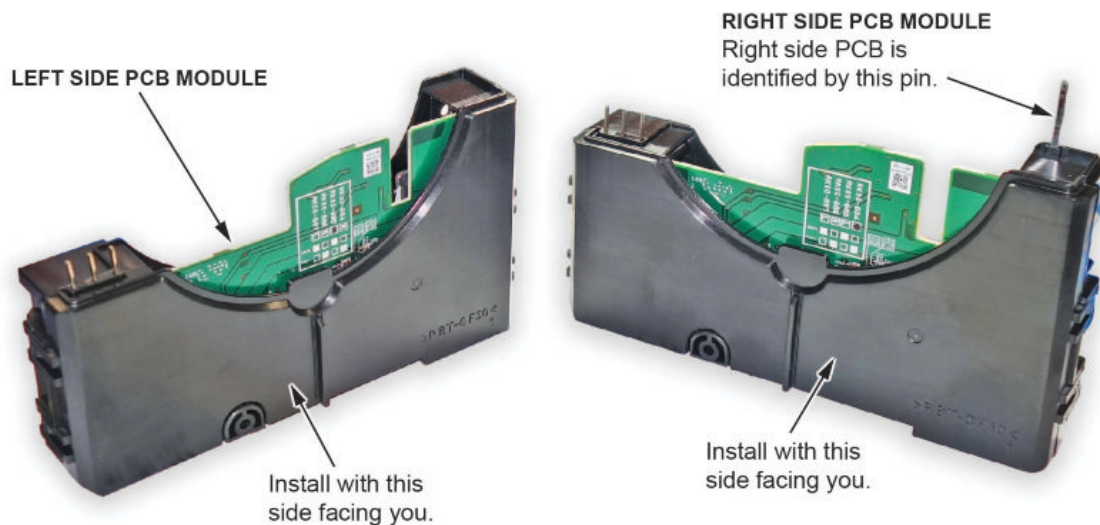
16. Insert the new PCB module into the motor unit assembly. Install the screw to secure the module.

The left and right side PCB modules appear similar, but they are not interchangeable. Make sure you install the correct module in the correct side because if you do not, the power sliding doors will not work properly.

17. Connect the battery, and check that the door operates properly.

18. Install the remaining parts in the reverse order of removal.
