| Title | Mack Chassis - <b>Anthem (AN)</b> - Hood Mounted Mirror Repair; Mirror Covers Loose, Rattling, Vibrating |

| <b>Mack Model</b> | AN - Anthem |

| Cause | Mack Anthems with hood mounted mirrors may experience rattling or vibration from the mirrors. This may be due to worn tabs on the mirror covers. |

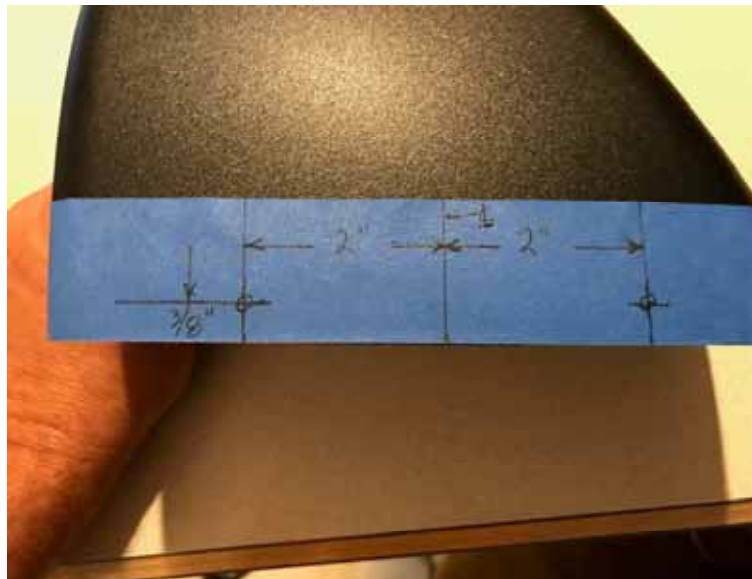
1. Lay out two 5/64" pilot holes on 2" centers 3/8" from the edge. A piece of painter's tape can be used to mark measurements.

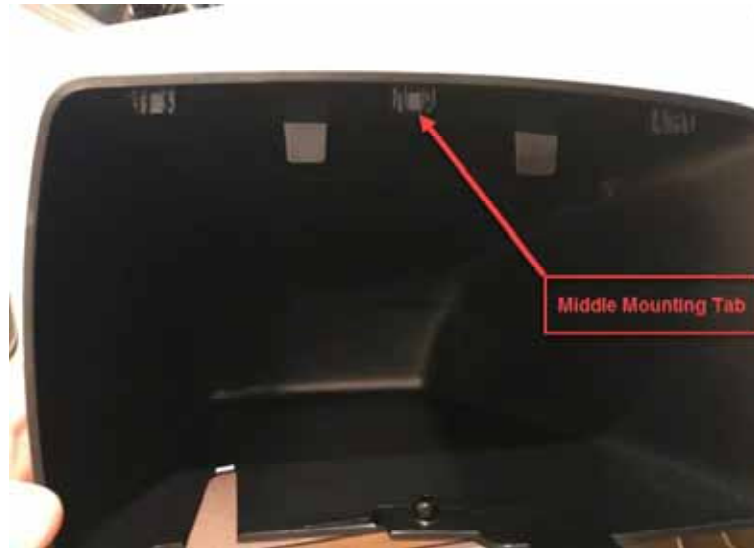
2. Transfer tape to the housing.
  - 2.1 Align centerline with the middle mounting tab inside the housing.
  - 2.2 Reinstall housing to the mirror.
  - 2.3 Drill two 5/64" pilot holes in the housing and the mirror body.

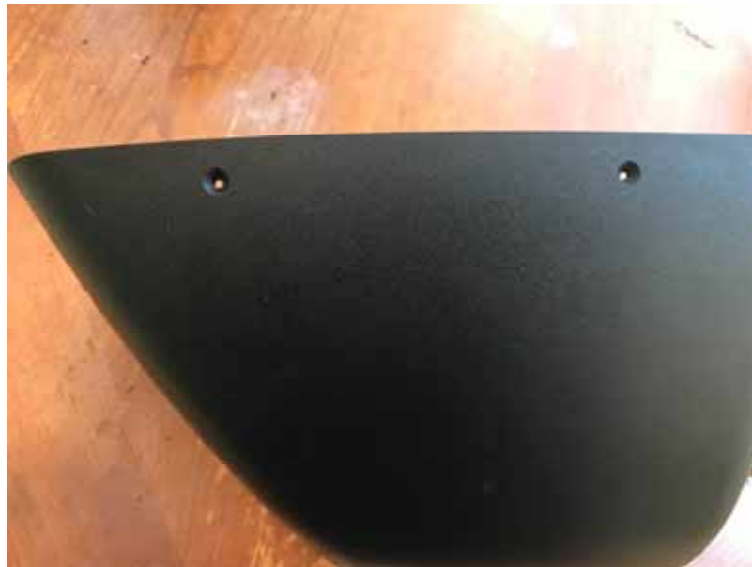
3. Remove housing and drill countersinks for #6-1/2 stainless steel screws.

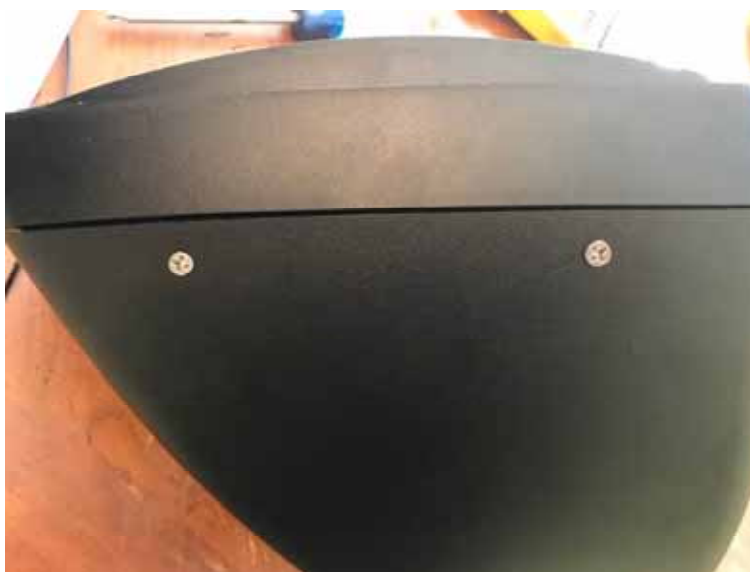
4. Reinstall housing with original screw on the bottom and two (993622) screws at the top.

**NOTE:** Do not over tighten the screws.
