Subject: MAZDA3 (MEXICO BUILT) TRUNK DISABLED / HIDDEN KEY AND FOB RETRIEVAL	Service Alert No.: SA-021/20
	Last Issued: 02/04/2020

2019-2020 Mazda3 (Mexico built)

DESCRIPTION

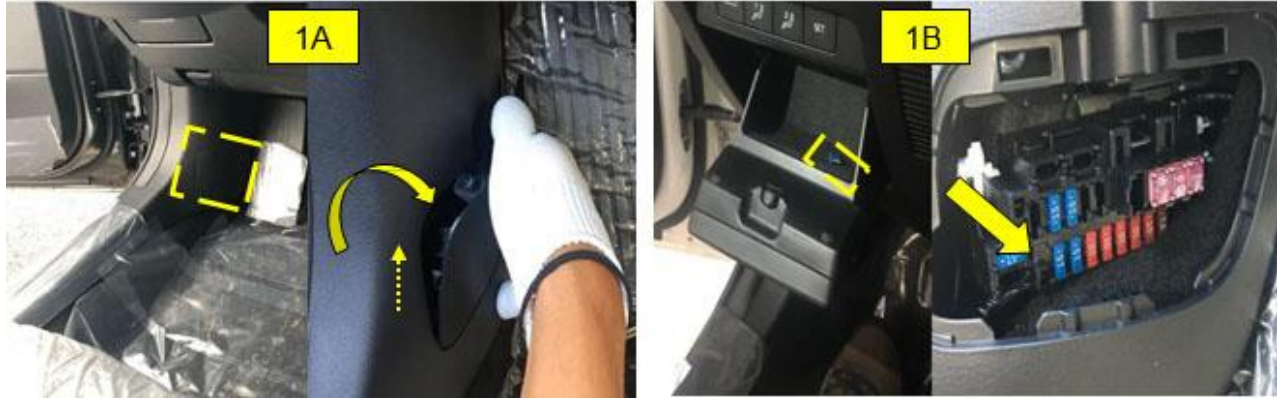
- a. Open the driver's door.
 - b. Locate the fuse box, which is along the bottom left side (1A).
 - c. Open the fuse box by holding the fuse box lid with the right hand and pressing on the clip with the thumb to release the cover.
 - d. Remove the clip on the sides and carefully pull the lid out.
 - e. Locate the 15 amp blue colored fuse hidden in the lower panel compartment on the left side of the steering wheel (1B).
 - f. Avoid touching the metal tabs of the fuse and carefully install the fuse into empty space F15 (1B). Space F15 can be verified by referencing the inside of the fuse box lid.
- NOTE:** Make sure the fuse is installed fully into position and flush with all of the other fuses.
- g. Reinstall the fuse box lid in the reverse order of removal.
4. Retrieve the key/fob hidden in the cargo area.

1. Verify that the key/fob is missing from the main cabin.
2. Verify that the Mazda3 is manufactured in México as the Mazda3 sedan is manufactured in both Mexico and Japan. This can easily be identified by the first three (3) digits of the VIN: 3MZ = Mexico Plant.
 - If manufactured in Mexico, go to the next step to enable the trunk and retrieve the hidden key/fob.
 - If not manufactured in Mexico, this SA does not apply.
3. Enable the trunk lid opener by installing the back door lock fuse into the fuse box located in the driver's footwell.
