WARRANTY BULLETIN QUALITY

Campaign no.: 2020-0006

Subject: **Spyder® RT - Abnormal Gaps Around the Rear Cargo Module Access Covers**

No. **2020-4**

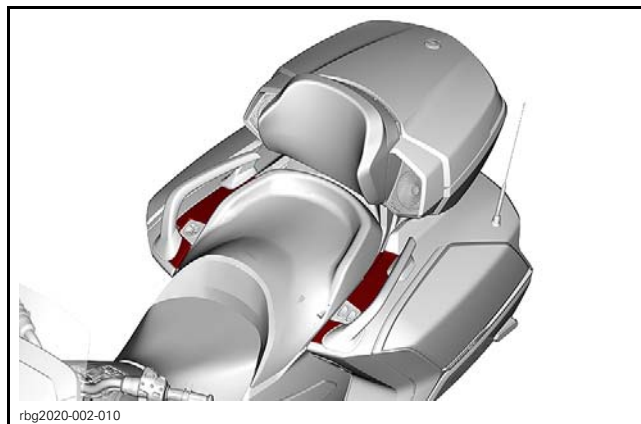
rbg2020-002-010

On some Spyder RT manufactured since February 6th, abnormal gaps may be present between both rear cargo module access covers and adjacent body parts.

Replace both access covers.

1. Remove the passenger seat.
2. Remove and keep both screws securing the access cover.
3. Remove and discard the access cover.
4. Position the access cover and loosely install the previously removed screws.
5. Move the access cover to have an equal gap in back and in front.
6. Hold the access cover in this position and tighten screws.

TIGHTENING TOQUE	
Access cover screws	2.75 N•m ± 0.25 N•m (24 lbf•in ± 2 lbf•in)

7. On the other side of the vehicle, repeat steps 2 to 6.
8. Reinstall the passenger seat.
