Technical Service Bulletin

34 Vehicle Electronics Malfunction message, DTC B116229 is stored in the steering wheel or vehicle electronics module

34 20 43 2047609/2 February 19, 2020. Supersedes Technical Service Bulletin Group 34 number 17-20 dated April 25, 2017 for reasons listed below.

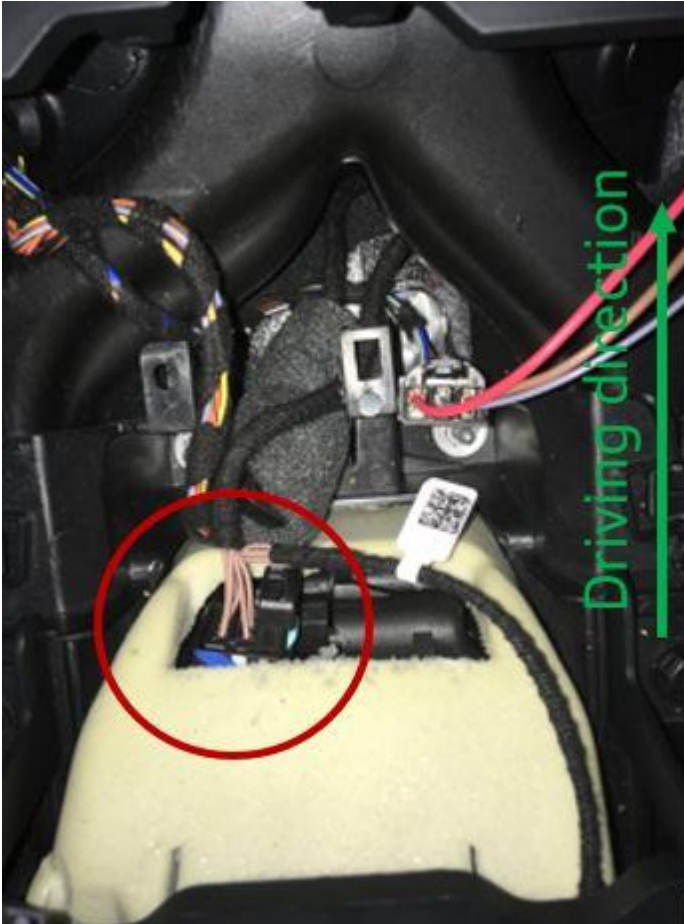
Figure 3. The electrical connection of the selector lever control module.

2. Disconnect the electrical connector from the selector lever control module (Figure 3).

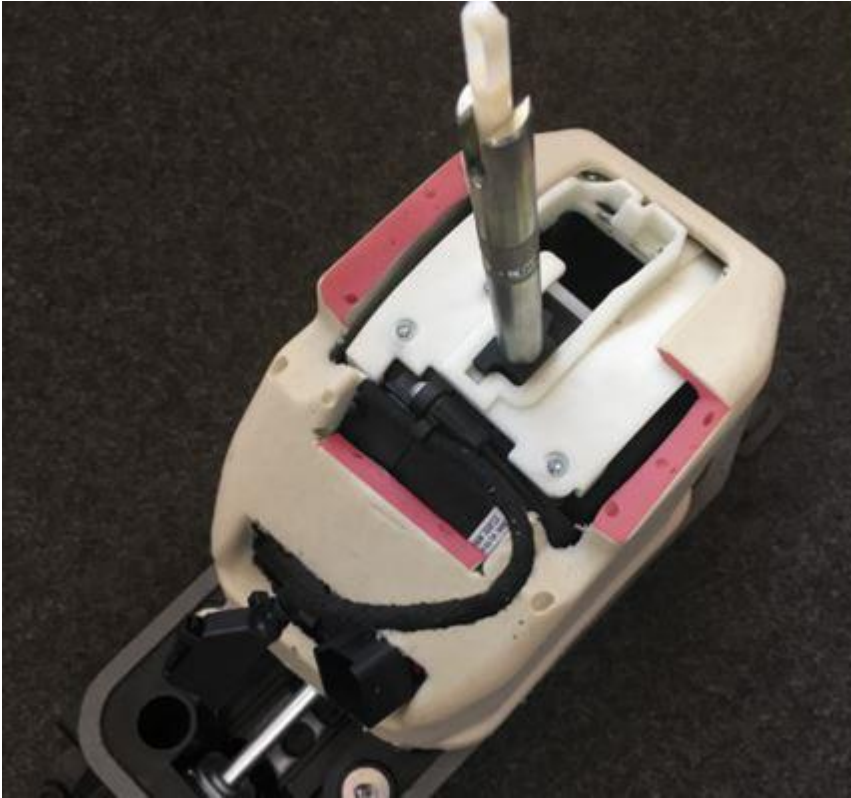
Figure 5. Example of modified insulation installed on a shifter housing.

- Carefully reinstall the foam insulation as shown above (Figure 5).

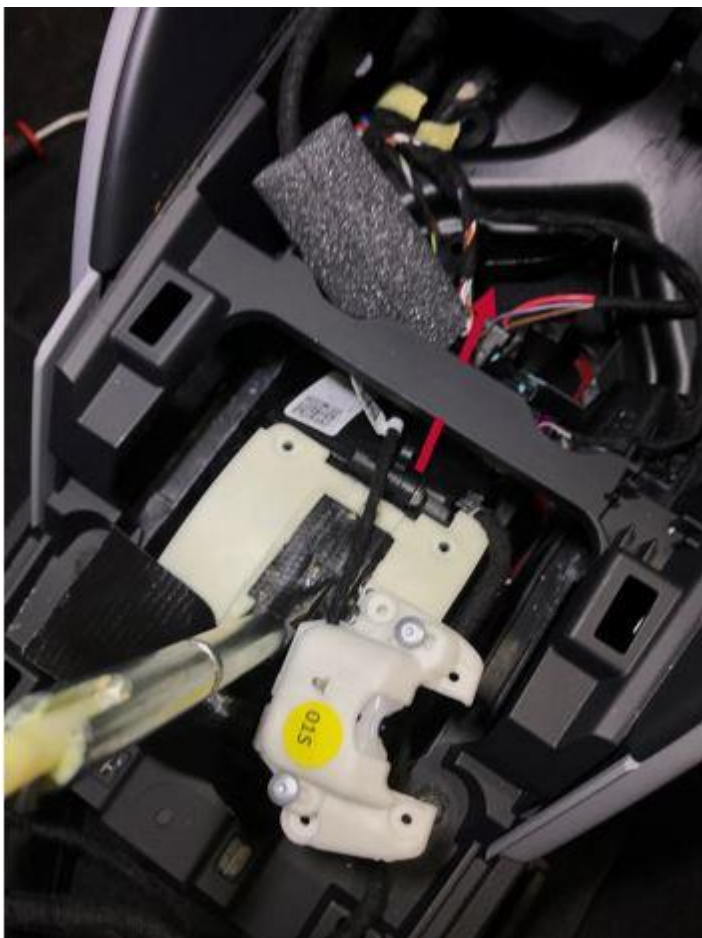
Figure 8. Wiring harness run under the crosspiece.

7. Lead the Y cable wiring harness of the new micro switch module under the crosspiece and on top of the foam insulation (Figure 8).

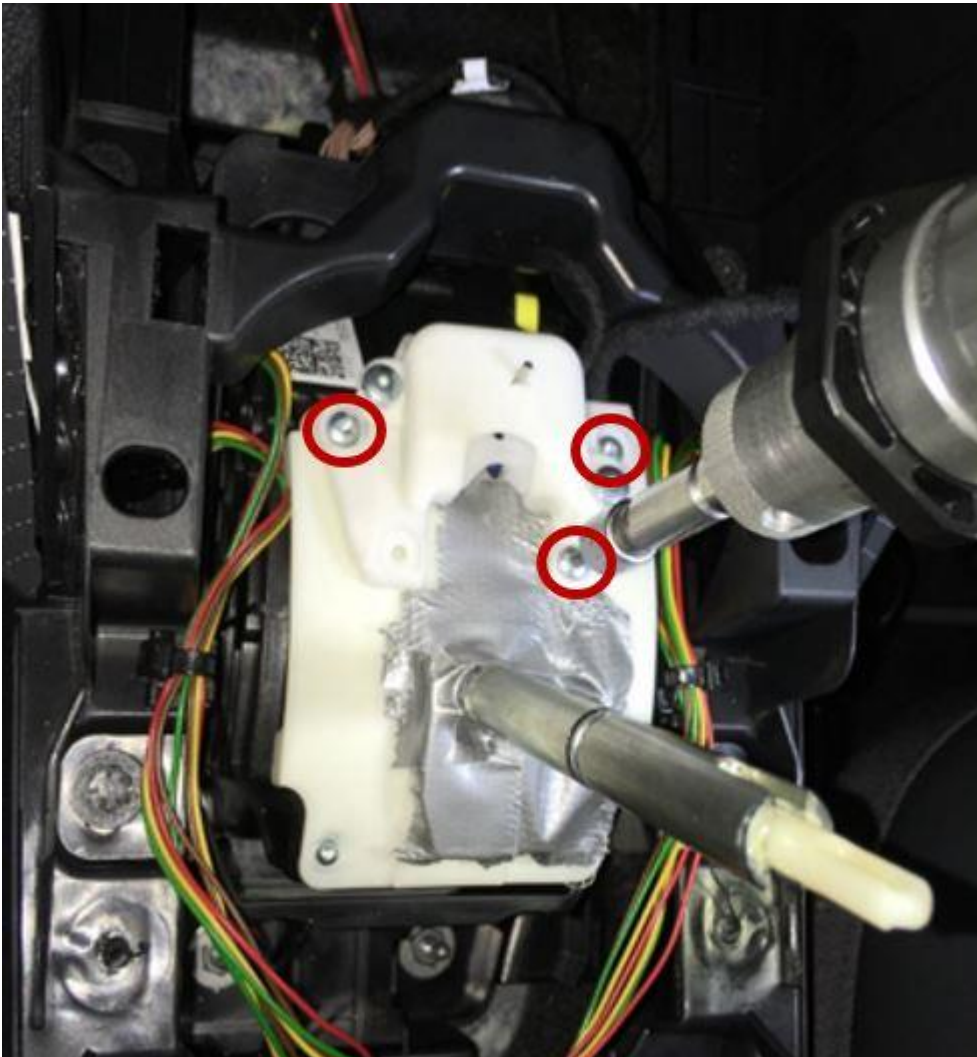
Figure 10. *Installing the microswitch module.*

9. Install the microswitch module to the selector using the new longer T-9 screws included in the repair kit. After all three screws have been started, remove any of the tape that might interfere with the base of the microswitch module. Torque the screws to 1.0 Nm and remove the remaining tape from the shift gate (Figure 10).

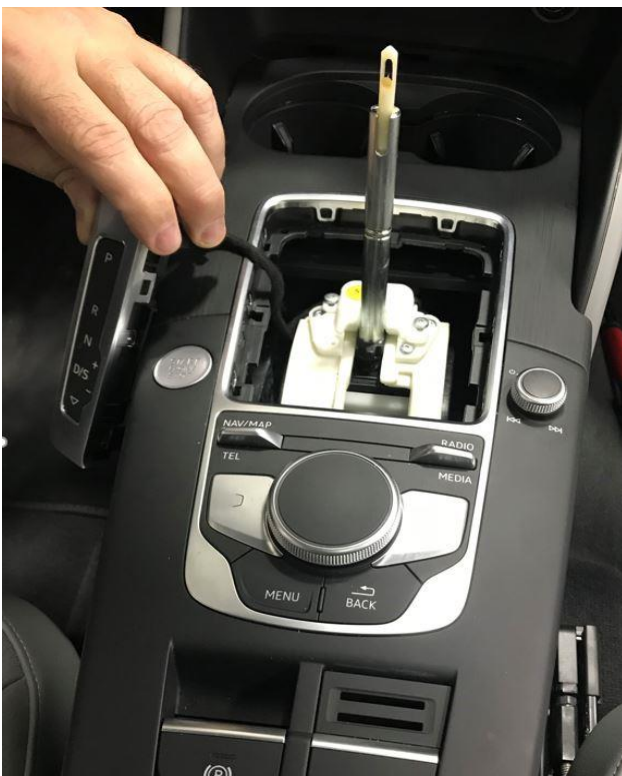
Figure 13. Console insert installed.

12. Reinstall the center console insert. Make sure all wiring has been routed correctly and cannot be damaged by sharp edges. Plug in display unit Y26 but do not install it in the console yet. (Figure 13).

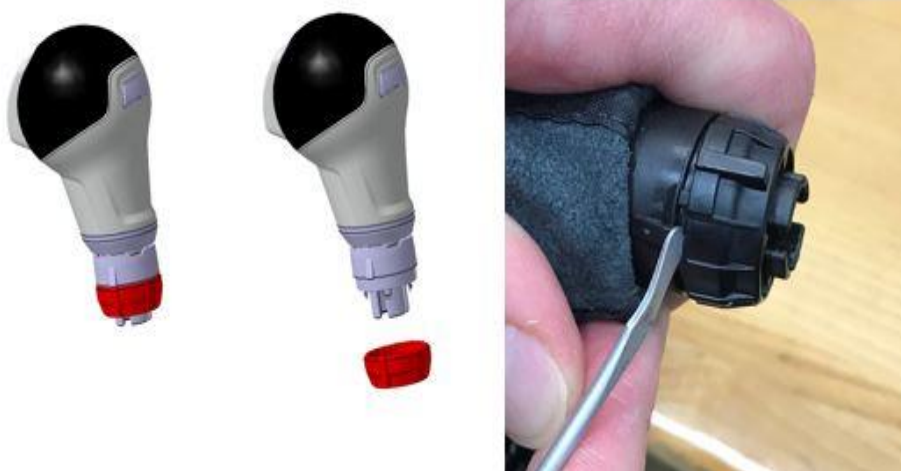
Figure 14. Locking collar removing.

13. Install the new selector lever handle sleeve on the bottom of the shift knob. The original locking collar can be removed with a small screwdriver or micro pry bar (Figure 14). The new selector lever handle sleeve snaps in place of the old collar (Figure 15) and operates with the same locking function while protecting the microswitch module from interference with the shift boot.

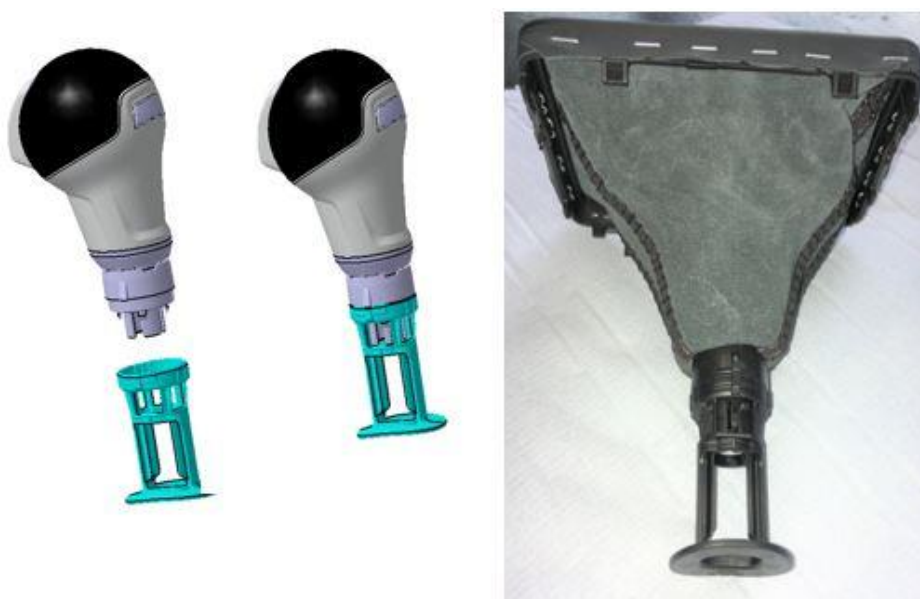
Figure 15. Selector lever handle sleeve.
