SS 1034558 OBD16 M2,108SD & 114SD Allison transmission not shifting due to harness chafing

M2, 108SD and 114SD OBD 2016 vehicles with Allison 1K, 2K, 3K and 4K transmission.

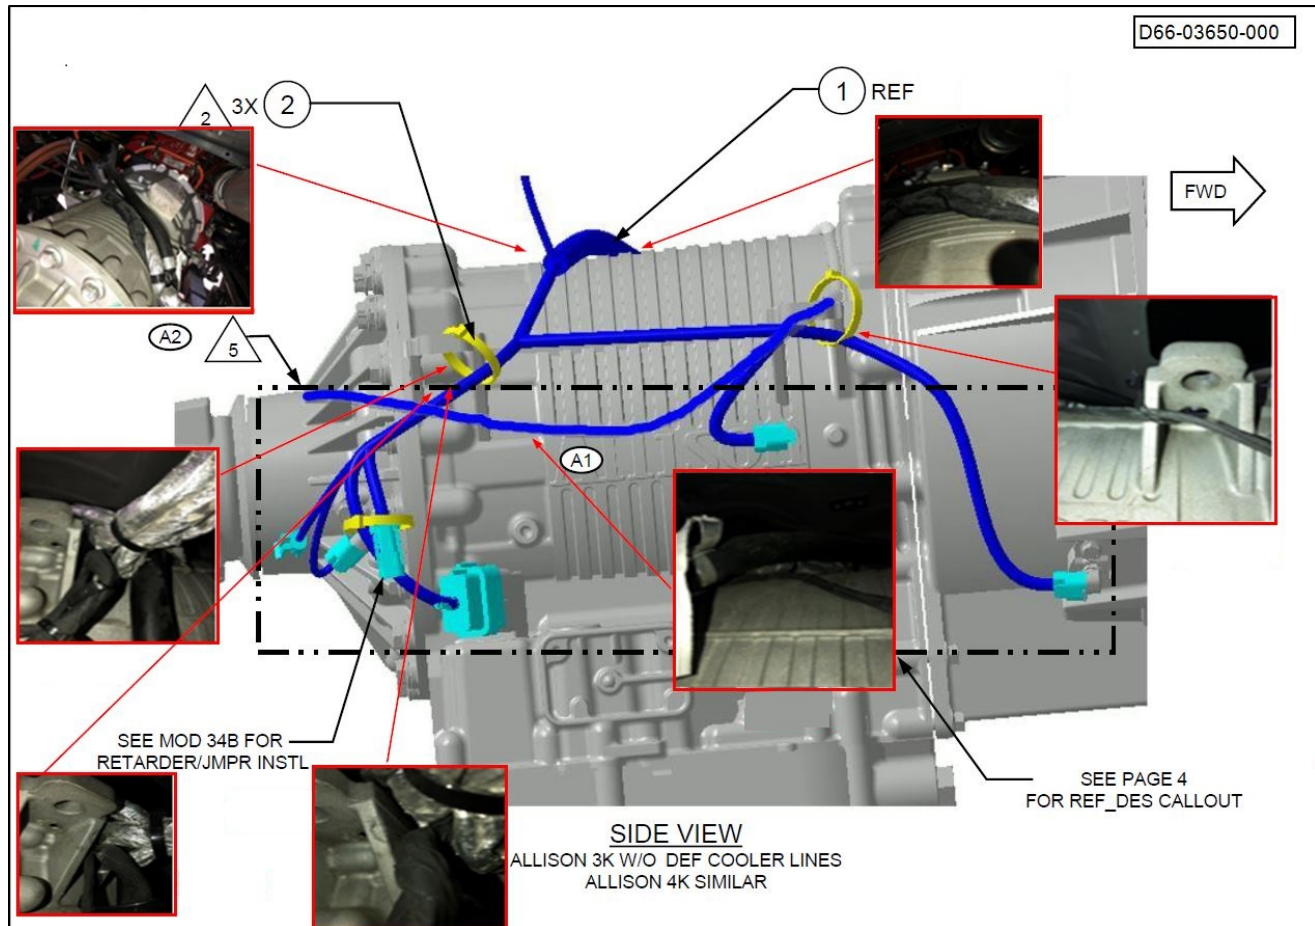
Picture 1

Chaffing can occur on several areas of the transmission wiring as noted in the first picture 1 below. The example picture is of an Allison 3K transmission, but similar chaffing can occur on the 1K, 2K and 4K transmissions. Over time the chaffing can lead to wires coming in contact with each mounting point and or wires coming in contact with each other.

To reduce the risk of chafing , fastening location on the transmission were update at both Mount Holy and Santiago truck plants on 9/26/2019. The updates for each of the vehicle / transmission types is listed below and labeled. If chafing is found at or around any of the mounting points on the transmission, it would be recommended to update the harness routing per the vehicle / transmission types listed below.
