SERVICE BULLETIN

Reference number:	SB-06-1117V4	Issued: 21 February, 2020
Subject:	Brake Squeal	
Model(s):	DB11 & Vantage 19MY (with steel brake discs)	
VIN Range:	All	
Applicable to:	All Dealers	
Distribute to:	After Sales Manager Executive Manager Service Manager Sales Manager	Warranty Staff Technician(s) Parts Staff

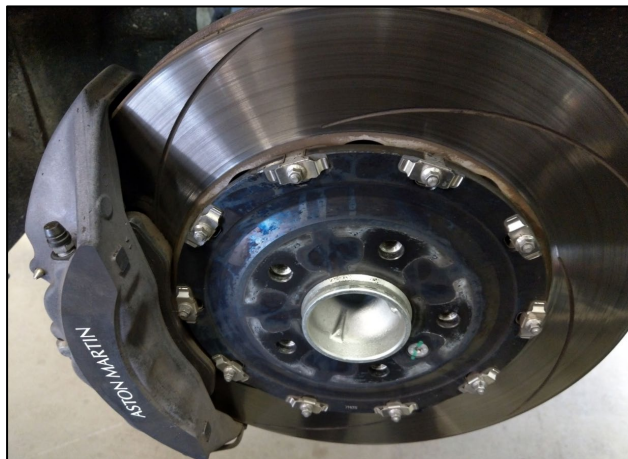
Do a visual inspection of the brake discs, pads and wheel mounting face for signs of external contamination. If there are signs of external contamination because the incorrect wheel cleaner was used, this damage will not be covered by the vehicle warranty. The brake pads must be replaced. Figure 1 gives an example of contamination on the wheel mounting face and calliper.

4. Use an abrasive paper to fully clean the braking surface of all four brake discs.
5. With the brake discs and callipers in position, clean all brake dust and contaminants with an aerosol brake cleaner.
6. Apply Tunap paste to the rear of the brake pads (refer to Service Bulletin SB-06-0344V2).
7. Do Service Bulletin: SB-06-1005 - Low-Speed Brake Modulation, if applicable.
8. Do the brake pad bedding-in procedure (refer to Workshop Manual procedure 06.03.BC).
9. If there is still a noise, start a SpotLight case for authority to send an order for parts with the -BB suffix.

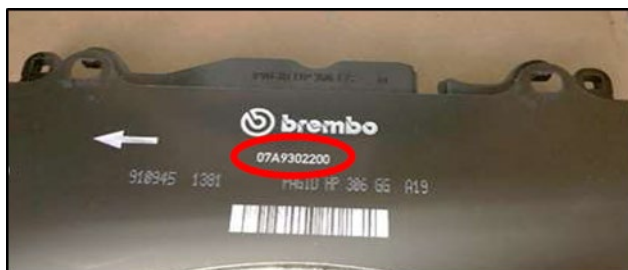
Figure 2

1. Remove the brake pads (refer to Workshop Manual procedure 06.03.AD or 06.04.AD).
2. Do a check of the manufacturer's part number (refer to Figure 2).

3. Use the manufacturer's part number to find the Aston Martin part version, in the table below (refer to Figure 3). Follow the recommendation for the part version.

- Pictures of the brake discs, pads, pad level information (refer to Figure 2), hubs and callipers.
- A video file, with audio, before steps 1-6 are done.
- A video file, with audio, after step 6 is completed.
