Service Action

Code: 60E5

Subject	Front Sunroof Drain Cleaning & Modification																												
Release Date	February 27, 2020																												
REVISION SUMMARY	Model code chart updated to include 2017 Golf Alltrack.																												
Affected Vehicles

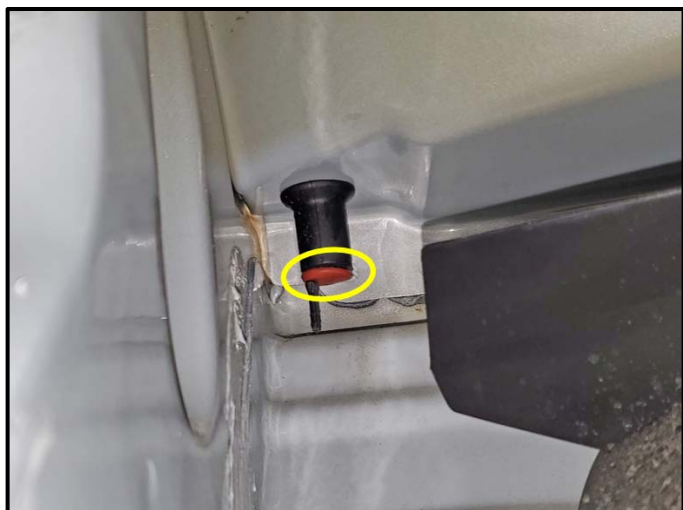
Repair Overview

- Remove flaps from left front and right front sunroof drains.

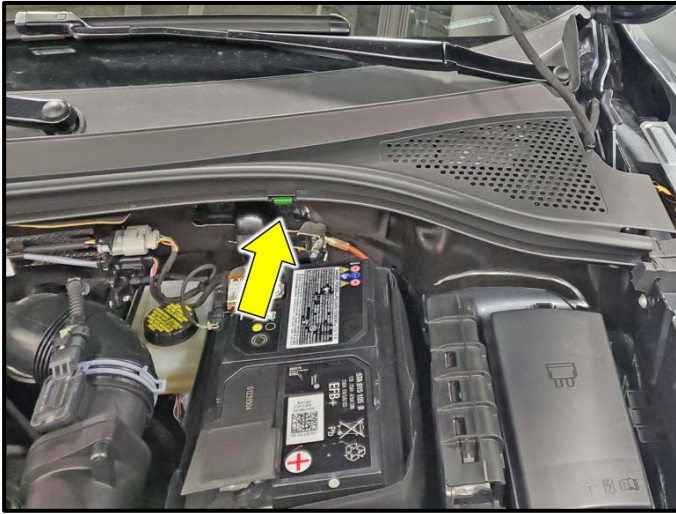
Remove plenum chamber cover clips:

- Remove the outer most plenum chamber cover clip <arrow> on the left and right plenum chamber covers.

Left side shown. Procedure for right side is similar.

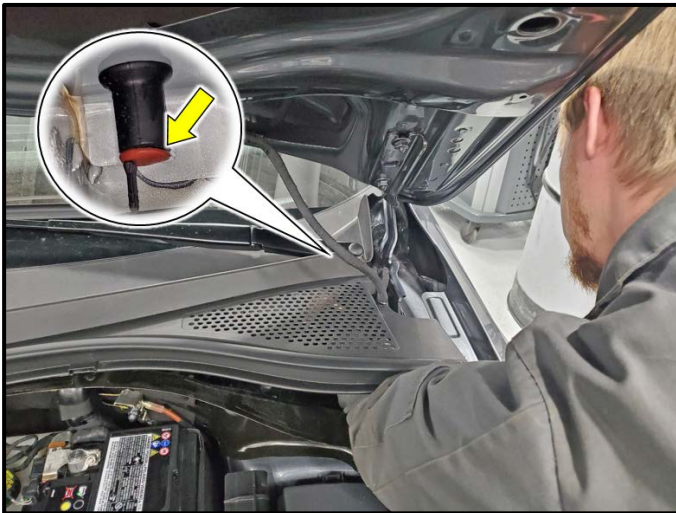
Removing sunroof drain flap:

- Carefully lift the plenum chamber cover approximately 15 cm.
- Reach in along the outer edge of the plenum chamber (between the wiper transmission and the plenum chamber on the left side).
- Carefully remove the red sunroof drain flap <arrow> downward off the sunroof drain.
- Repeat on the opposite side.

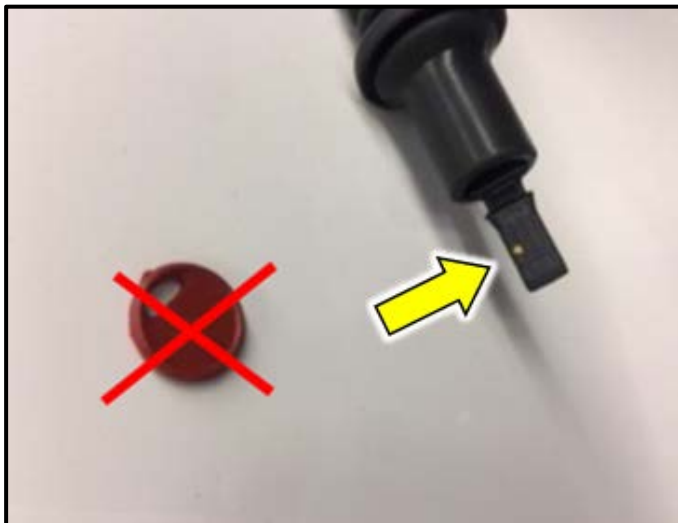
DO NOT remove the sunroof drain from the vehicle.
The tab <arrow> on the sunroof drain remains on the sunroof drain.
The red flap can be discarded.

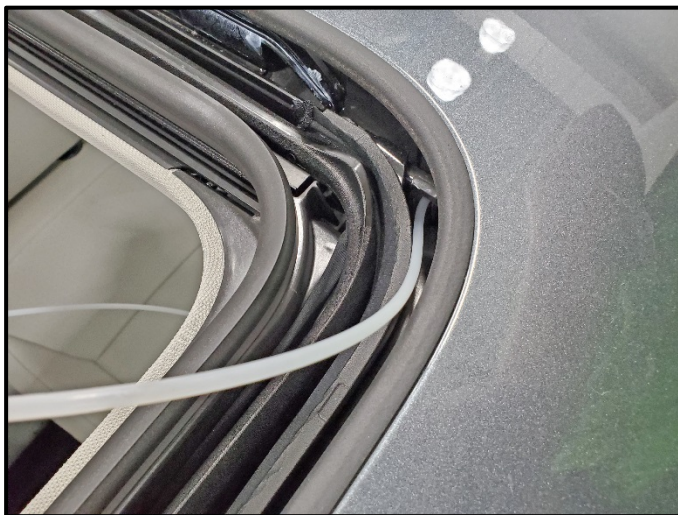
Clean the sunroof drains:

- Clean both front sunroof drains using the -VAS6620- (or equivalent).

DO NOT use extra force if resistance is encountered when using the -VAS6620-. Doing so could result in damaging the sunroof drain or disengaging the sunroof drain from the sunroof. Damage to the sunroof drain or time to reattach the sunroof drains to the sunroof will not be covered under this action.

- The -VAS6620- will exit the sunroof drain tube in the plenum chamber after approximately 120 cm.
- If the -VAS6620- cannot be started from the top, start the tool from the bottom (from inside the plenum chamber).

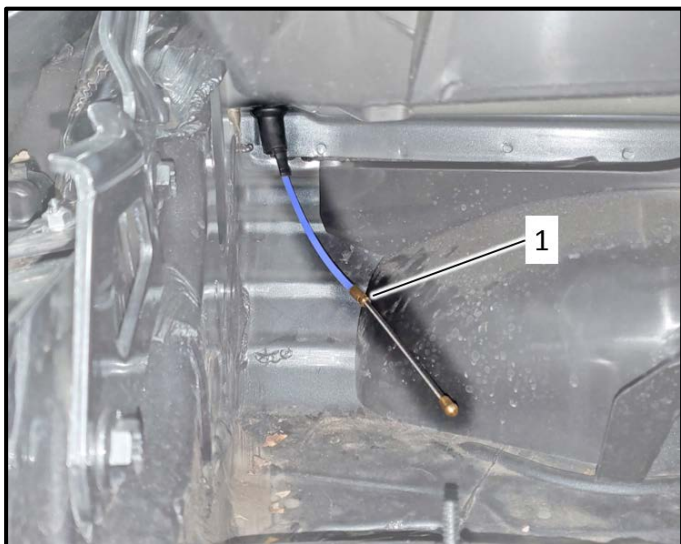
If the -VAS6620- cannot be removed out of the sunroof drain, the end of the tool <1> can be unscrewed and the tool can then be easily removed.

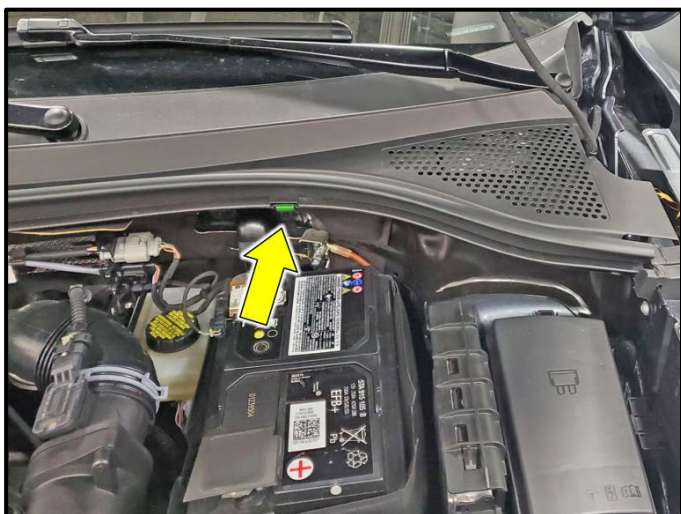
Reinstall the plenum chamber covers:

- Installation is the reverse order of removal.
- Ensure all seals are in place.

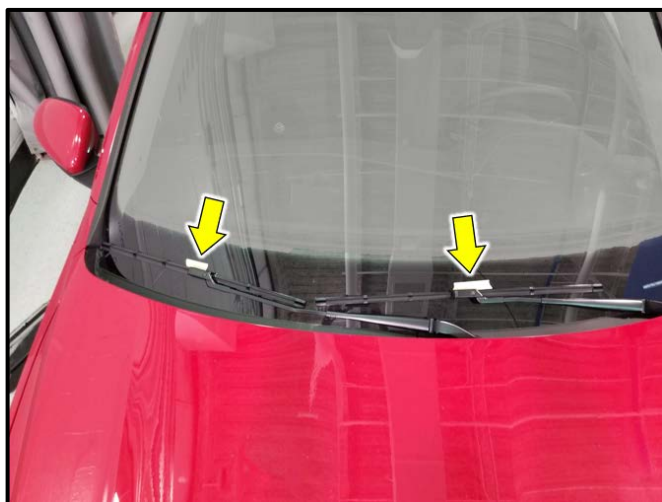
Mark wiper park position.

- Mark the wiper park position with tape <arrows> or other means.

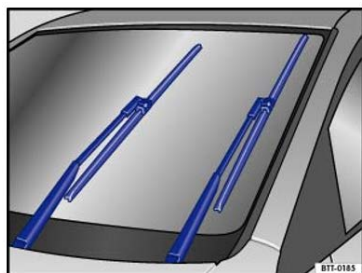
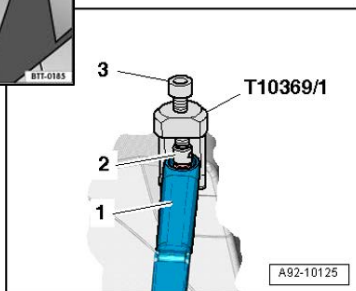
Bring windshield wipers into service position and remove wiper arms:

- See ELSA Repair Manual: *Repair manual > Electrical System > Electrical Equipment > 92 Windshield Wiper/Washer System > Windshield Wiper System > Windshield Wiper, Bringing into Service Position*
- See ELSA Repair Manual: *Repair manual > Electrical System > Electrical Equipment > 92 Windshield Wiper/Washer System > Windshield Wiper System > Windshield Wiper Arms, Removing and Installing*

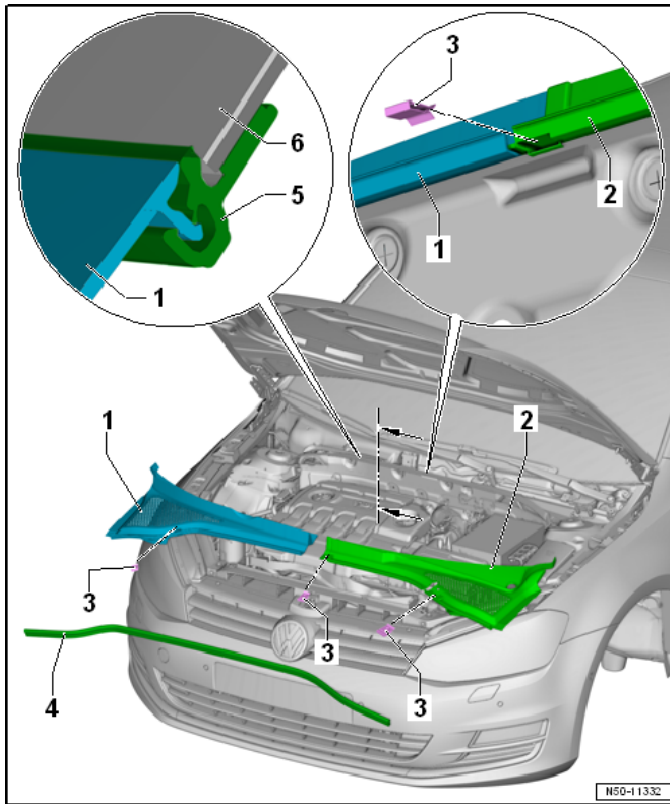
Remove left and right plenum chamber covers:

- See ELSA Repair Manual: *Repair manual > Body > Body Exterior > 50 Body Front > Bulkhead > Plenum Chamber Cover, Removing and Installing*

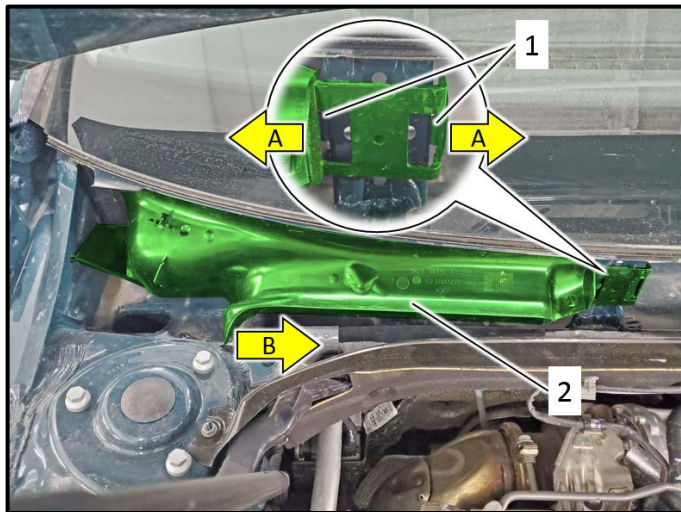
Remove right side cover:

- Release locking tabs <1> in direction of <arrows A>.
- Remove cover <2> from plenum chamber in direction of <arrow B>.

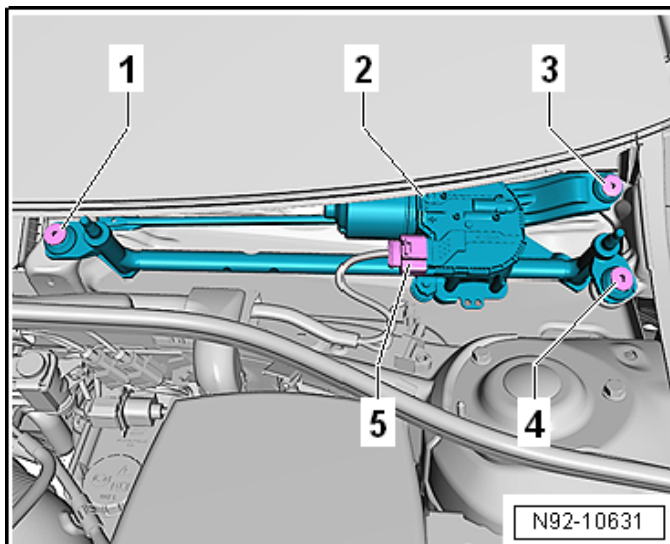
Remove wiper linkage:

- Reference ELSA Repair Manual: *Repair manual > Electrical System > Electrical Equipment > 92 Windshield Wiper/Washer System > Windshield Wiper System > Windshield Wiper Motor V, Removing and Installing*

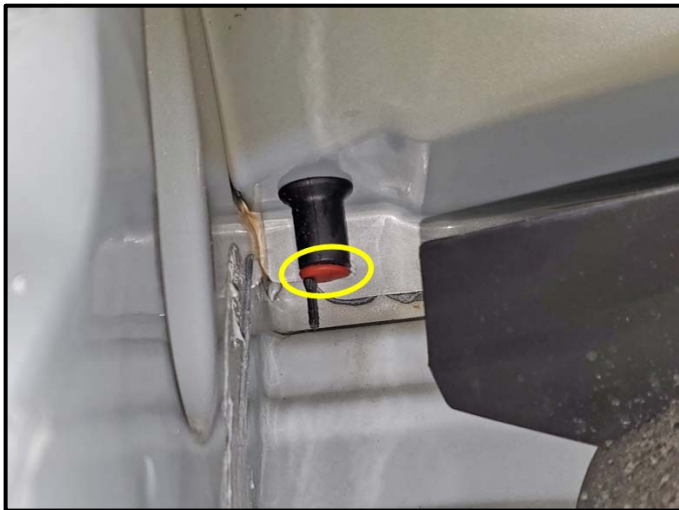
Removing sunroof drain flaps:

- Carefully remove the red sunroof drain flap <circle> downward off both front sunroof drains.

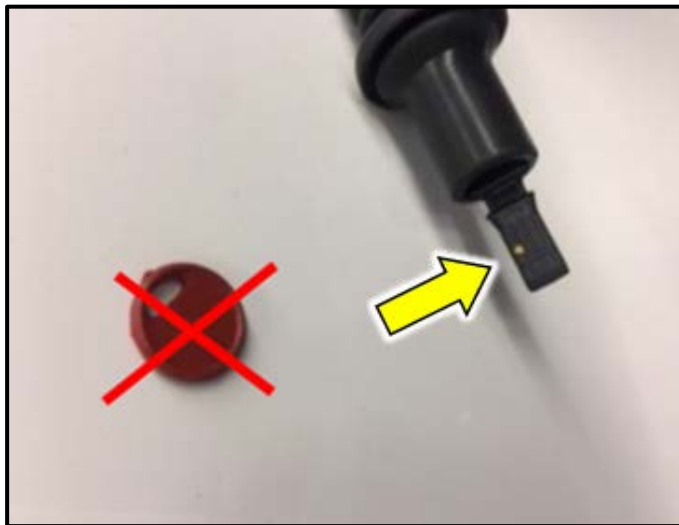
DO NOT remove the sunroof drain from the vehicle. The tab <arrow> on the sunroof drain remains on the sunroof drain. The red flap can be discarded.

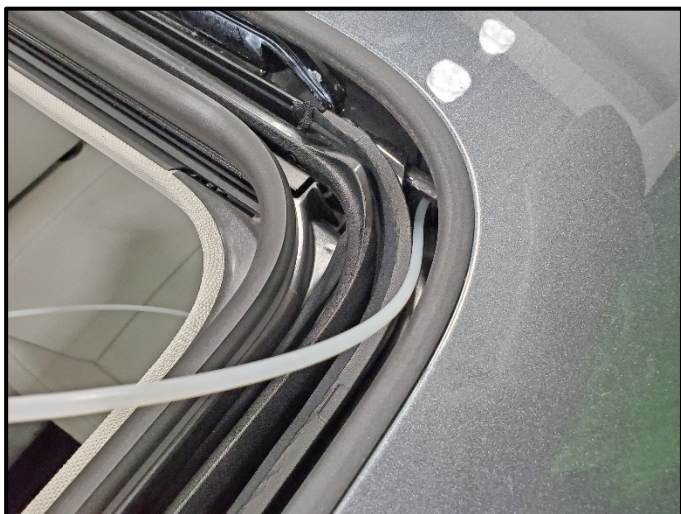
Clean the sunroof drains:

- Clean both front sunroof drains using the -VAS6620- (or equivalent).

DO NOT use extra force if resistance is encountered when using the -VAS6620-. Doing so could result in damaging the sunroof drain or disengaging the sunroof drain from the sunroof. Damage to the sunroof drain or time to reattach the sunroof drains to the sunroof will not be covered under this action.

If the -VAS6620- cannot be started from the top, start the tool from the bottom (from inside the plenum chamber).

If the -VAS6620- cannot be removed out of the sunroof drain, the end of the tool <1> can be unscrewed and the tool can then be easily removed.

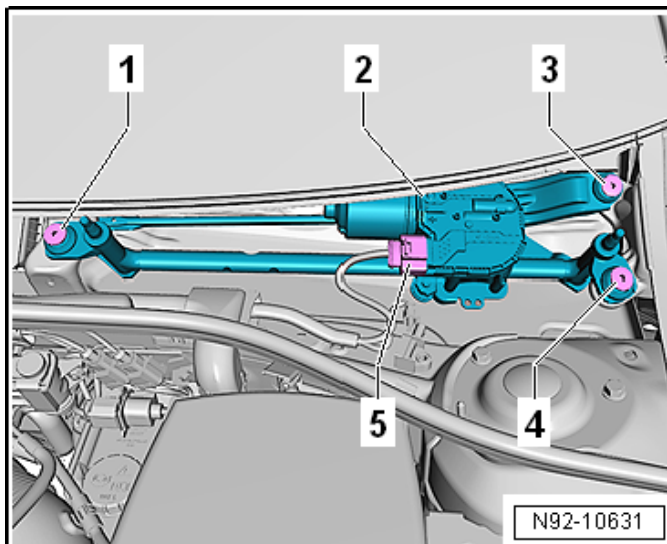
- Reinstall wiper linkage in the reverse order of removal according to the ELSA Repair Manual.

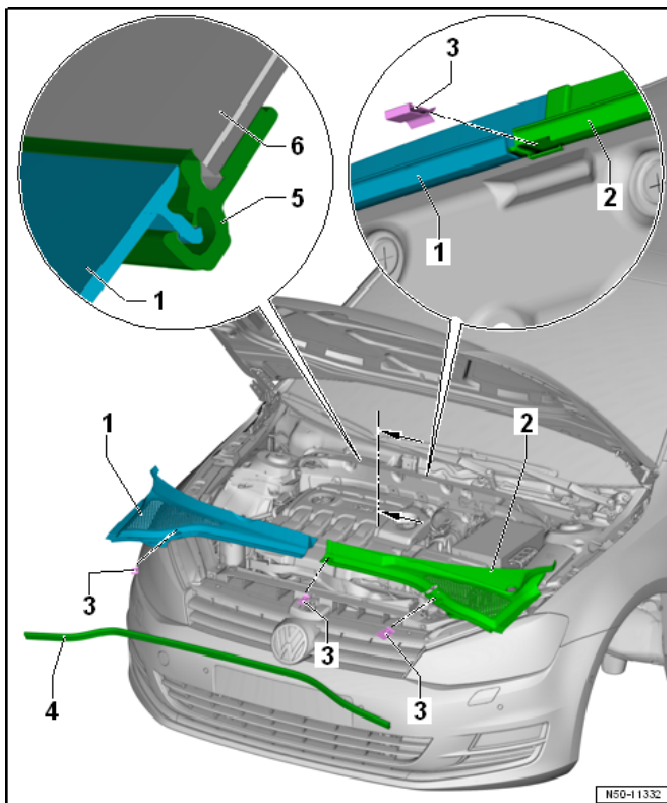
- Reinstall plenum chamber cover in the reverse order of removal according to the ELSA Repair Manual.

Striking the plenum chamber cover into the windshield retainer may cause the windshield to crack. Damage to the windshield or plenum chamber covers will not be covered under this action.

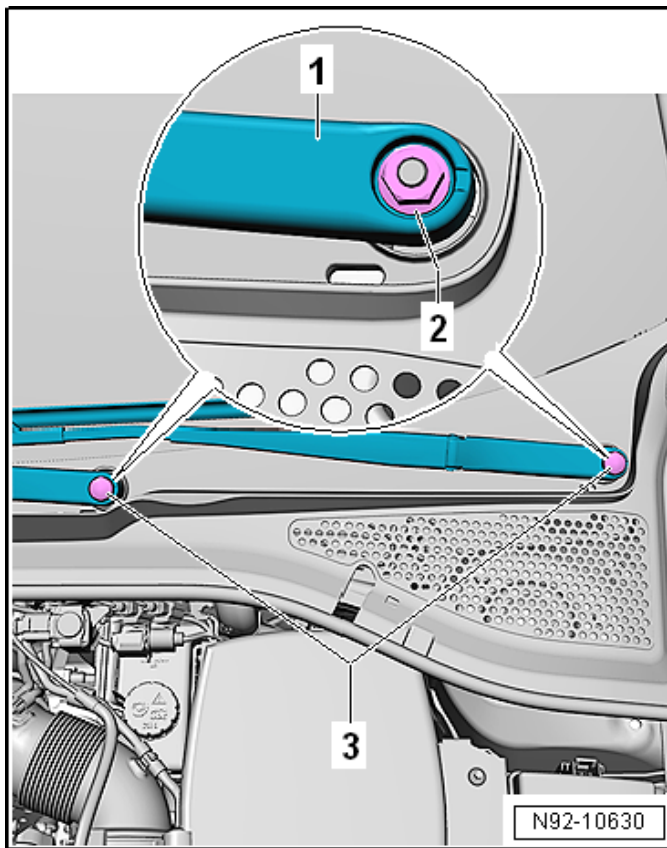
Take wipers out of service position.

- Close the hood.
- Turn ignition on.
- Operate wipers and then turn wipers to the off position.
- Turn ignition off.

Install left and right wiper arms.

- Open the hood.
- Reference previously made marks and install wiper arms on wiper linkage studs.
- Install nuts <2> and torque to 20 Nm.
- Install caps <1>.
- Close the hood.
- Turn ignition on and verify wiper operation.
