**Noise symptom - Rumbling Noises in the Vehicle/Vibrations on the Steering Wheel when Air Conditioning is Activated: Reworking Compressor/Evaporator Line (SY 57/19)**

Vehicle type: **Panamera 4 E-Hybrid (971)/Panamera Turbo S E-Hybrid (971)**  
**Panamera 4 E-Hybrid Executive (971)/Panamera Turbo S E-Hybrid Executive (971)**  
**Panamera 4 E-Hybrid Sport Turismo (971)/Panamera Turbo S E-Hybrid Sport Turismo (971)**

Model Year: **As of 2017 up to 2019**

Subject: **Air conditioning – compressor/evaporator line**

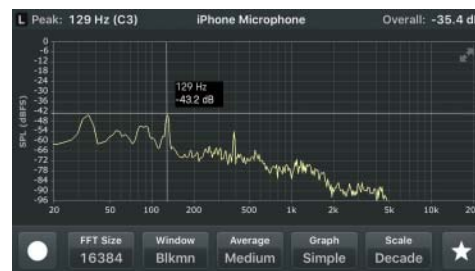
*G2 PHEV AC Compressor vibration-noise*

Symptom: When air conditioning is activated and the blower is at its highest setting, rumbling noises can be heard in the vehicle and vibrations can be felt on the steering wheel. A plot showing the frequency of the noise/vibration is below.

Cause: Vibrations in the air-conditioning compressor can be transmitted into the interior of the vehicle via the compressor/evaporator line.

Remedial Action: Fit blocking mass on compressor/evaporator line.

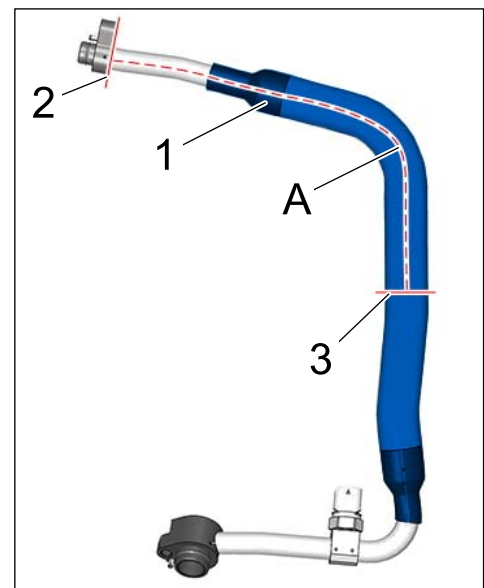
*Cut protection*

- 1 – Cut protection
- 2 – Starting point for measurement
- 3 – Marking
- A – Length: 355 mm

Work Procedure: 1 Determine the position on the cut protection ⇒ *Cut protection -1-*.

- 1.1 Place measuring tape at the starting point ⇒ *Cut protection -2-* and measure **355 mm** along the compressor/evaporator line ⇒ *Cut protection -A-*.
- 1.2 Mark position ⇒ *Cut protection -3-* using a textile marker.

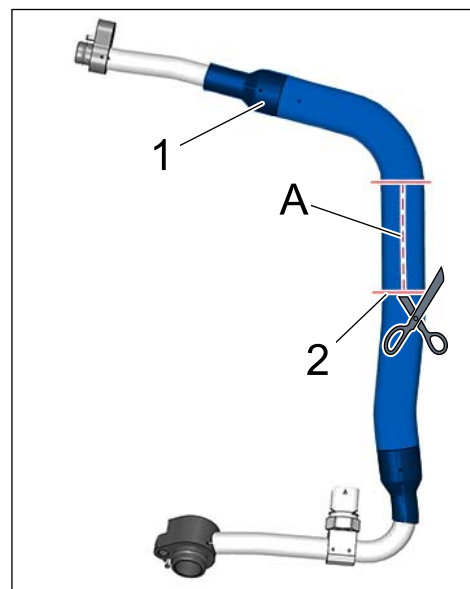
*Marking on cut protection*

- 1** – Cut protection
- 2** – Marking
- A** – Length: 70 mm

Be extremely careful when cutting open the cut protection so as not to damage the hose on the refrigerant line underneath.

- 2 Cut open cut protection ⇒ *Marking on cut protection -1-*, starting from the marking ⇒ *Marking on cut protection -2-*, to a length of **70 mm** (⇒ *Marking on cut protection -A-*).

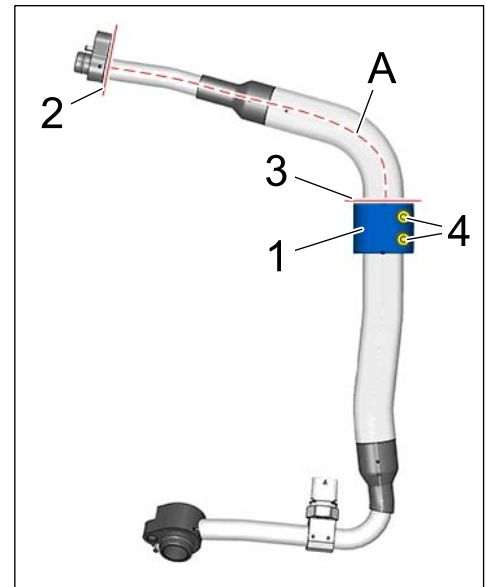
*Blocking mass*

- 1** – Blocking mass
- 2** – Starting point for measurement
- 3** – Marking
- A** – Length: 291 mm

- 4 Fit blocking mass ⇒ *Blocking mass -1-* on compressor/evaporator line.
  - 4.1 Place measuring tape at the starting point ⇒ *Blocking mass -2-* and measure **291 mm** along the compressor/evaporator line ⇒ *Blocking mass -A-*.
  - 4.2 Mark position ⇒ *Blocking mass -3-* using a textile marker.
  - 4.3 Position blocking mass ⇒ *Blocking mass -1-* below the marking ⇒ *Blocking mass -3-* and tighten screws ⇒ *Blocking mass -4-* to **Tightening torque 8 Nm (6 ftlb.)**.
