Noise Symptom - Rattling Noises from Engine Compartment: Checking Balance Shaft Bracing Wheel and Replacing it if Necessary (SY 120/19)

Vehicle Types: **Panamera (971)/Panamera 4 (971)/Panamera 4S (971)/Panamera 4 E-Hybrid (971)/Panamera 4 Sport Turismo (971)/Panamera 4S Sport Turismo (971)/Panamera 4 E-Hybrid Sport Turismo (971)**

Subject: **Balance shaft bracing wheel**

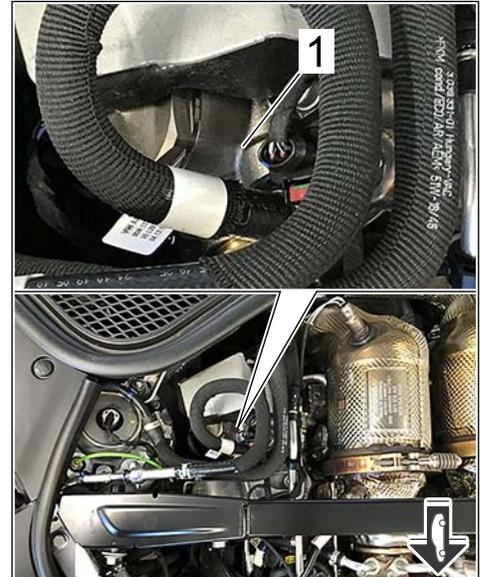
- Work Procedure: 1 Start the engine.
- 2 **Nr.172 - Stethoscope** must be used on the high-pressure pump ⇒ *Contact point on high-pressure pump -1-* and then on the engine housing ⇒ *Contact point on engine housing -2-* in order to find the rattling noise.

If you can clearly hear the rattling noise at the contact point on the high-pressure pump ⇒ *Contact point on high-pressure pump -1-*, stop the engine and continue fault finding. Something else is causing the fault.

Contact point on high-pressure pump

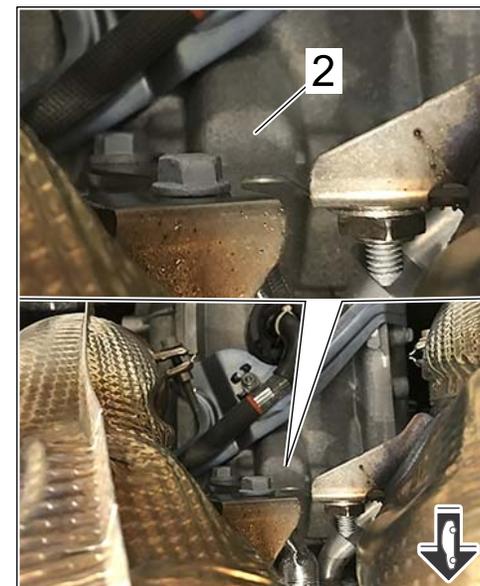
If you can clearly hear the rattling noise at the contact point on the engine housing ⇒ *Contact point on engine housing -2-*, stop the engine and continue with Step 3.

Contact point on engine housing

- 3 Replace balance shaft bracing wheel, see ⇒ *Workshop Manual '138019 Removing and installing balance shaft bracing wheel (V6 Turbo)'*.
