HYUNDAI
Technical Service Bulletin

GROUP CAMPAIGN	NUMBER 20-01-004H
DATE FEBRUARY 2020	MODEL(S) APPLICABLE VEHICLES BELOW

SUBJECT: THETA GDI ENGINE DTC P1326 - ENGINE INSPECTION / REPLACEMENT (SERVICE CAMPAIGN T3G)

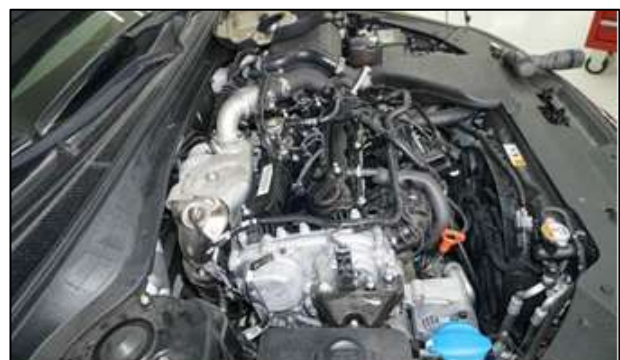
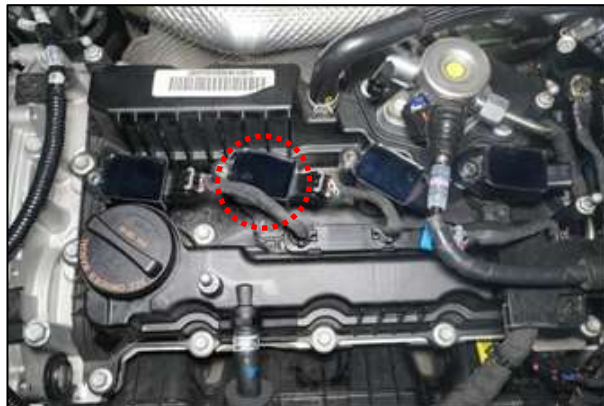
2. Remove the engine cover and the 4 ignition coils.

Tightening Torque (ignition coils):
9.8 - 11.8 N·m (1.0 - 1.2 kgf·m, 7.2 - 8.7 lb·ft)

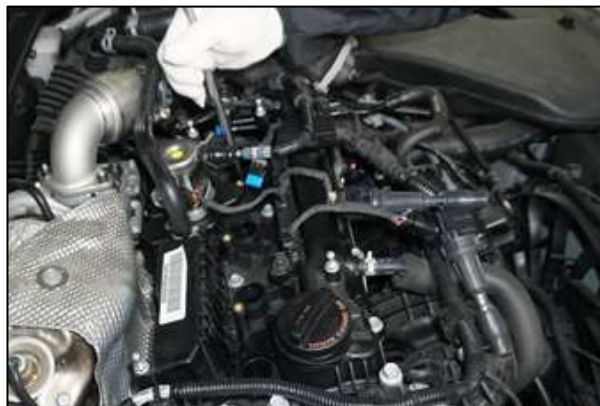
3. Remove the 4 spark plugs.

Tightening Torque:

14.7 - 24.5 N·m

(1.5 - 2.5 kgf·m, 10.9 - 18.0 lb·ft)

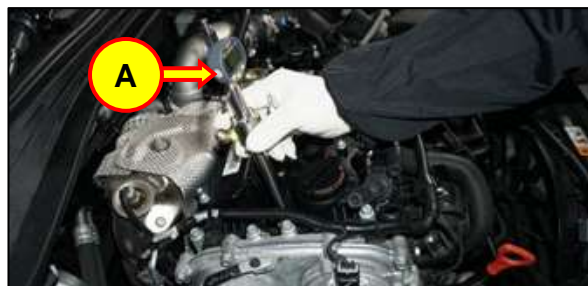
4. Insert the spark plug rod SST (A) into Cylinder #1 spark plug hole and turn until hand tight. Insert the clearance gauge SST into the spark plug rod and tighten using the thumb screw.

DO NOT use a wrench.

DO NOT connect the test air hose.

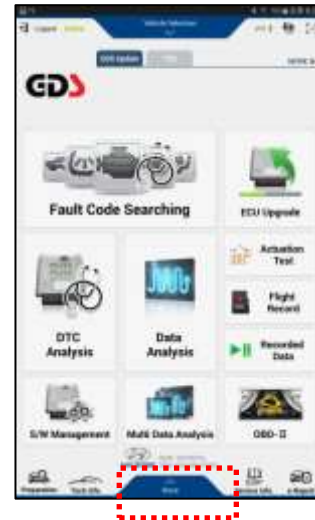
6. Swipe up on the 'More' tab at the bottom of the GDS home screen. Select the 'Special Inspection' function.

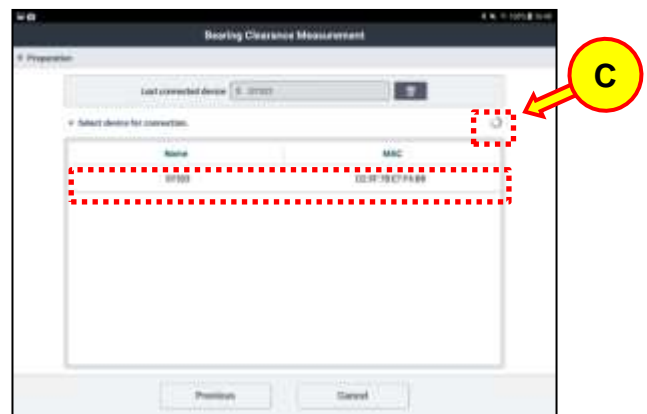
9. Connect the GDS to the clearance gauge SST (gauge) via Bluetooth:

- Press the "Set" button (B) on the gauge to turn it on.
- Press the "Set" (B) and "Mode" buttons at the same time for about 4 sec until the "reset" message is displayed.
- Select the gauge in the list of devices on the GDS. Select the 'Refresh' icon (C) if the gauge doesn't appear automatically.

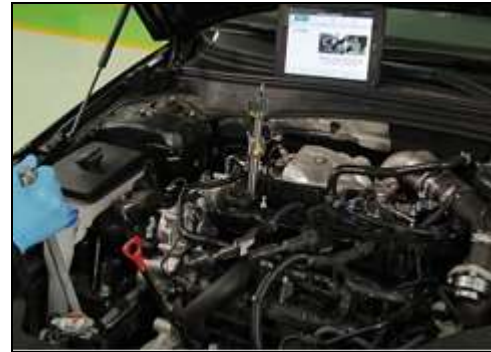
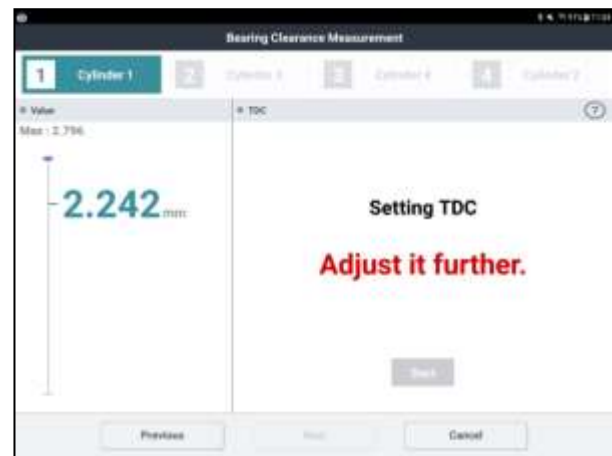
12. To find TDC compression (TDC), rotate the crankshaft with the crank rotator SST at least one cycle (1/2 turn). If the SST does not fit the specific vehicle type, remove the front passenger wheel and wheel liner or underbody tray as needed to rotate the crankshaft using standard shop tools..

Monitor the value on GDS screen or the clearance gauge SST while turning the wrench. Turn the wrench slowly as the value reaches a max/min value. When the value changes direction (increasing → decreasing or decreasing → increasing), stop turning the crank.

Ensure the test hose is disconnected from the clearance gauge when finding TDC.

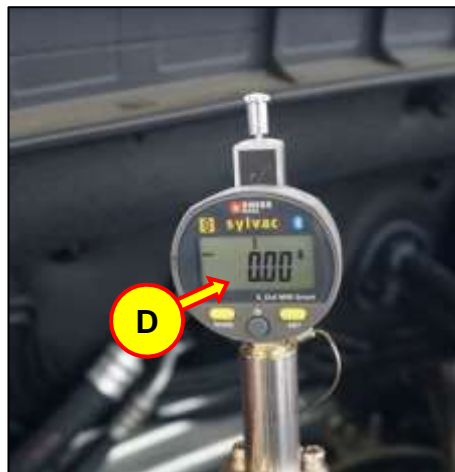
13. Select 'Next' when TDC is found.

TDC is found when the maximum value is reached on the clearance gauge SST (D). The value is also displayed on the GDS.

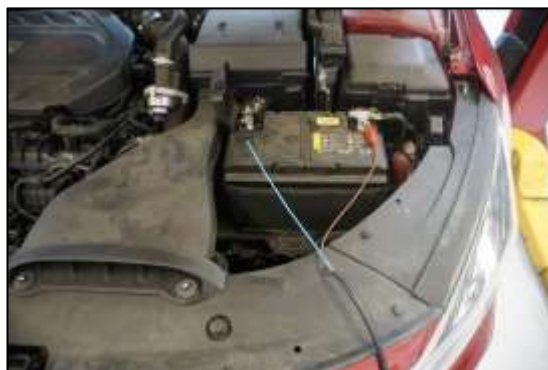
16. Connect the SST power cables to the vehicle's 12V battery. Turn the bearing tool SST power switch 'ON'.

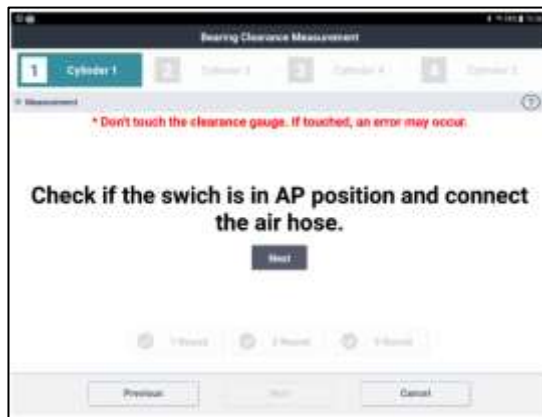
17. Locate the AP/VC switch on the bearing tool SST and switch it to the AP Position.

18. Follow the instructions on the GDS to test each cylinder. Cylinder #1 is checked first.

The cylinders will be checked per the engine’s firing order : #1→#3→#4→#2.

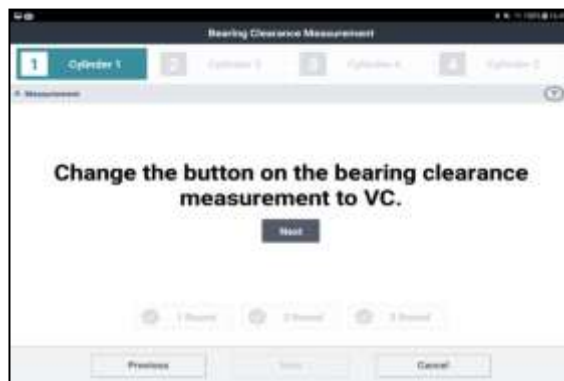
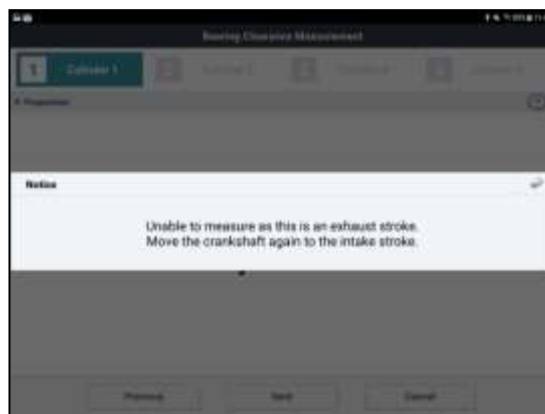
19. On the bearing tool SST, change the AP/VC switch to the VC position when instructed by the GDS.

If the bearing measurement value does not change when the AP/VC is switched or the “Unable to measure” message appears on the GDS, rotate the crankshaft further as the exhaust valves could be open. Set the crankshaft to TDC again (Step 11).

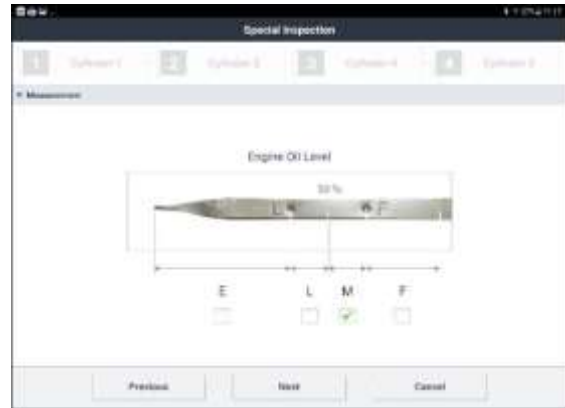
20. Continue following the instructions on the GDS to complete the bearing inspection. Check the engine oil level and select the level in the GDS.

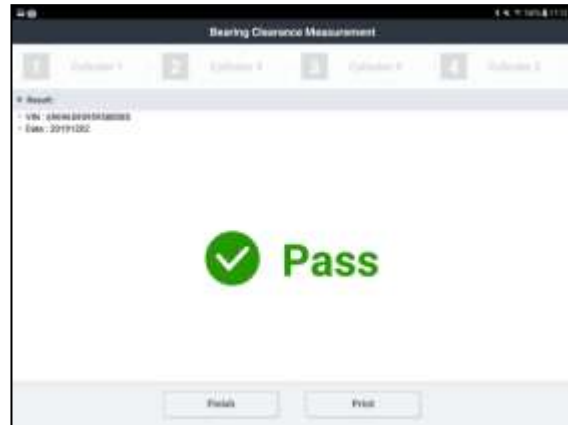
21. If the test result is “PASS”:

- Save a screenshot of the results screen.
- Refer to Campaign 953 to update the Engine ECM if new software is available.
- Reinstall all components in the reverse order of removal.
- Check for DTCs and perform the appropriate diagnostic service. Ensure no warning lights are present to complete the procedure.

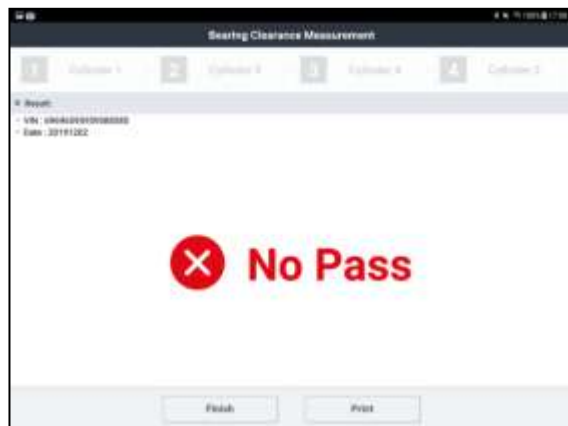
If the test result is “NO PASS”:

- Save a screenshot of the results screen.
- Continue to the engine replacement procedure.
- Refer to Campaign 953 to update the Engine ECM if new software is available.
- Check for DTCs and perform the appropriate diagnostic service. Ensure no warning lights are present to complete the procedure.

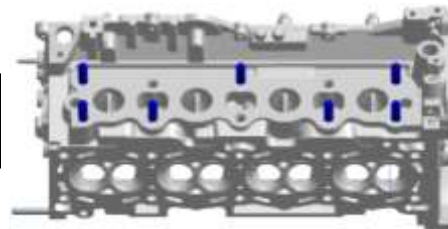
SULEV / CAL Spec

4. **For 2.4L with ULEV / FED emissions only**
 2.4L replacement engines are produced with the exhaust manifold studs configured for SULEV / CAL emissions package.

Two exhaust studs must be relocated on the new engine and 1 exhaust stud must be transferred from the old engine.

Exhaust Stud Position Relocation Information

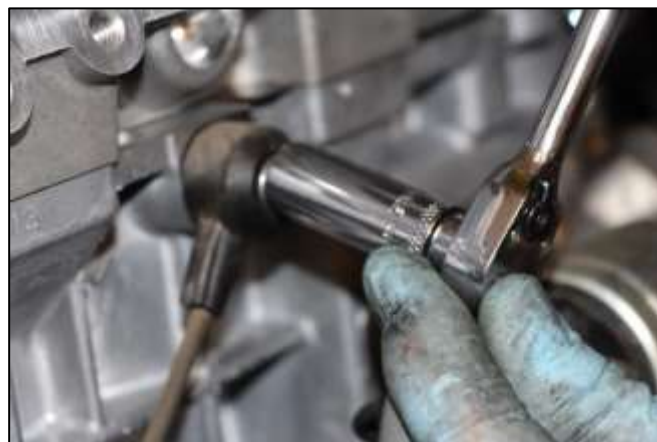
5. Remove and reinstall the engine knock sensor from the old engine to the new engine.

Knock Sensor Fastener
Tightening torque: 21Nm (15.5lb-ft)

Ensure the knock sensor is torqued to specification using a torque wrench. Improper installation can result in DTC codes.

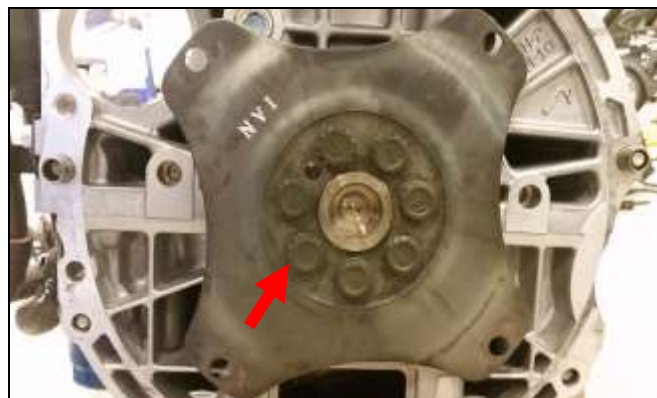
6. **If 21101-2GK70QQA engine is used:**

- Install the oil filler cap from the old engine to the new one.
- Install the drive plate/flywheel on the new engine using new bolts (QTY 7).

Drive Plate Tightening torque :
 111.7 ~ 127.5 Nm (86.8 ~ 94.1 lb-ft)

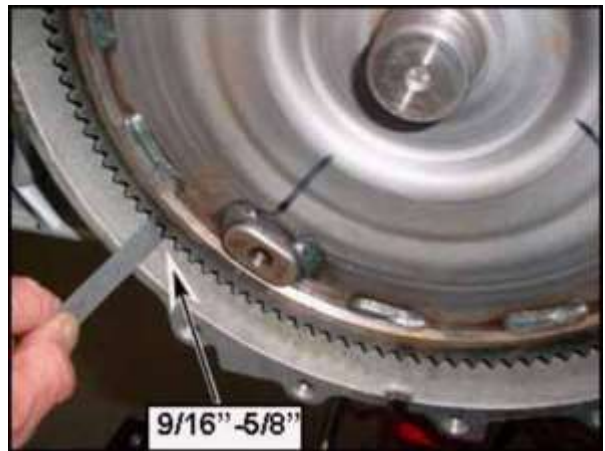
If the torque converter has moved from the fully inserted position, carefully push inward and rotate the torque converter until the converter is recessed approximately 9/16 - 5/8" (14 -16 mm) into the transaxle case when reinstalling the automatic transaxle.

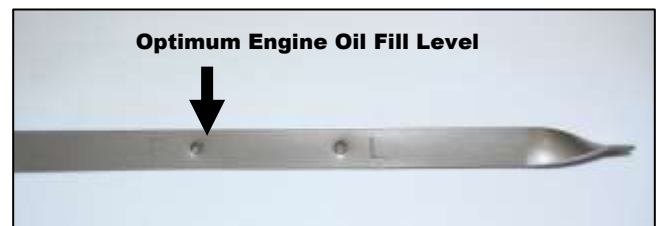
13. Start the engine to warm it up and begin the cooling system air bleeding process.
 - Check for any leaks during this time.
 - After the engine has warmed up to normal operating temperature, turn the engine off, wait a few minutes, and then **adjust the engine oil level to near the “F” mark as shown.**
