# HYUNDAI

## Technical Service Bulletin

20-BD-003H

SEAT BACKBOARD CLIP REPLACEMENT

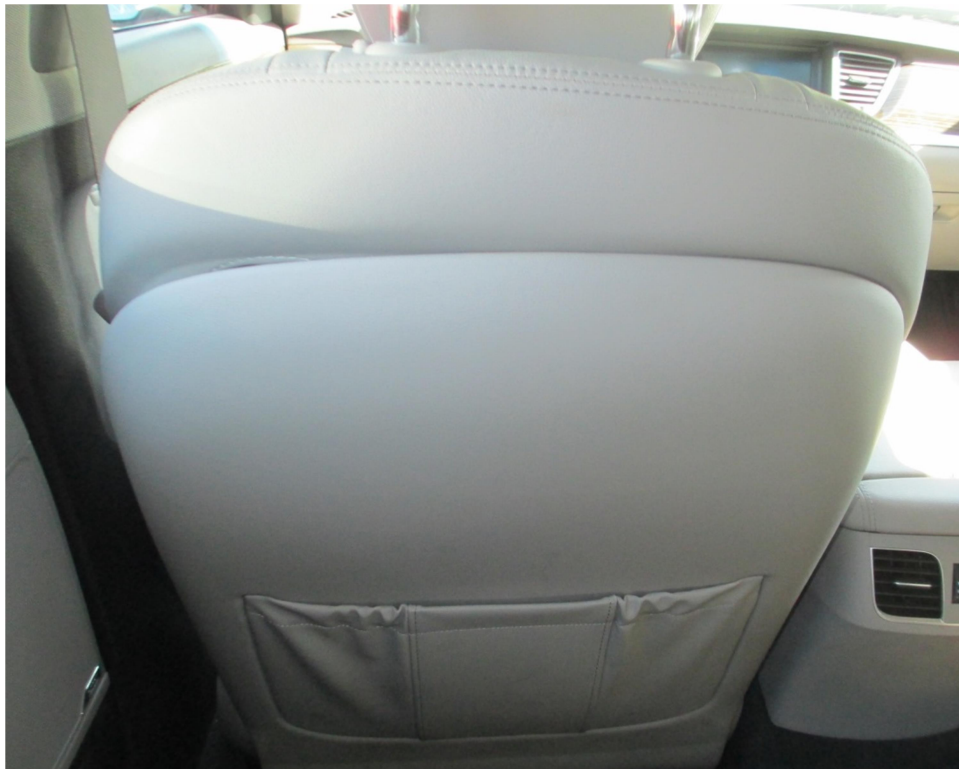
**Description:** Certain 2015-2016 Genesis (DH) vehicles may have a condition where the seat backboard comes loose. This bulletin describes the procedure to replace the seat backboard clip.

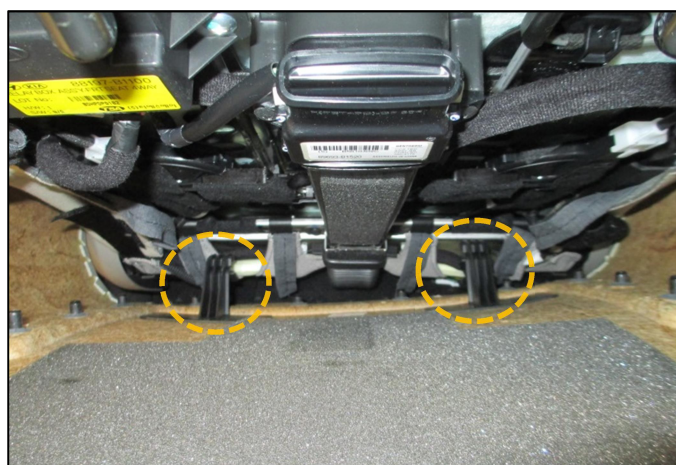
When removing, ensure not to damage bottom seat back retention hooks.

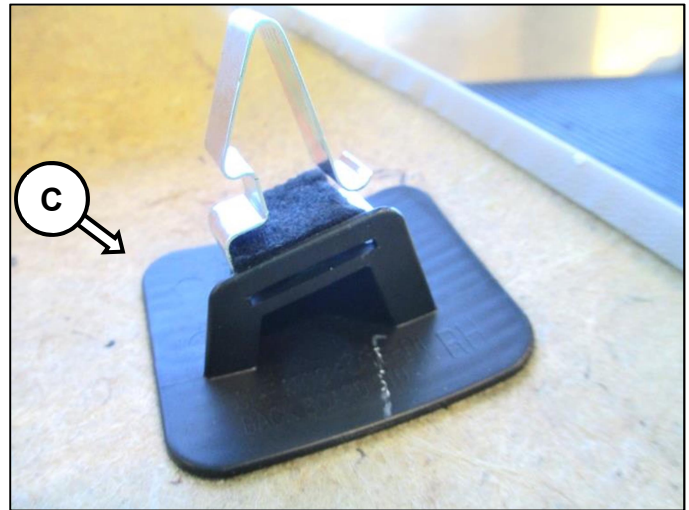
**The base clip is normal.**

4. Inspect the base clips.

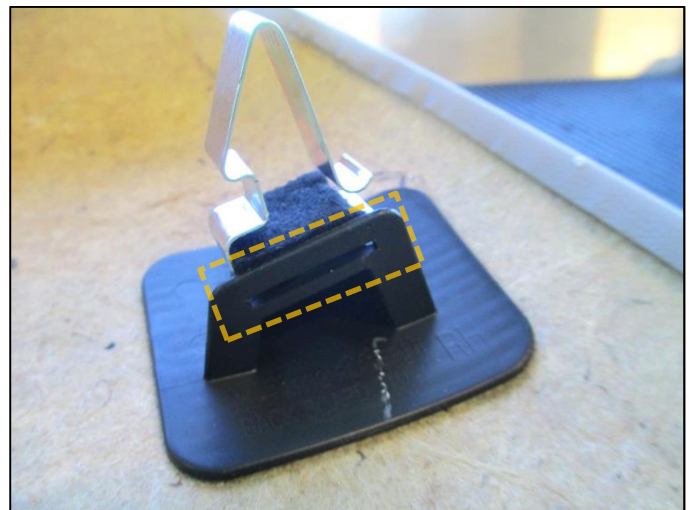
**The base clip is broken.**

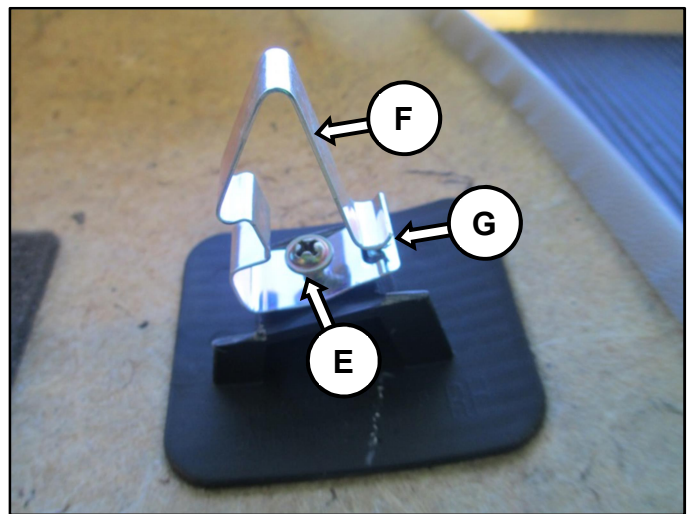
Ensure opening (G) of clip is facing upward.
