# SERVICE BULLETIN

Classification: EL19-049	Reference: NTB20-008	Date: February 14, 2020
-----------------------------	-------------------------	----------------------------

## 2013-2019 PATHFINDER; CLIMATE CONTROLLED SEAT INOPERATIVE

**APPLIED VEHICLES:** 2013-2019 Pathfinder (R52)  
2014-2015 Pathfinder Hybrid (R52)

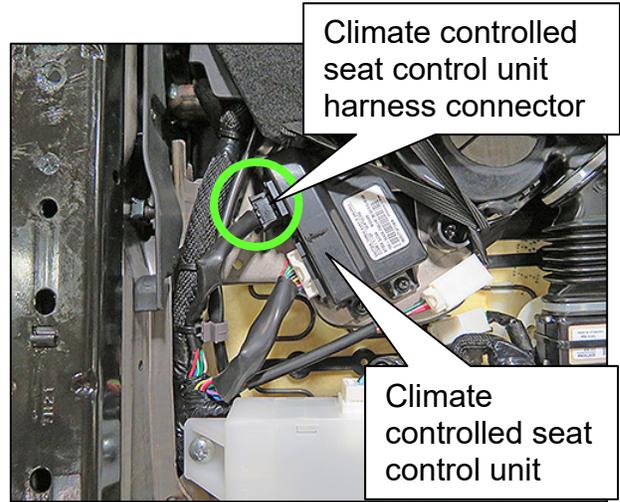
Figure 1

7. Disconnect the **black** climate controlled seat control unit harness connector from the control unit.

8. Visually inspect the harness connector and control unit near the terminals.

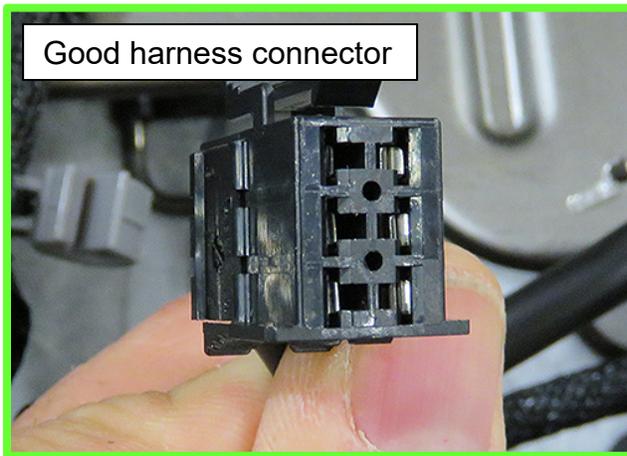
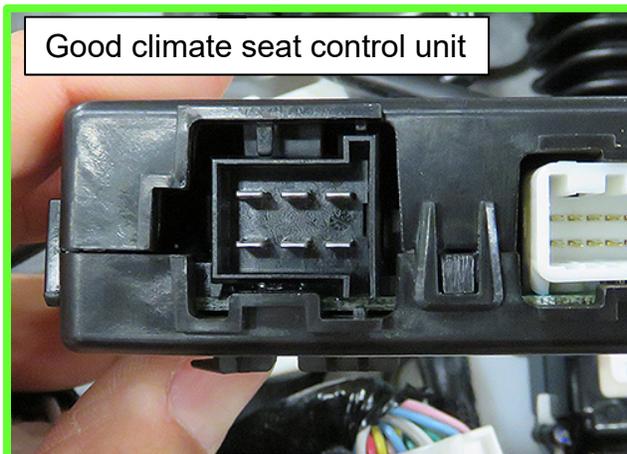
- If the harness connector or the control unit appear similar to Figure 3 and/or Figure 5 (**NG**), proceed to step 9.
- If the harness connector and the control unit appear similar to Figure 2 **and** Figure 4 (**Good harness and connector**), this bulletin does not apply. Refer to the ESM for additional diagnostic information.

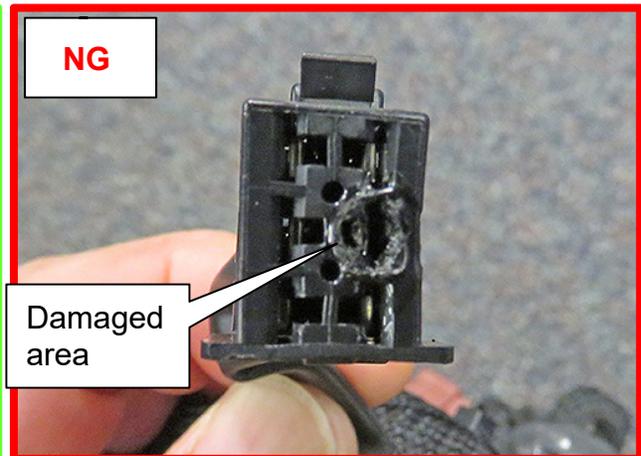
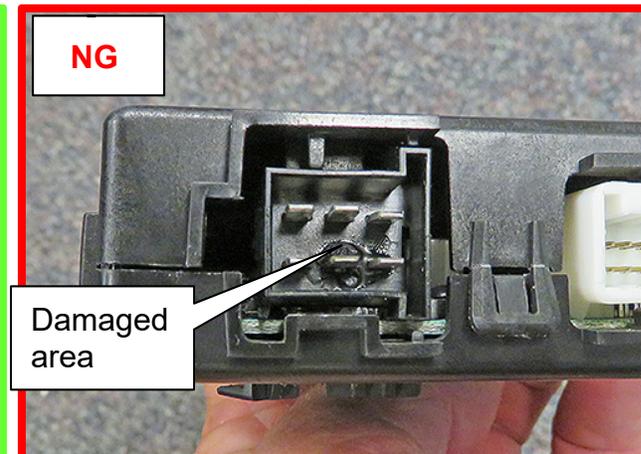
- The harness connector or control unit of the climate controlled seat appears as shown in Figure 3 or Figure 5.

- A. Replace the climate controlled seat control unit.
- B. Drill a hole for the new harness clip.
- C. Replace the harness connector of the climate controlled seat control unit.

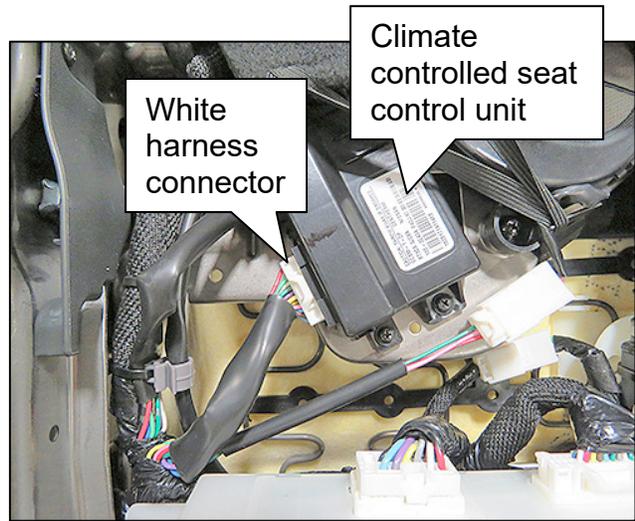
Figure 6

9. Disconnect the white harness connector from the climate controlled seat control unit.

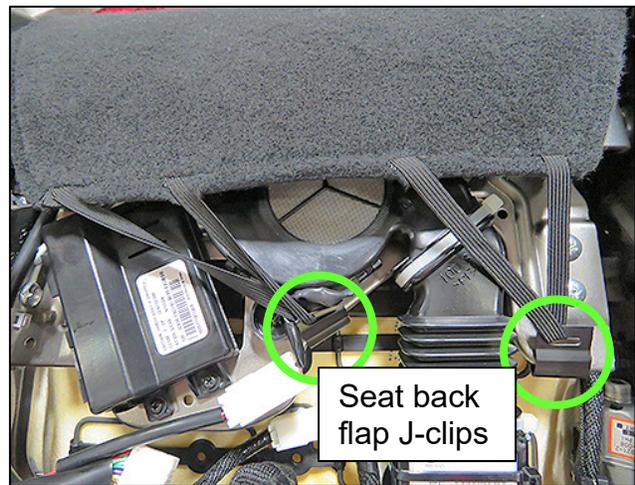
Figure 7

10. Detach the seat back flap J-clips from the seat frame and fold the seat back flap out of the way.

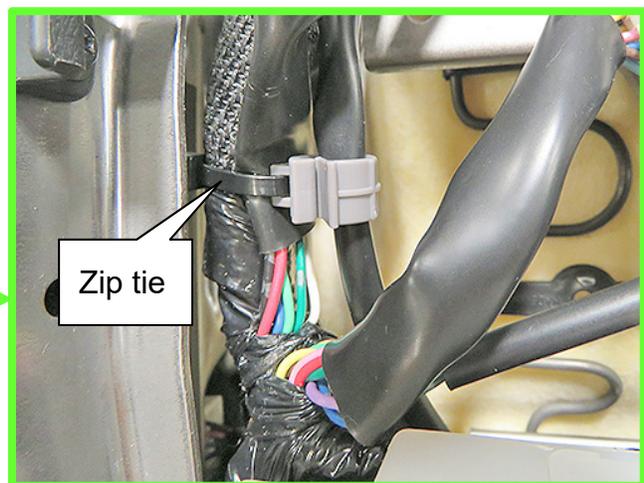
Figure 9

11. Cut through the zip tie shown in Figure 9.

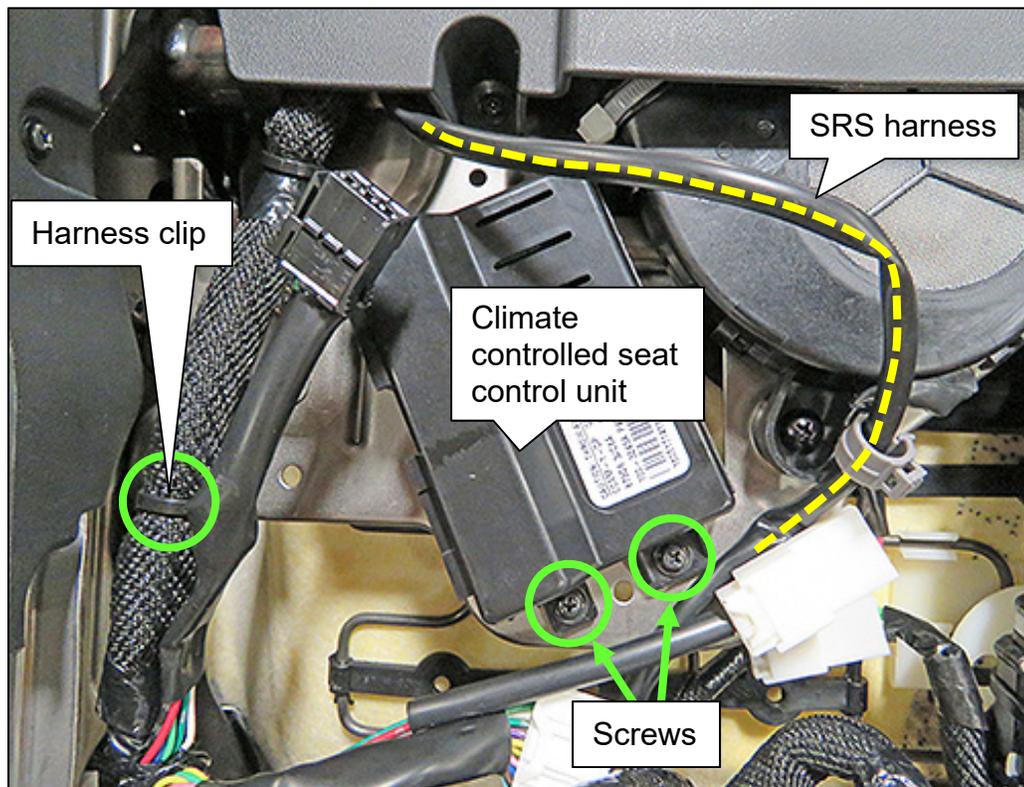
12. Move the SRS harness out of the way, as shown in Figure 10.
  - Highlighted in yellow.
13. Detach the harness clip shown in Figure 10 from the seat frame.
14. Remove the two (2) screws (Figure 10) retaining the climate controlled seat control unit, and then remove control unit from the seat.

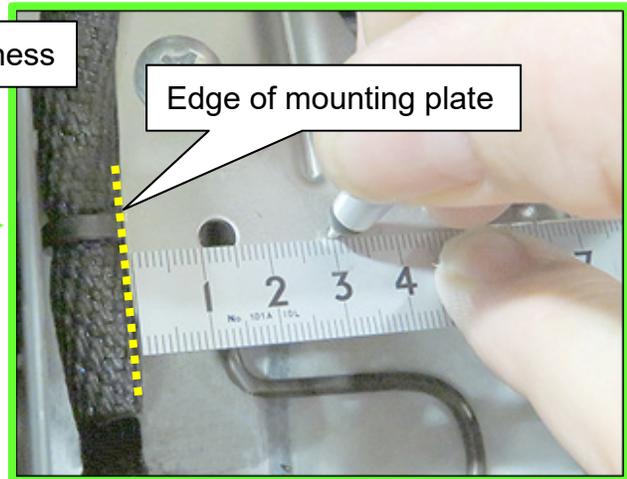
Figure 12

15. Using a ruler, measure approximately 30 mm from the left edge of the climate controlled seat control unit mounting plate, and then mark as shown in Figure 12.

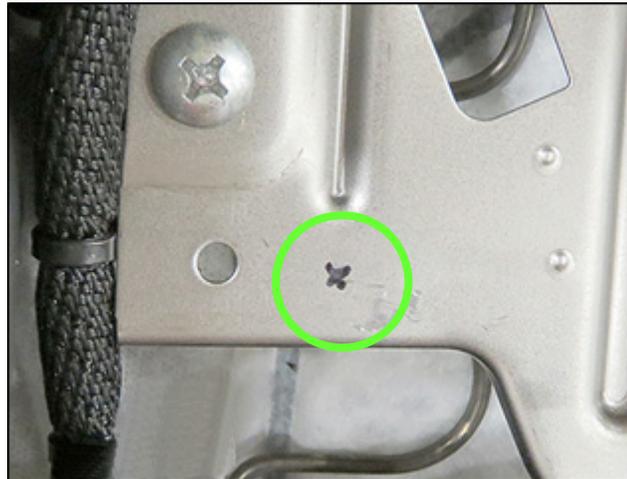
Figure 14

16. Measure approximately 9.4 mm ( $\pm 2$  mm) from the bottom of the same mounting plate, and then mark where the two measurements intersect as shown in Figure 14.

17. Use a punch to make a slight indentation at the intersection from steps 15 and 16.
18. Place a clean shop cloth under the mounting plate to catch metal debris.
19. Drill a hole using a 7/32 inch or a number 3 drill bit.
  - A pilot hole made with a smaller drill bit may help.

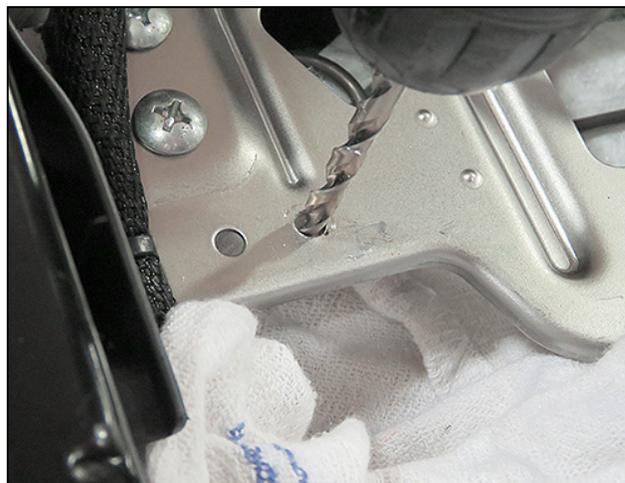
Figure 15

**NOTICE** Take care to not damage the seat cushion. Limit the drill bit depth to prevent seat cushion contact.

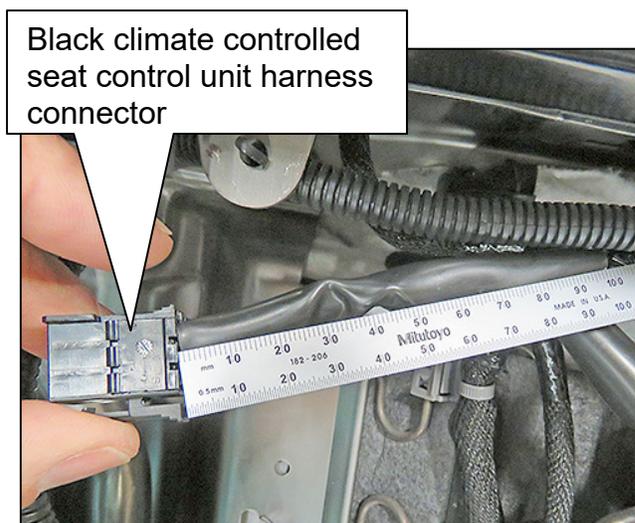
Figure 16

21. Measure from the back end of the **black** climate controlled seat control unit harness connector.

- If working on a **driver's seat** measure 60 mm.
- If working on a **passenger seat** measure 65 mm.

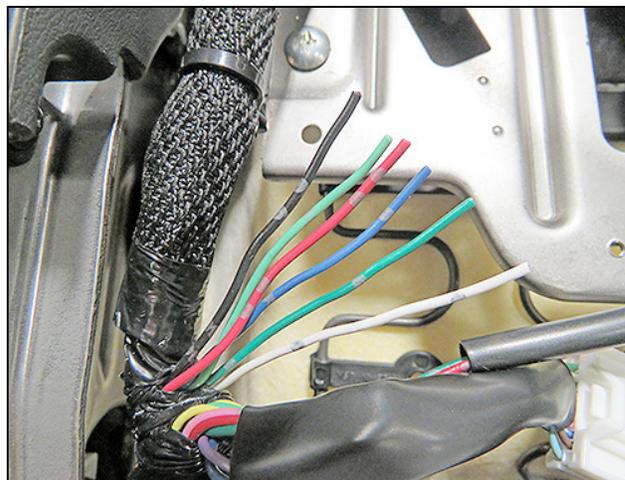
Figure 17

22. Cut through the harness, at the point that was measured to in step 21, with an appropriate tool.

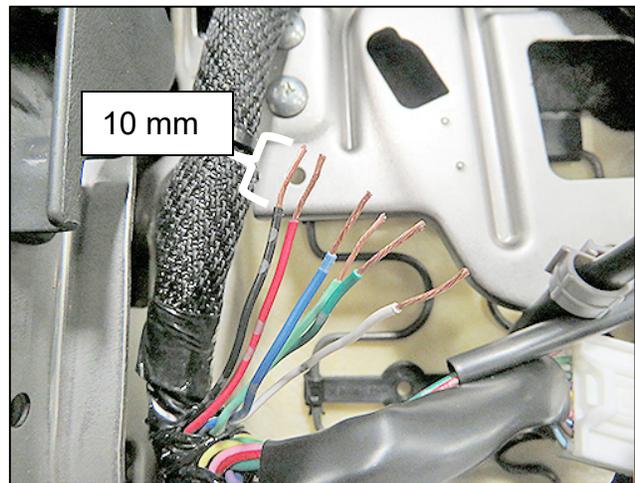
Figure 18

23. Remove approximately 10 mm of insulation from the six (6) wires.

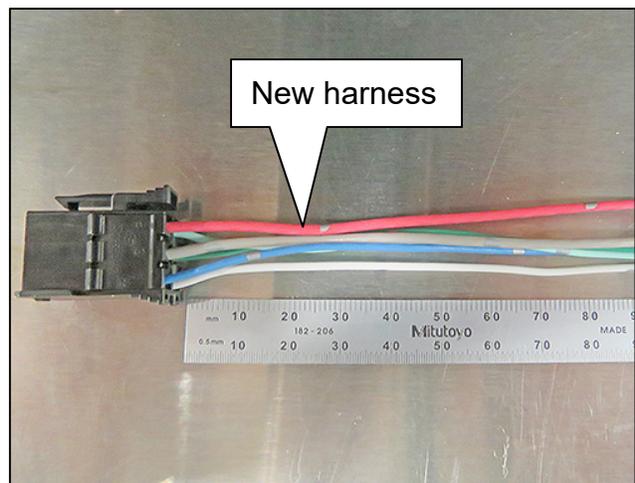
Figure 19

24. Measure from the harness side of the **new** climate controlled seat control unit harness connector (new harness) the following amount:

- If working on a **driver's seat** measure 70 mm.
- If working on a **passenger seat** measure 75 mm.

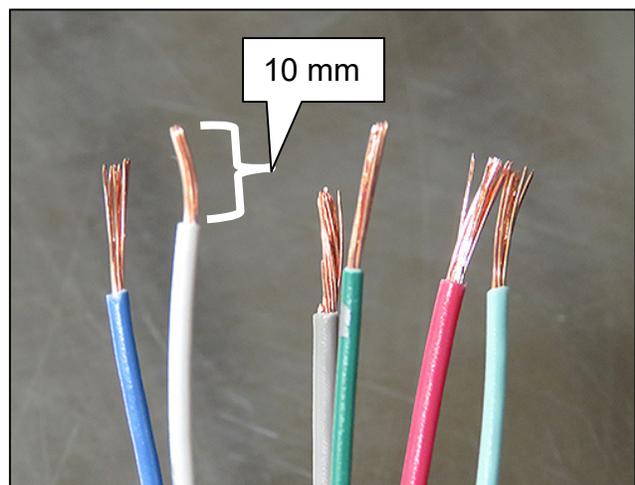
Figure 20

25. Cut through the new harness, at the point that was measured to in step 24, with an appropriate tool.

26. Remove approximately 10 mm of insulation from the six (6) wires of the new harness.

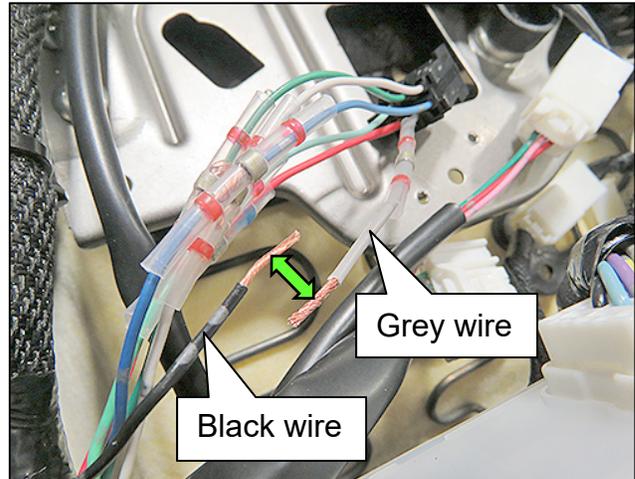
Figure 21

**IMPORTANT:** The gray wire of the new harness will be connected to the black wire of the vehicle seat harness.

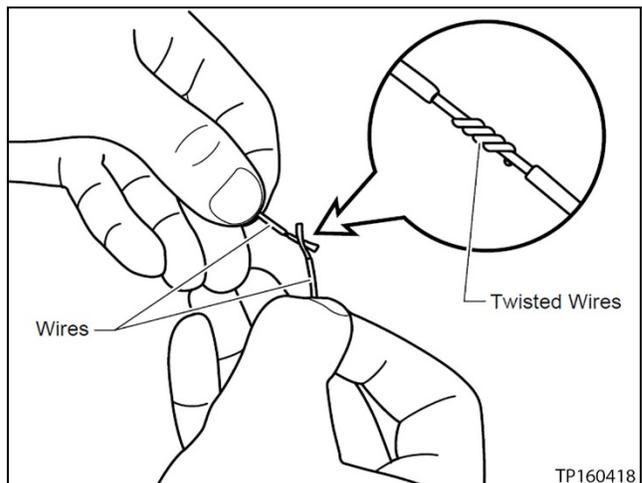
28. Twist the new harness connector wire (with solder sleeve) together with the same colored wire of the harness that was stripped in step 23.

- See Figure 22 for an example of twisting wires.

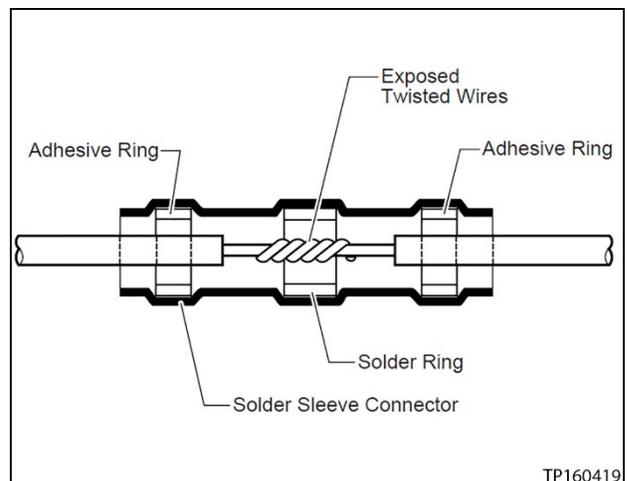
Figure 23

29. Slide the red solder sleeve over the twisted pair and position it so that the solder ring is over the two twisted wires as shown in Figure 23.

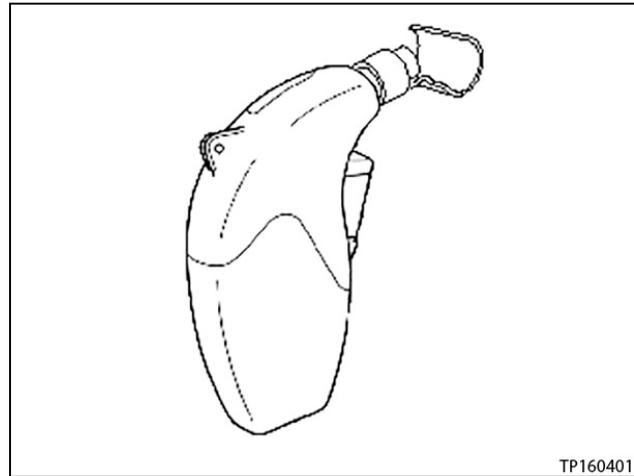
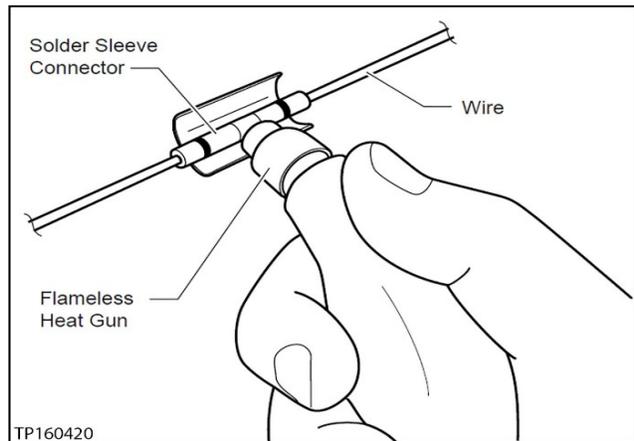
30. Install the solder sleeve connector by shrinking it to the wire with essential tool Flameless Heat Gun J-46538 or equivalent flameless heating tool (see Figure 24 and Figure 25).

- Melt the solder (silver ring inside the solder sleeve connector) into the exposed twisted wire area.
- Melt the sealant (red rings inside the solder sleeve connector) onto the wires.
- Shrink the remainder of the solder sleeve connector to the wire.

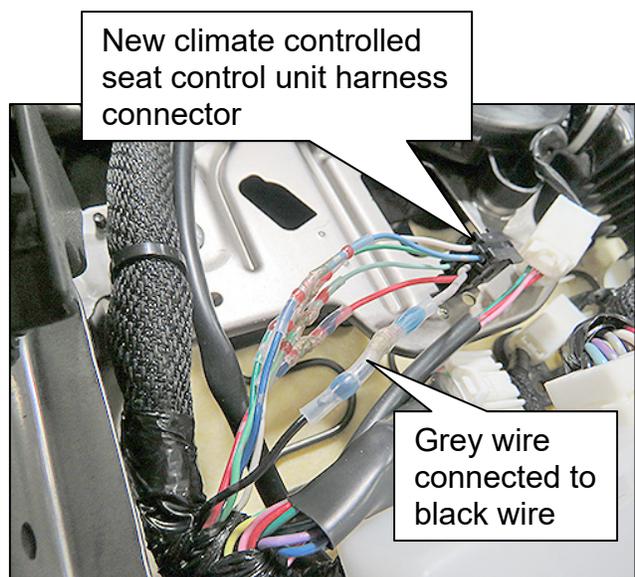
31. Perform steps 27-30 on the remaining five (5) wires and then proceed to step 32.
- Figure 26 is shown with all solder connections completed.

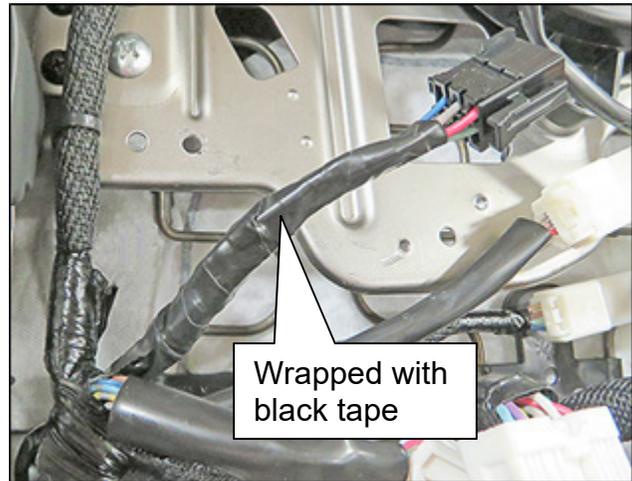
Figure 27

32. Completely wrap the newly joined harness with electrical tape as shown in Figure 27.

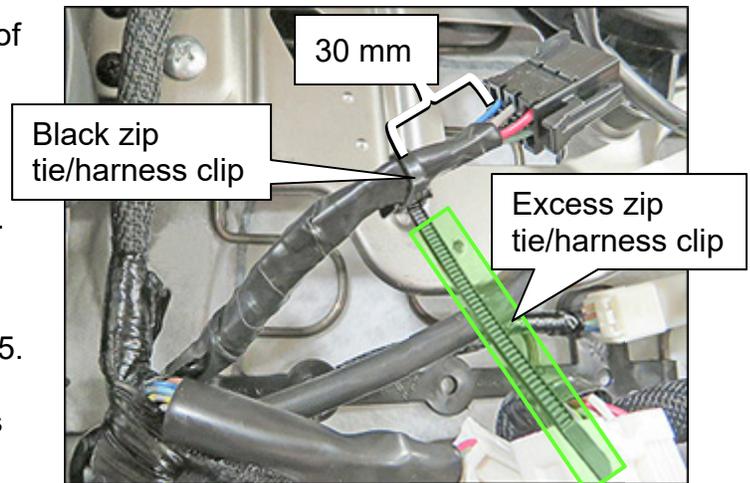
Figure 28

33. Measure 30 mm from the back end of the **black** climate controlled seat control unit harness connector.
34. Attach the black zip tie/harness clip provided, where shown in Figure 28.
- The black zip tie/harness clip is listed in the **Parts Information** section of this bulletin on page 15.
35. Trim excess from the zip tie/harness clip with an appropriate tool.

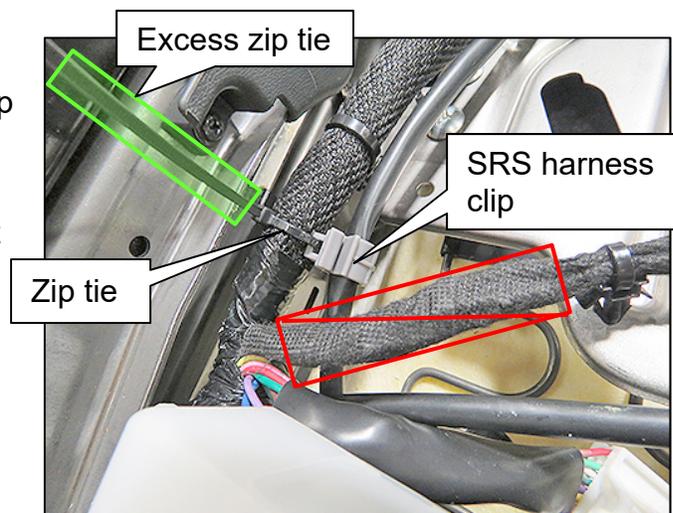
Figure 29

36. Reattach the SRS harness clip that was removed in step 11 with a new zip tie, as shown in Figure 29.
- Do not install the zip tie over the climate controlled seat control unit harness.
  - See the **Parts Information** on page 15.
37. Trim the excess from the zip tie with an appropriate tool.

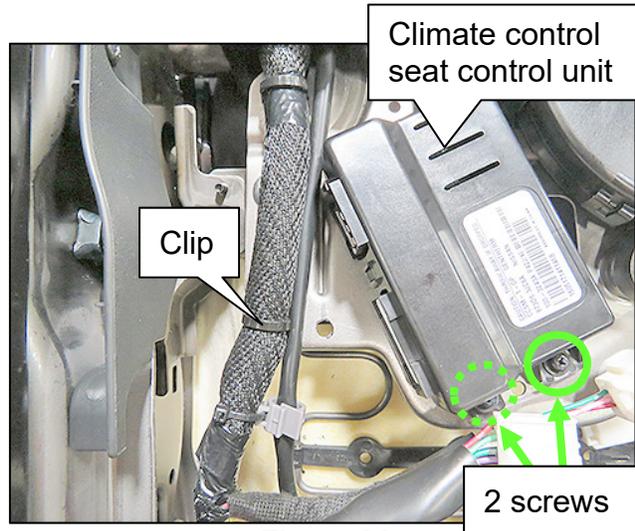
Figure 30

38. Install the new climate controlled seat control unit to the seat frame.
- Held by two (2) screws.
  - See the **Parts Information** section of this bulletin on page 15.

39. Reattach the clip removed in step 13 and shown in Figure 30.

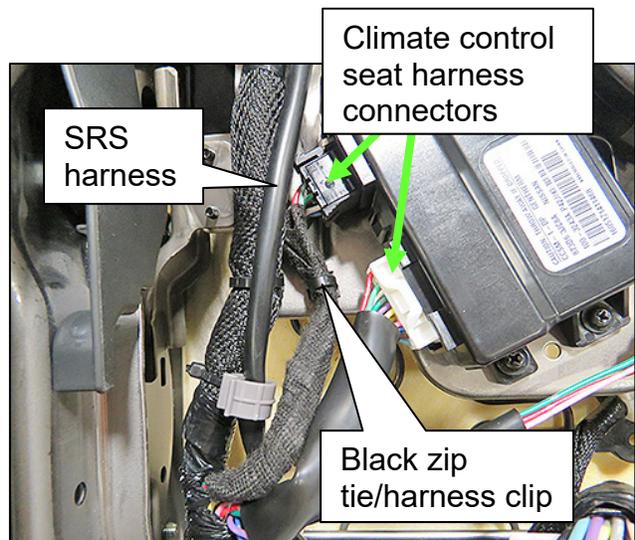
Figure 31

40. Connect the harness connectors to the climate controlled seat control unit.
- Route the SRS harness as shown in Figure 31.

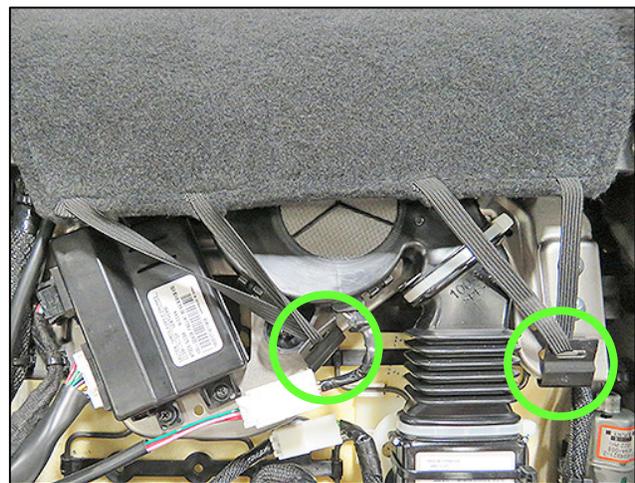
Figure 32

42. Reattach the seat back flap J-clips to the seat frame as shown in Figure 32.

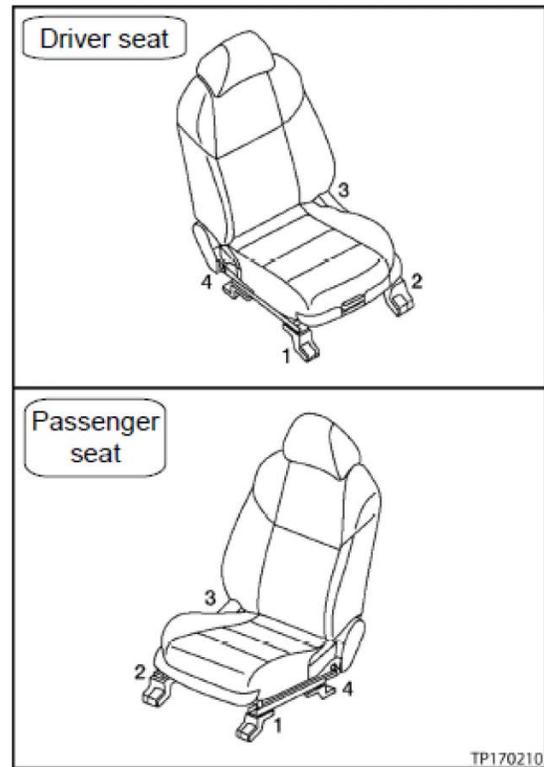
Figure 33

- Torque the seat bolts in the order shown in Figure 33.

- Seat bolt torque: 48 N•m (4.9 kg-m, **35 ft-lbs**)
