SERVICE BULLETIN

BT20-001

2015-2020 MURANO; CARPET PULLED OUT FROM UNDER INNER KICKING PLATE

APPLIED VEHICLES: 2015-2020 Murano (Z52)
2016 Murano Hybrid (Z52)

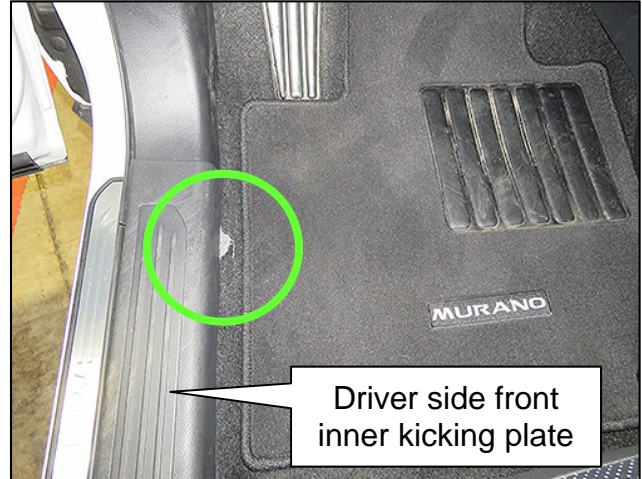
The carpet is pulling out from under the driver side front, passenger side front or the passenger side rear inner kicking plates (See Figure 1 for example).

Add foam padding to the floor spacer plate near the affected area of the vehicle.

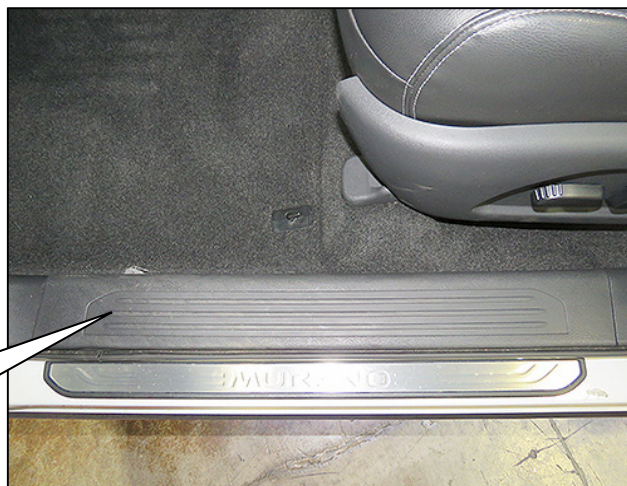
Figure 3

Driver side front
inner kicking plate

2. Remove the driver side front inner kicking plate.

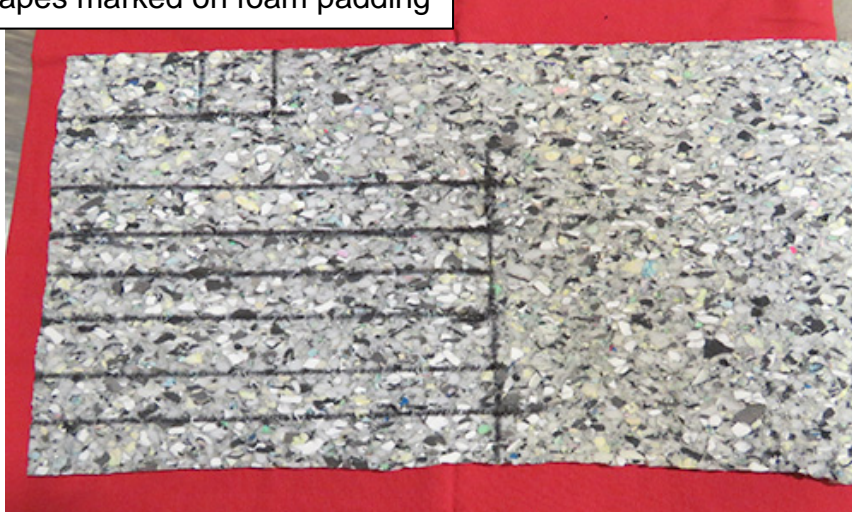
Figure 7

Shapes marked on foam padding

7. On a piece of 10 mm thick (3/8 inch) Carpet and Rug Cushion (foam padding), measure and mark the following shapes (See the Parts Information on page 12):
- Six (6) 30 mm x 300 mm (1.2 in X 11.8 in) strips.
 - One (1) 50 mm x 100 mm (2 in x 3.9 in) strip.
 - One (1) 50 mm x 50 mm (2 in x 2 in) square.

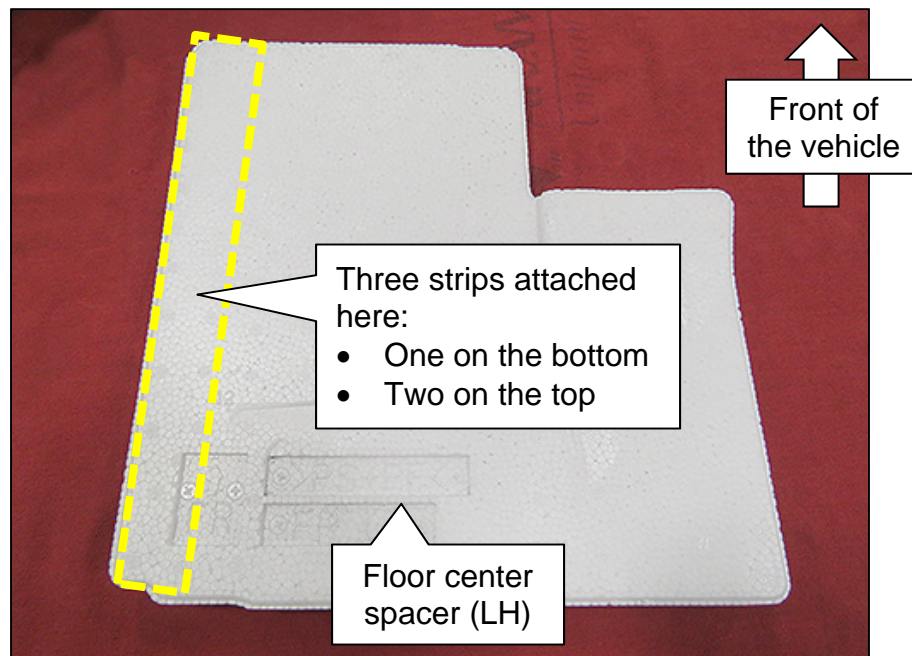
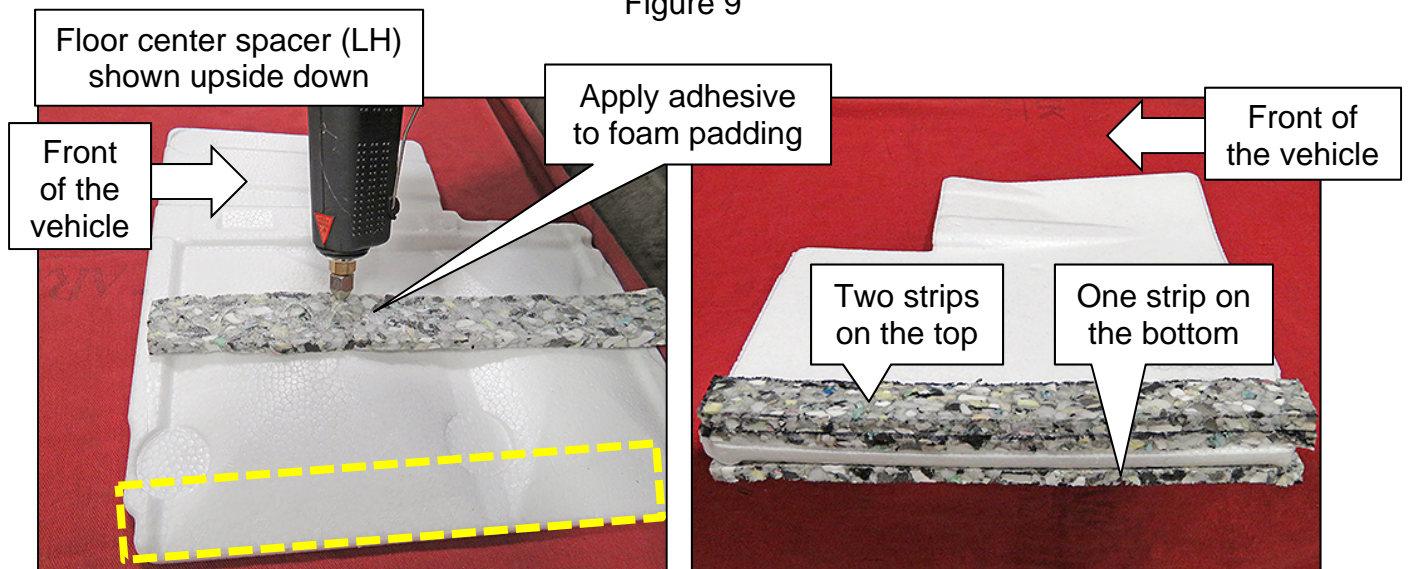
NOTE: The attached strips should look like Figure 11.

9. Attach three (3) 30 mm x 300 mm strips of the foam padding to the floor center spacer (LH) with a hot glue gun as follows:

- Attach one (1) strip to the bottom along the edge, closest to the door opening.
- Attach two (2) strips to the top side, closest to the door opening.
 - Stack two (2) strips of padding on top of one another to achieve a 20 mm thickness with adhesive.

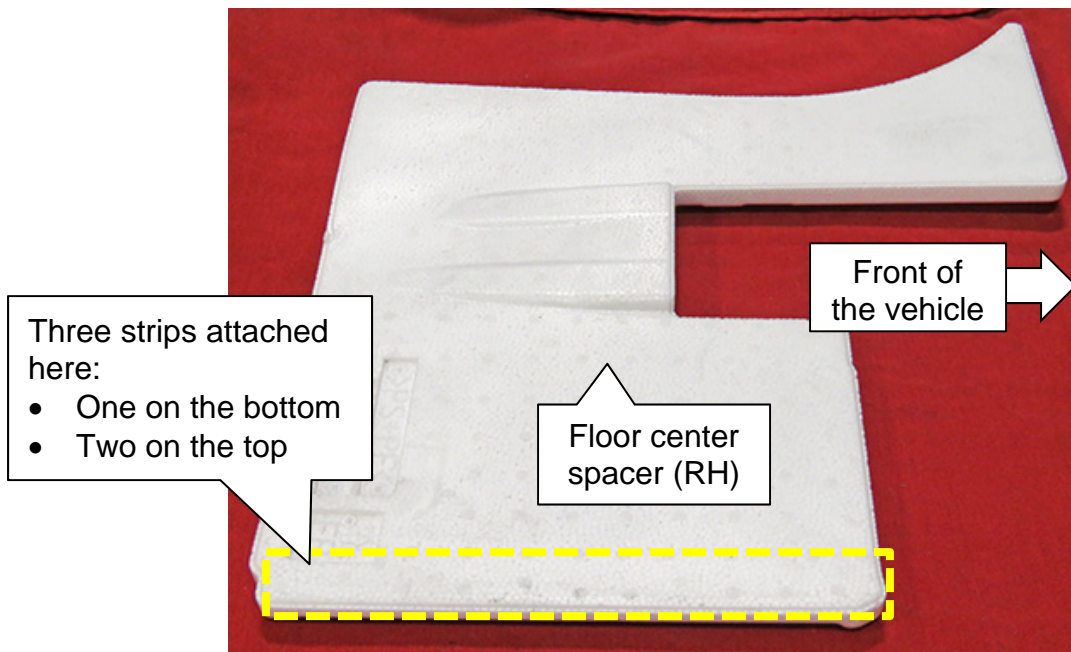
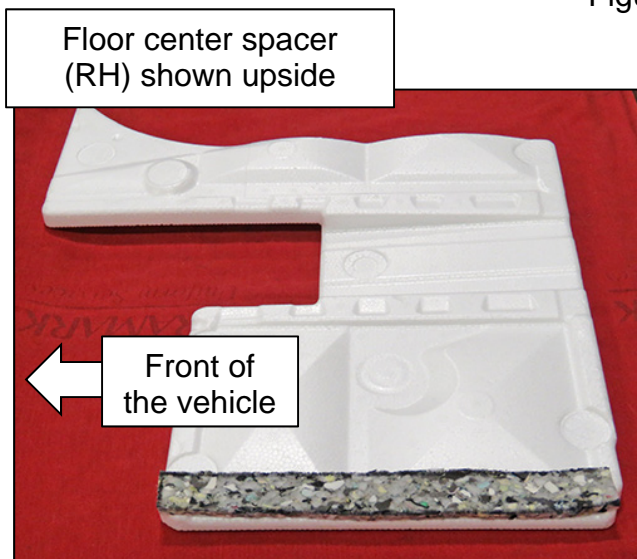
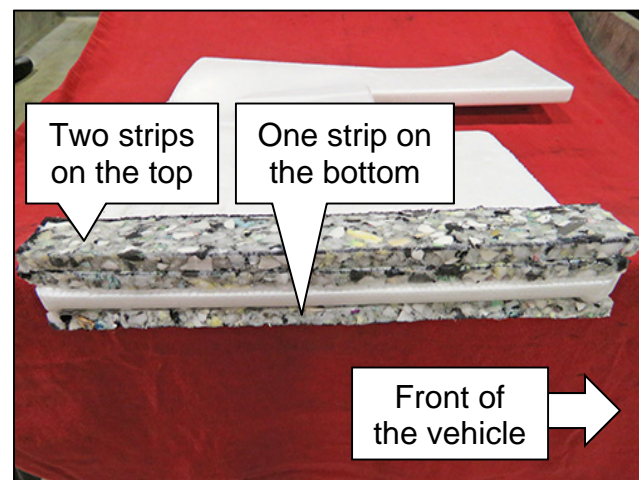
NOTE: The attached strips should look like Figure 20.

18. Attach three (3) 30 mm x 300 mm strips of the foam padding to the floor center spacer (RH) with a hot glue gun as follows:
- Attach one (1) strip to the bottom along the edge, closest to the door opening.
 - Attach two (2) strips to the top side, closest to the door opening.
 - Stack two (2) strips of padding on top of one another to achieve a 20 mm thickness with adhesive.

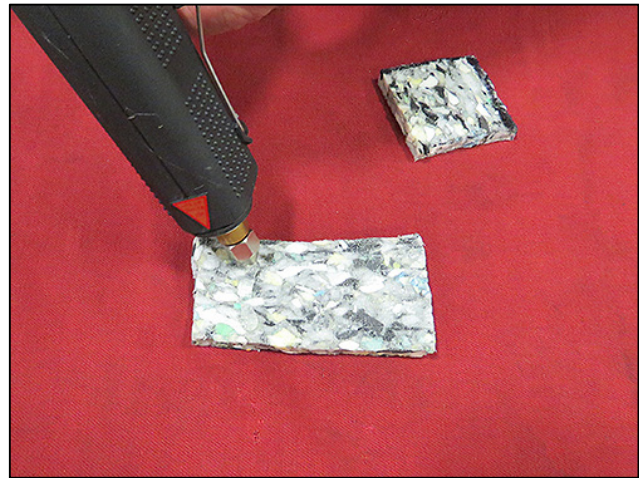
- Align one end of both pieces so that they are flush.
- See Figure 24 and Figure 25.

24. Apply a small amount of hot glue and then attach the 50 mm x 50 mm square to the 50 mm x 100 mm strip as shown in Figure 25.
