## Purpose

This document describes the procedure to replace the vertical mullion in the center of the screen door of an RV entry door.

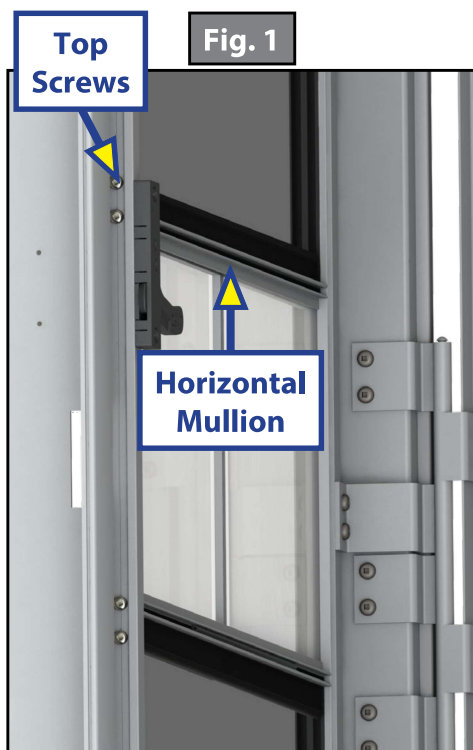
1. Remove both top screws on each side of the screen's horizontal mullion (Fig. 1).
2. Pull out enough of the screen spline in order to provide room to maneuver during the replacement procedure, about 4" past the vertical mullion (Fig. 2).
3. Pull out on vertical mullion to remove it (Fig. 2).

4. Install replacement vertical mullion by tapping it softly to seat it.
5. Replace the spline using a rubber mallet or a flat screwdriver and hammer to reinstall.
6. Reinstall the top horizontal mullion screws (Fig. 1) on both sides of the screen.
