# Technical Service Bulletin

| <b>Technical Service Bulletin:</b> TSB200040 | <b>Released Date:</b> 26-Feb-2020 |

## HGJBB Crank but No Start or Hard Start Due to Leaking LP Hoses

- HGJBB Spec A-B (liquid propane models only)
- While the details within this document are specific to HGJBB, the principles apply to any LP-fueled generator set. Cummins always recommends following the engine manufacturer's guidelines for fuel hose maintenance.

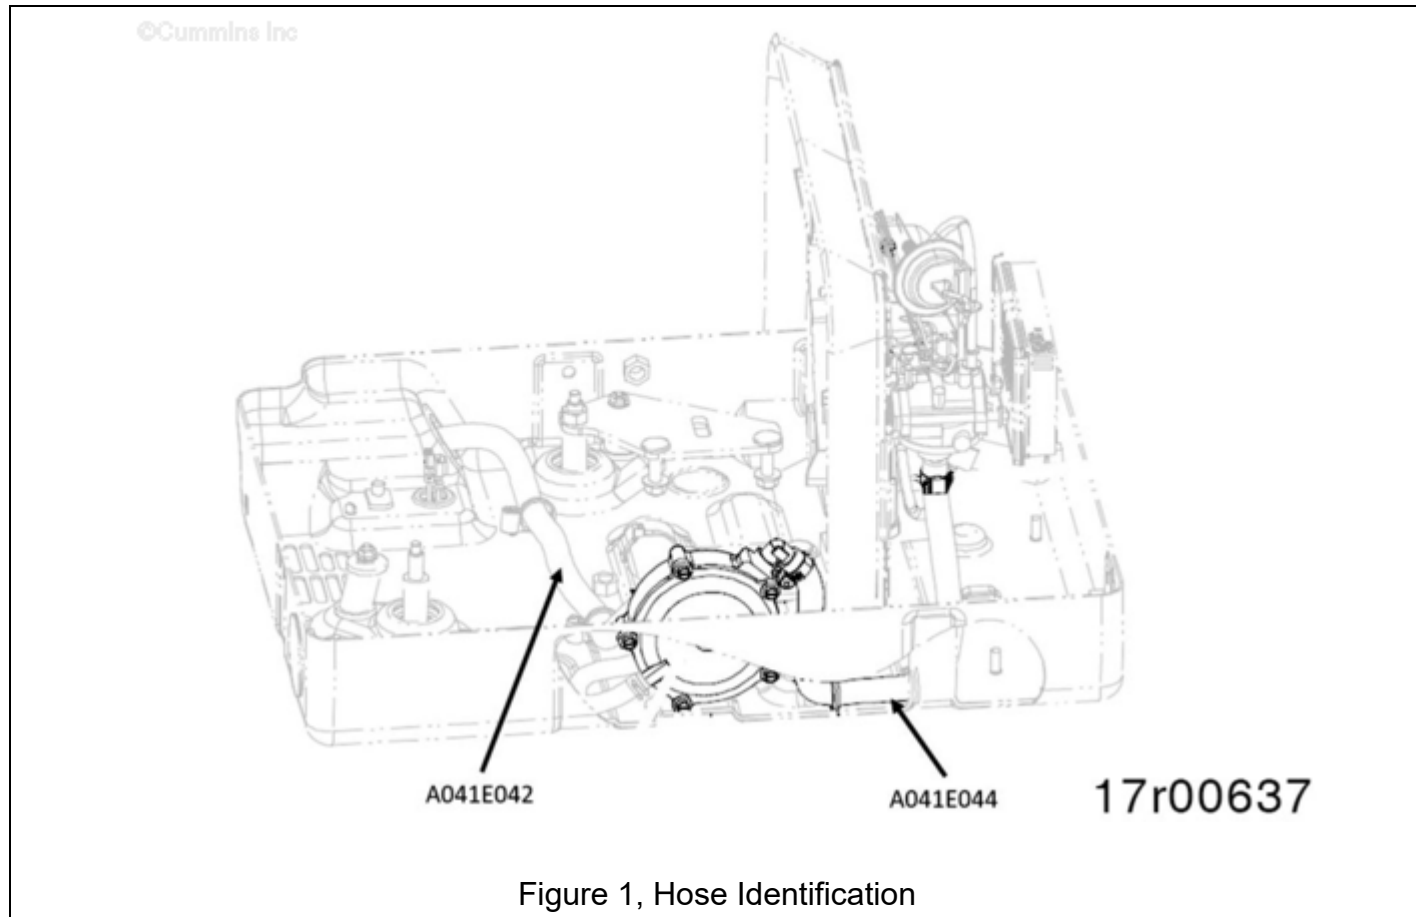
If troubleshooting has led to the discovery of cracked or leaking hoses, order new fuel hoses (part number A041E042 and part number A041E044) through the aftermarket channel. If one hose is found to be cracked or leaking, then both hoses should be replaced. Refer to Figure 1 for part identification.

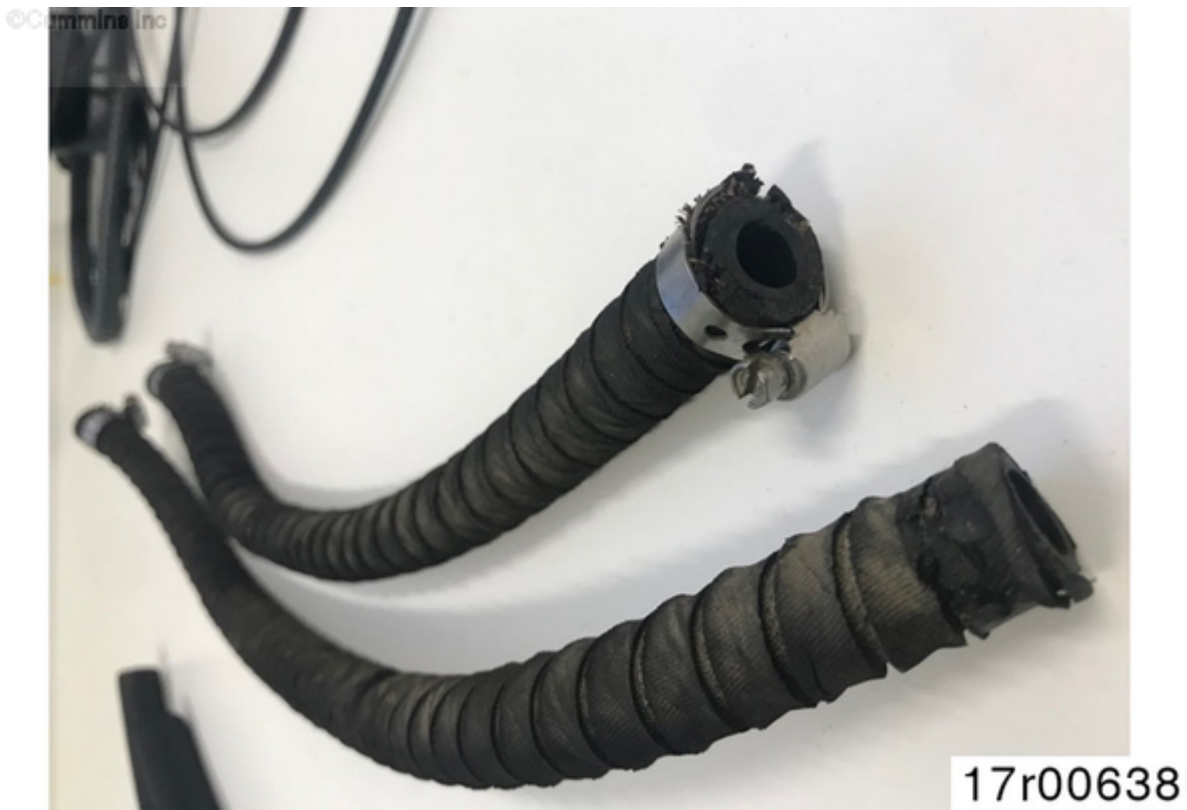
- The liquid propane (LP) hoses carrying LP to and from the regulator can crack and deteriorate over time due to age and environmental stress. The cracked hoses pull in excess air, resulting in a lean mixture which can cause the symptoms stated above.

The new hoses should appear visibly different than the older hoses (which were susceptible to cracking). Refer to Figure 2 and Figure 3 for the differences in the fuel hoses appearance.

Figure 2, Old LP Fuel Hoses that are Susceptible to Cracking

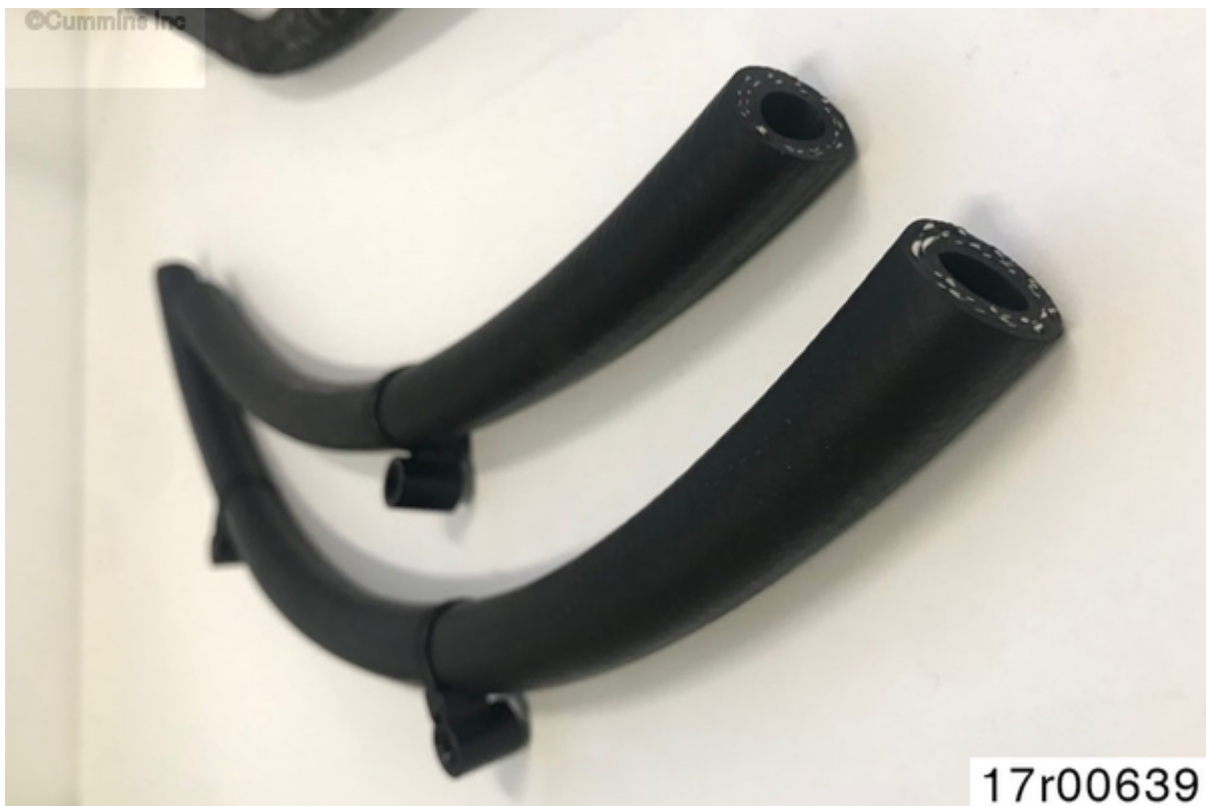
Figure 3, New LP Fuel Hoses

Additionally, engine service manual A043L675 lists fuel hoses as a maintenance item and recommends they are replaced every 1,000 hours or annually. These guidelines should be followed to ensure optimal performance of the fuel hoses.
