SIB 11 01 20

B58C AND B58M ENGINES: ENGINE OIL FILTER INSERT IS DIFFICULT TO REMOVE – REMOVAL

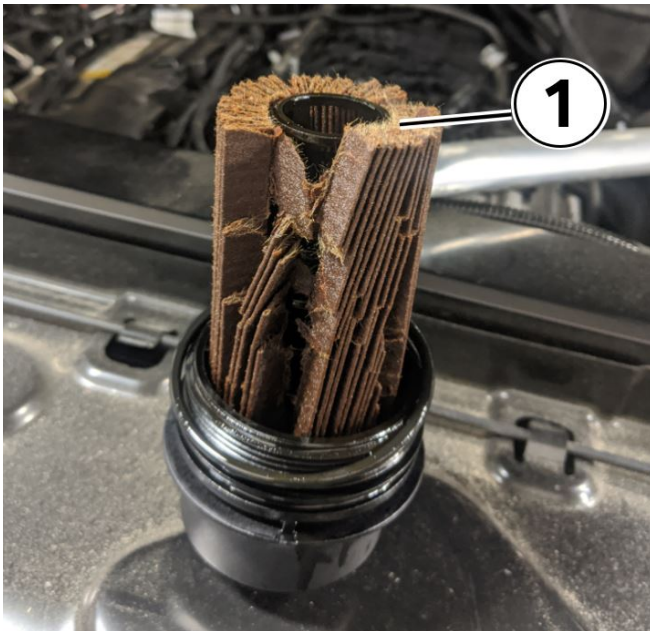
The engine oil filter is broken. The paper is torn, and the lower plastic section is stuck in the engine oil filter housing (1).

If the engine oil filter insert has broken apart inside the oil filter housing:

1. Take a clear picture of the broken oil filter insert, still located inside the filter housing.
 - Submit a TSARA case titled “B58 Oil Filter Stuck” with the attached pictures. Due to limited stock, parts will be released for individual VINs by the Parts Department ONLY after an approved TSARA case.

- Submit a Parts Matrix IDS ticket request including the VIN, part number and approved TSARA case
2. Replace the complete engine oil filter housing per the applicable repair instructions.

- **Do not replace the heat exchanger**
 - **Do not remove or try to clean the oil filter fragments from the engine oil filter housing**
3. When the oil filter housing is removed from the engine,
