SIB 61 01 20  
ACCESSORIES DO NOT POWER ON

E-Series	Model Description
F95	X5 M SAV (Sports Activity Vehicle)
F96	X6 M SAC (Sports Activity Coupe)
G05	X5 SAV
G06	X6 SAC
G07	X7 SAV
G20	3 Series Sedan
G29	Z4 Roadster

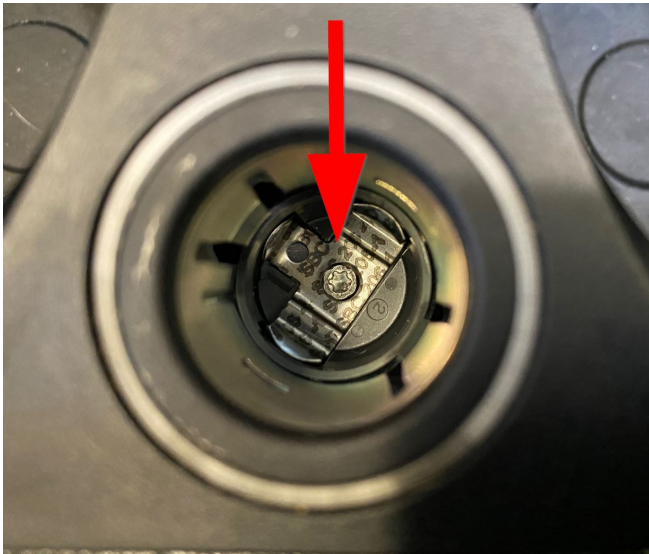
1. Remove the fuse that powers the front 12 V power socket. Fuse number and location can be found in ISTA or AIR.

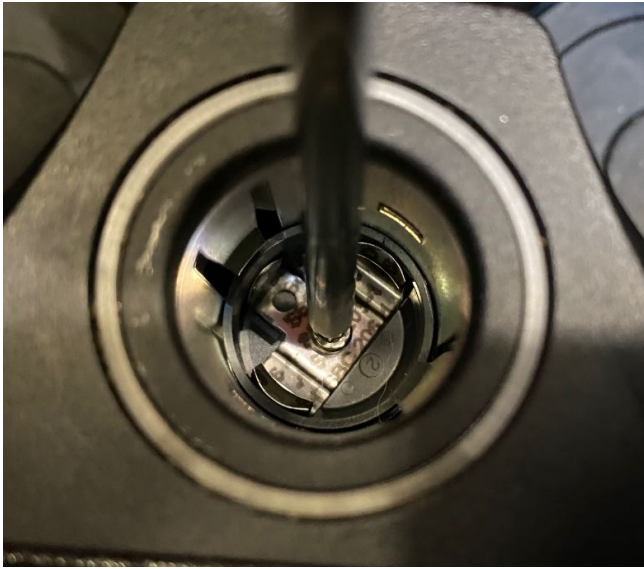
2. Loosen the Torx bolt using a T10 bit driver. DO NOT apply too much downward pressure as this can cause the power socket to come apart underneath.

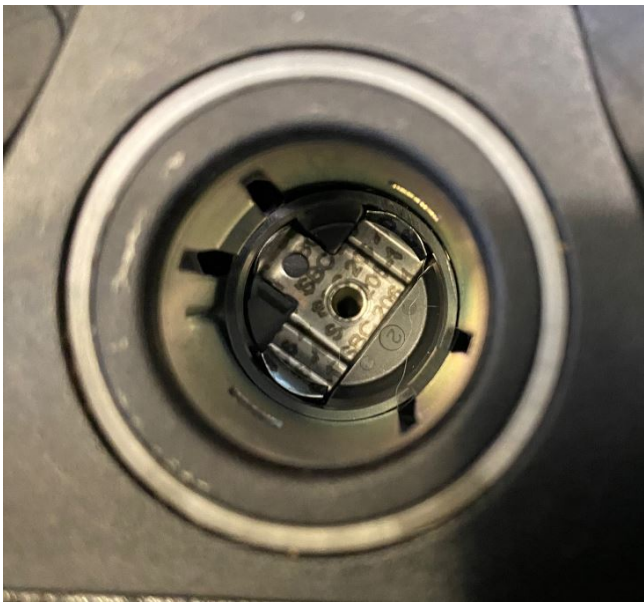
3. Remove the Torx bolt.

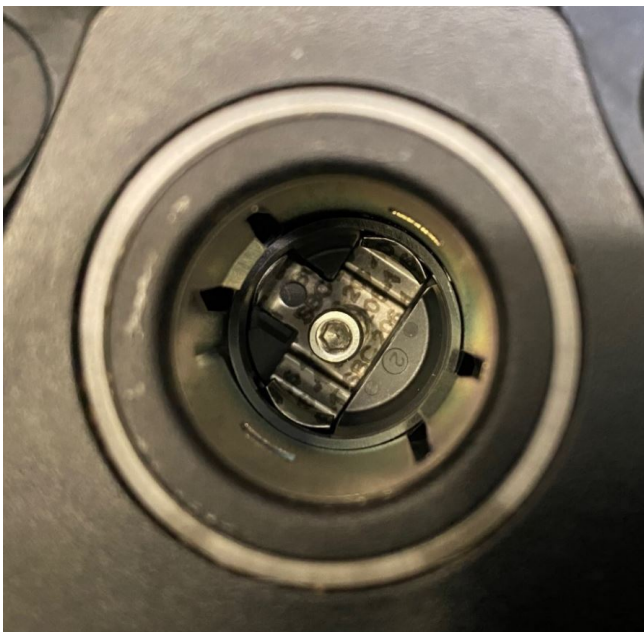
4. Insert the replacement bolt and hand tighten (McMASTER-CARR, item number 91292A112).

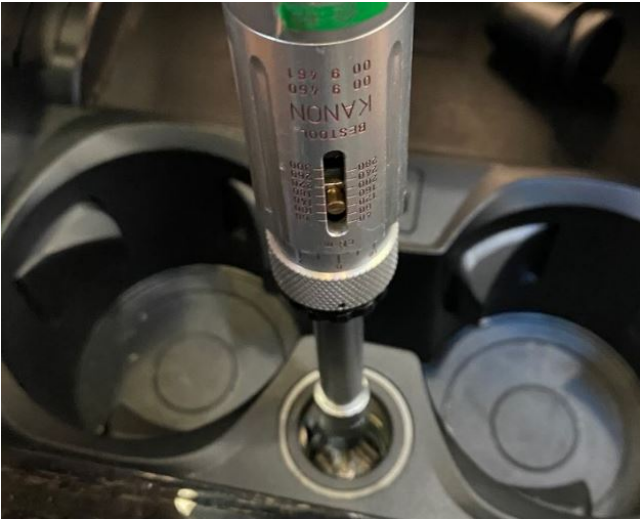
5. Using Special Tool 0496778, torque the bolt

to 1 NM.
