Technical Service Bulletin

01 MIL on, DTC P218100, P017B00, P308100, and/or P01E400 are stored in the ECM

01 20 48 2058767/1 March 11, 2020.

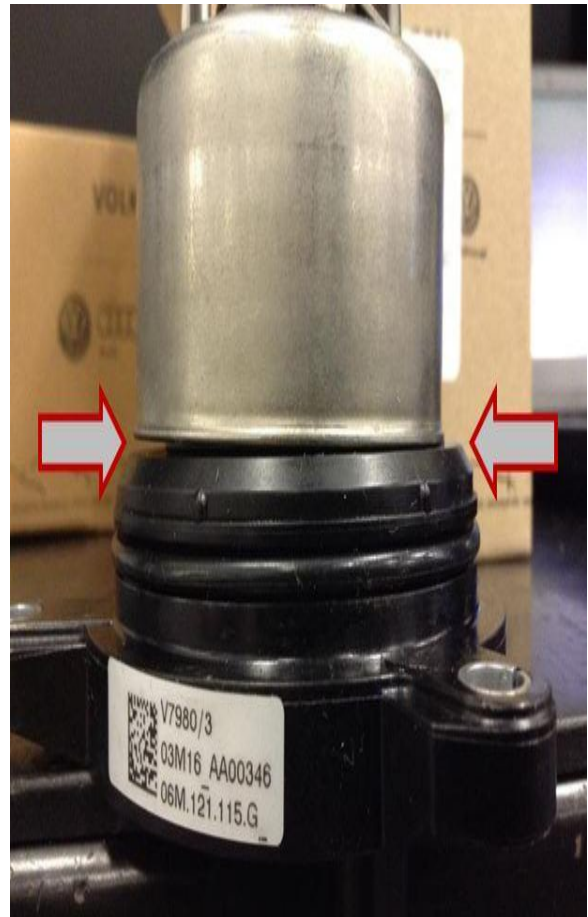
1. Remove the thermostat and check whether it closes completely. If the coolant is still warm, put the thermostat in cold water to restore its original condition. If there is a gap between chamber and seal, the thermostat is faulty.
2. Attach photos to the repair order which clearly shows that the thermostat does not close neatly.

Figure 1. Gap between chamber and seal.

Implementation of improved thermostat in production.

After the repair, fill with G12evo coolant in the coolant circuit.
