# Technical Service Bulletin

## 34 Vehicle Electronics Malfunction message, DTC B116229 is stored in the steering wheel or vehicle electronics module

34 20 44 2047609/3 March 5, 2020. Supersedes Technical Service Bulletin Group 34 number 20-43 dated February 19, 2020 for reasons listed below.

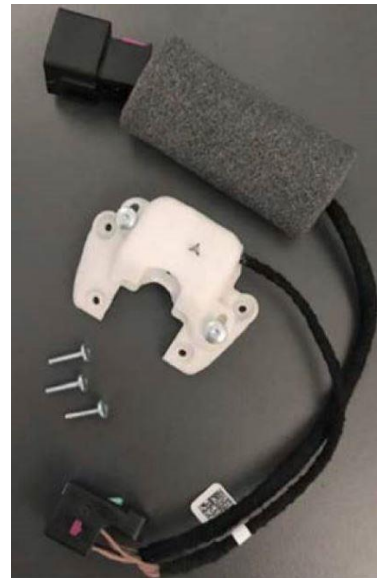
*Figure 1. New micro switch module.*

Component-related deviation in microswitch of the selector lever.

If the customer has the above condition and the DTC B116229 is stored in the steering wheel electronics module, J527 (address word 0016) or the vehicle central electrical system module J519 (address word 0009), then install the new externally mounted micro switch module and selector lever handle sleeve per the instructions below (Figure 1).
