NTG1 - Erroneous service alert or emissions inspection notice in instrument cluster (IC) and/or incorrect date/time in Audio 50/COMAND (HU) and instrument cluster

Topic number	LI82.85-P-071015
Version	1
Function group	82.85 Navigation and Communication systems
Date	02-18-2020
Validity	Model 171, 211, 219, 230 with code 525 (Audio 50 APS NTG 1) or with code 527 (COMAND APS NTG 1) up to and including code 808 (modification year)
Reason for change	Model series 230 added to validity
Reason for block

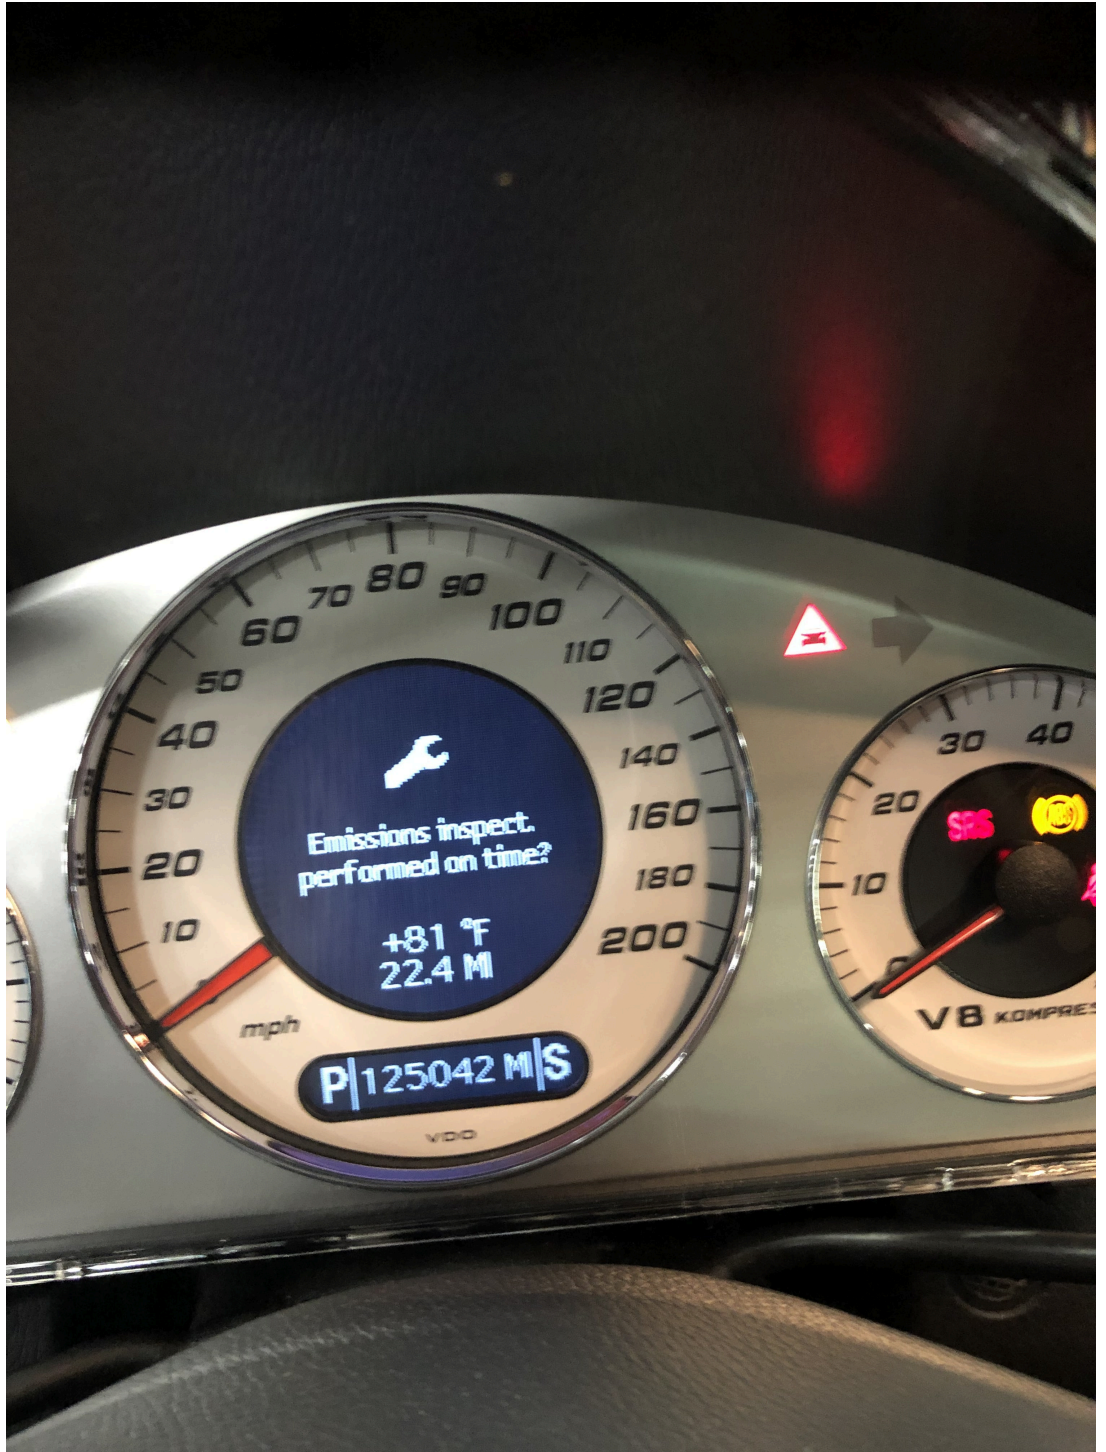
emissions inspection
message.JPG:

- Erroneous service alert or emissions inspection notice in instrument cluster (attachment 1)
- Date/time incorrect in instrument cluster
- Date/time incorrect in Audio 50/COMAND

Incorrect processing of the GPS signal within the head unit

NOTE: Please do not replace/exchange any parts. Emissions inspection notice is not relevant to vehicles in the US market.

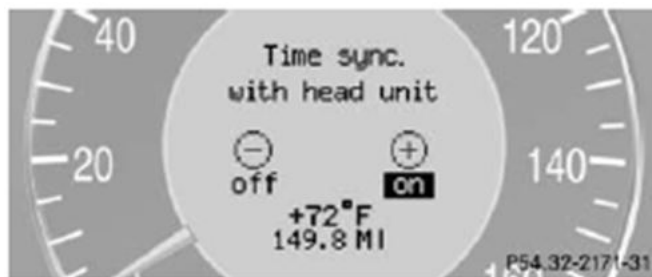
deactivate time synchronization with head unit.
jpg:

1. Select Settings
2. Deactivate time synchronization between instrument cluster and HU (attachment 2)
3. Manually set/correct date/time (attachment 3)

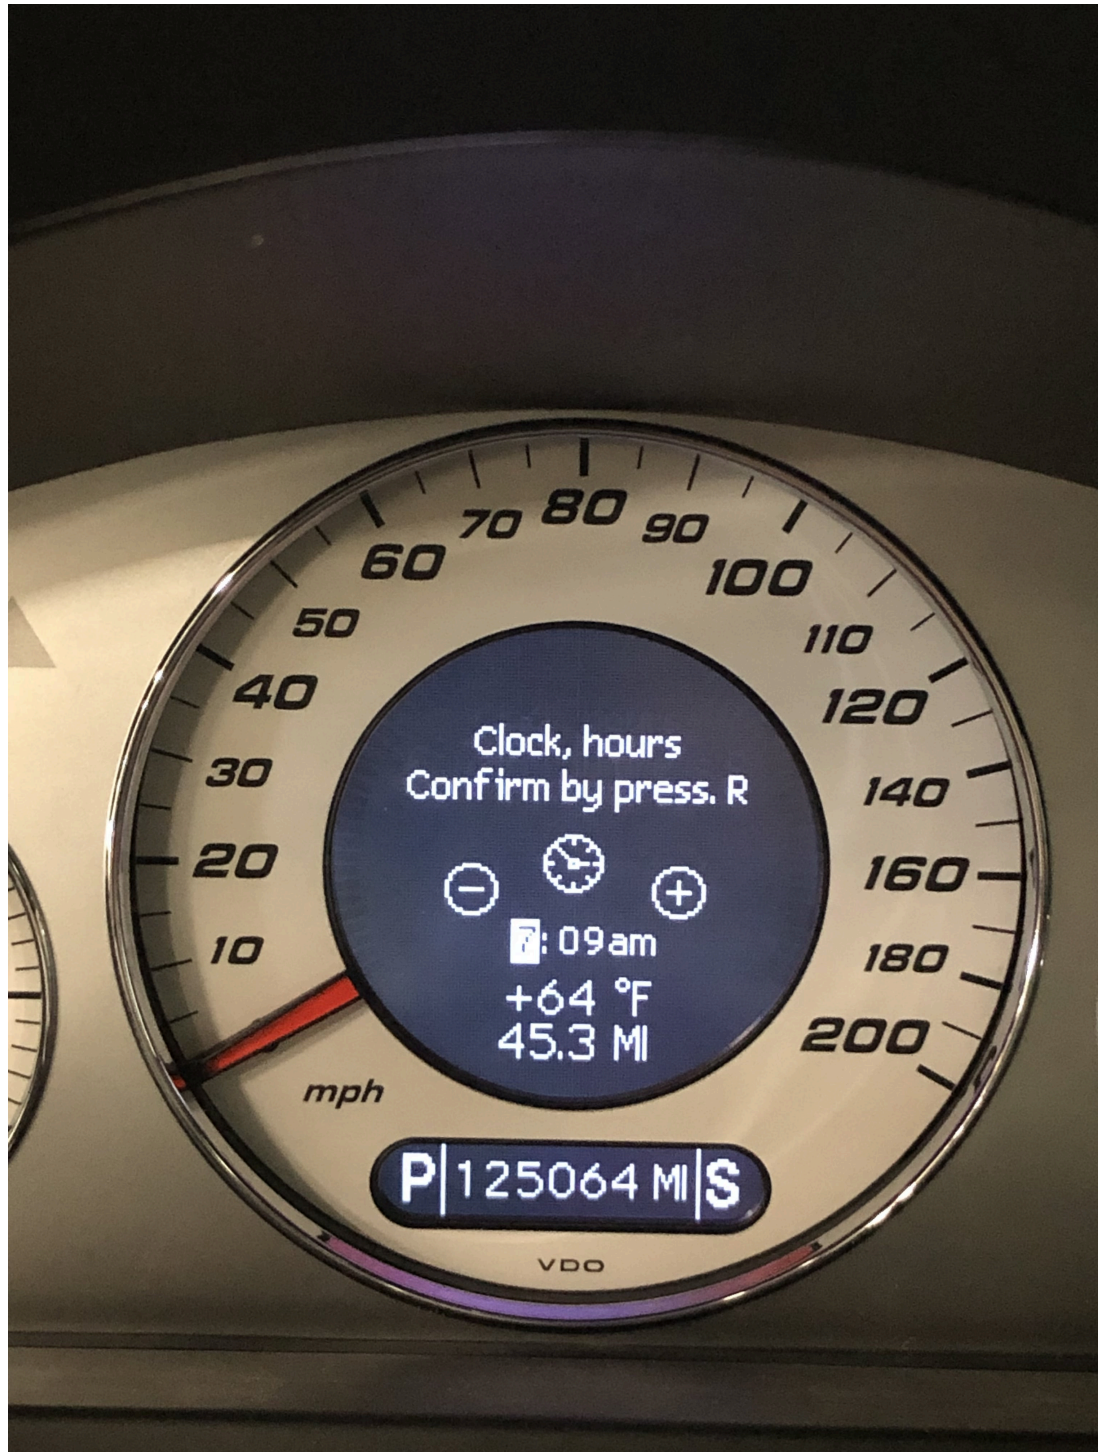
Manually set date and time.jpg:

5. Set date/time manually (attachment 3)
