| RE: Service Campaign Launch Notification Information Label on Tire Sealant MY16-20 117, 156, 166, 167, 172, 177, 190, 205, 213, 217, 222, 231, 238, 253, 290, 292 (A-Class, C-Class, CLA-Class, E-Class, GLA-Class, GLC-Class, GLE-Class, GLS-Class, GT-Class, S-Class, SL-Class, SLC-Class) | DATE: February 07, 2020 |

Campaign No. 2020020001, February 2020

Information Label on Tire Sealant

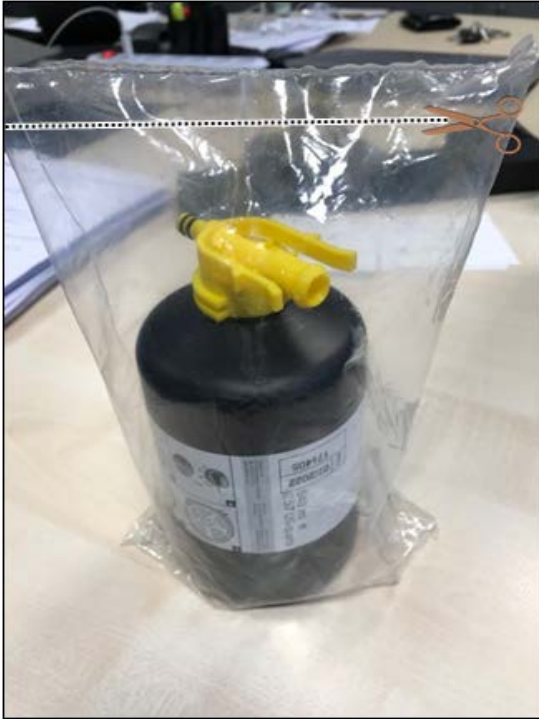
Figure 1

1. Remove tire sealant bottle (TIREFIT) from trunk.
i For basic data, see **AP40.10-P-4054R**.
2. Cut open storage bag for tire sealant bottle (TIREFIT).

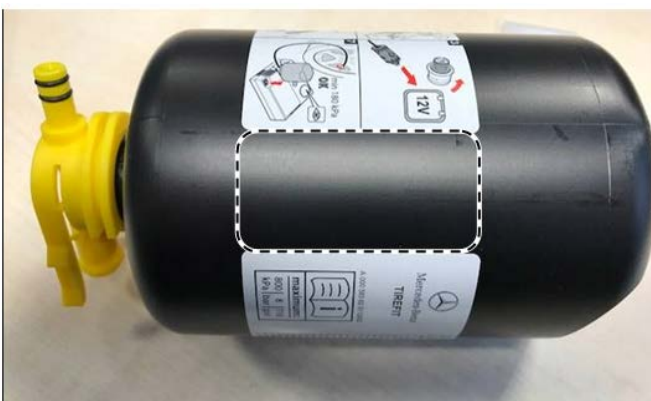
Figure 2

3. Remove tire sealant bottle (TIREFIT) and gloves from storage bag.
4. Position tire sealant bottle (TIREFIT) with the free area facing upward.

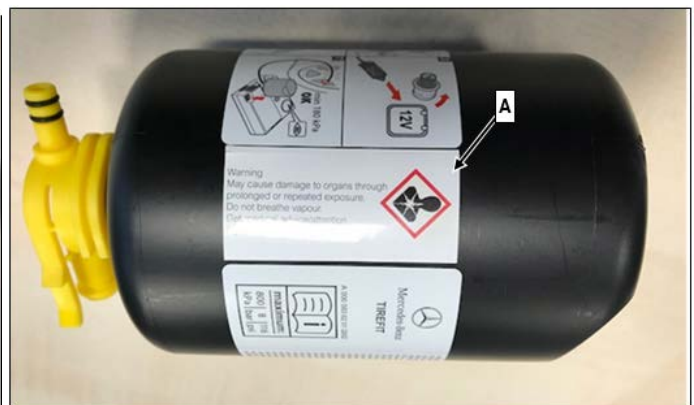
Figure 3

5. Subsequently attach information label (**A, Figure 3**) to tire sealant bottle (TIREFIT).

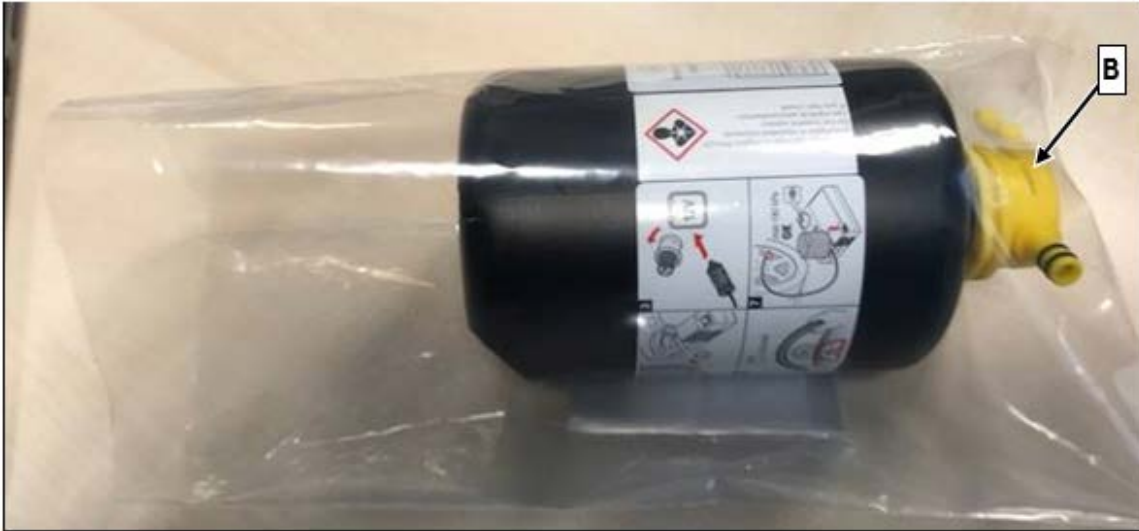
Figure 4

6. Place tire sealant bottle (TIREFIT) into the storage bag with the connection first (**B**, **Figure 4**).

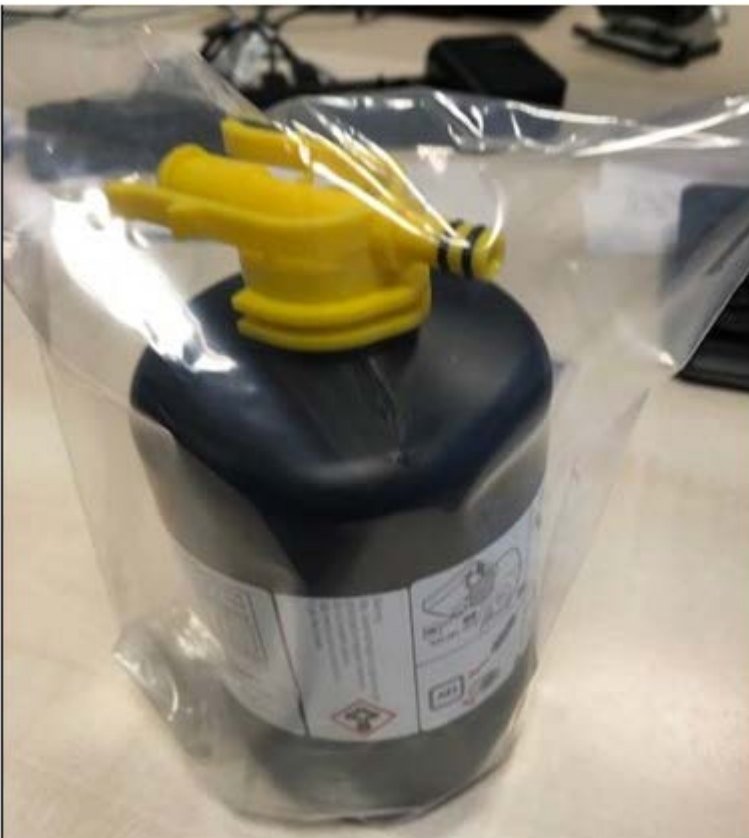
Figure 5

7. Place gloves in storage bag.
8. Fold over the storage bag (**Figure 5**) and place it in the bracket in the vehicle's trunk with the open side facing downward.
