Technical Service Bulletin

68 Noises from the center console

68 20 24 2055775/2 March 19, 2020. Supersedes Technical Service Bulletin Group 68 number 19-22 dated August 5, 2019 for reasons listed below.

Model(s)	Year	VIN Range	Vehicle-Specific Equipment
A6, A7	2019	000001 - 076631	Not Applicable

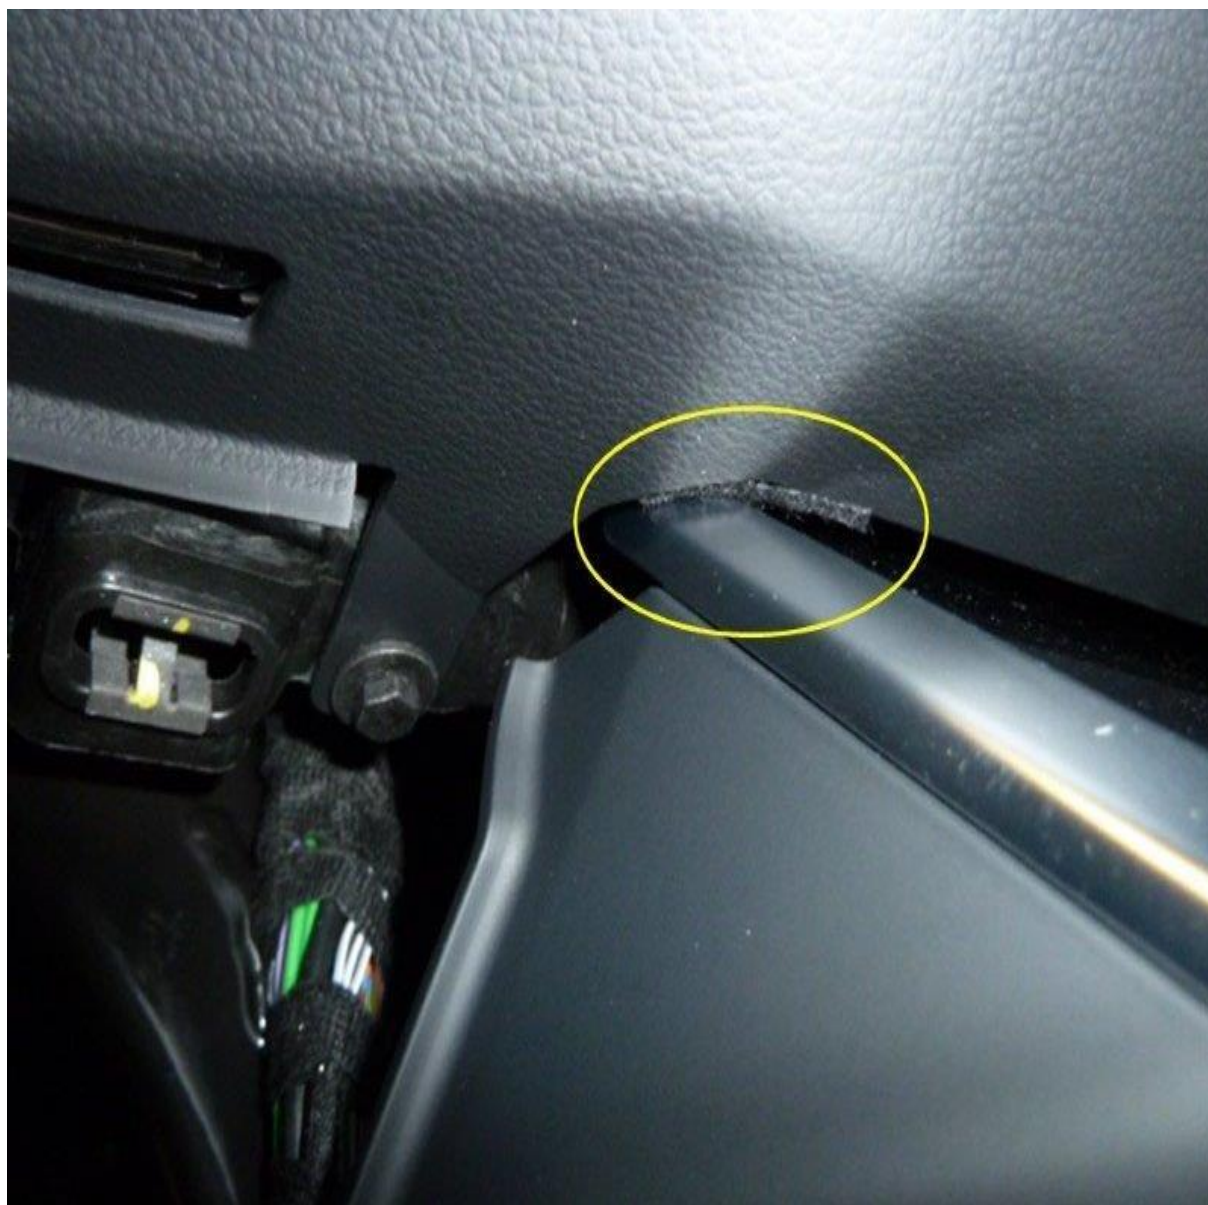
There is hard contact between left and right side of center console and dash panel.

Figure 1. Installation of the felt strip shown (yellow circle).

- Install two 1.5" long felt strips on the dash panel to eliminate hard contact between the dash panel and center console (Figure 1).

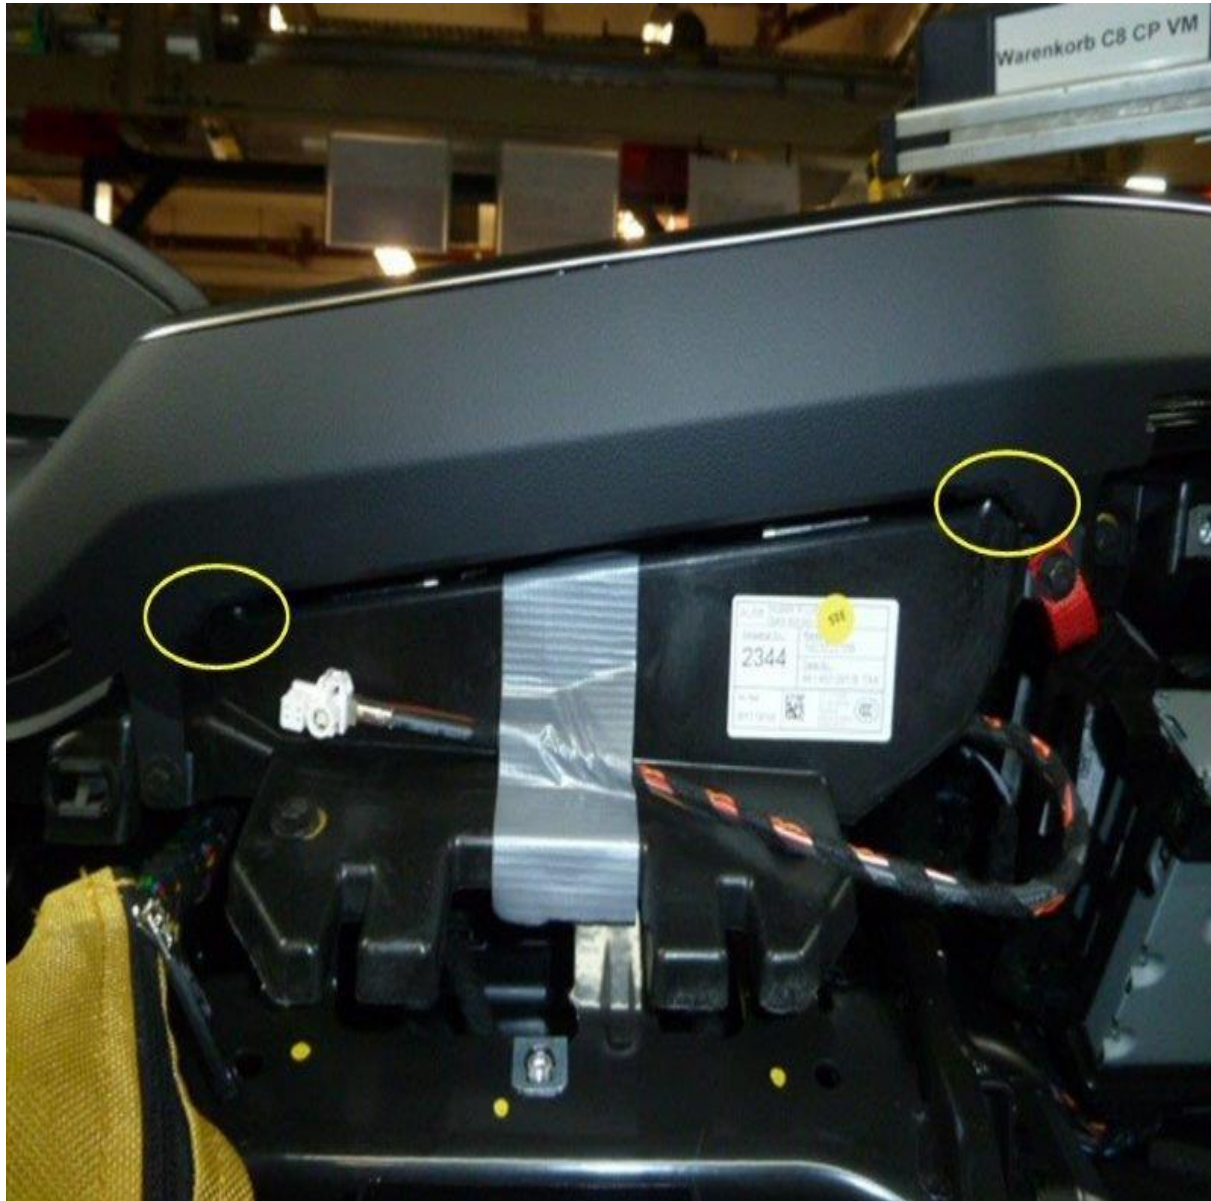
Figure 2. Positions of the felt strips (yellow circles).

Use a plastic wedge to create a gap between the center console and dash panel and install the felt strips (Figure 2).

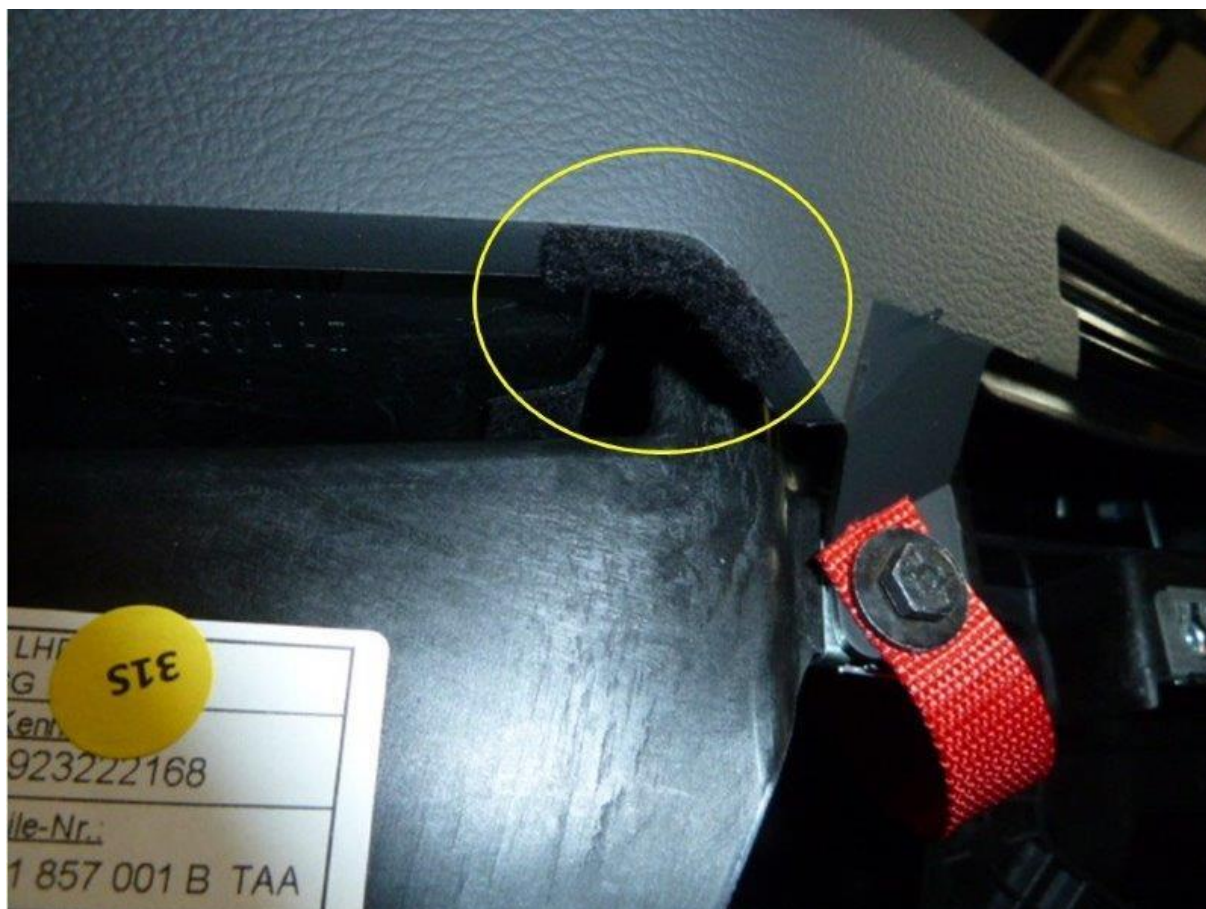
Figure 3. Close up of the right felt strip.

3. Install 1 felt strip on the left side and 1 on the right side of the dash (Figure 3).
