# Service Action

## Code: 38C5

**Subject** Transmission Oil Cooler Seals

**Problem Description** The seals on the transmission oil cooler may leak.

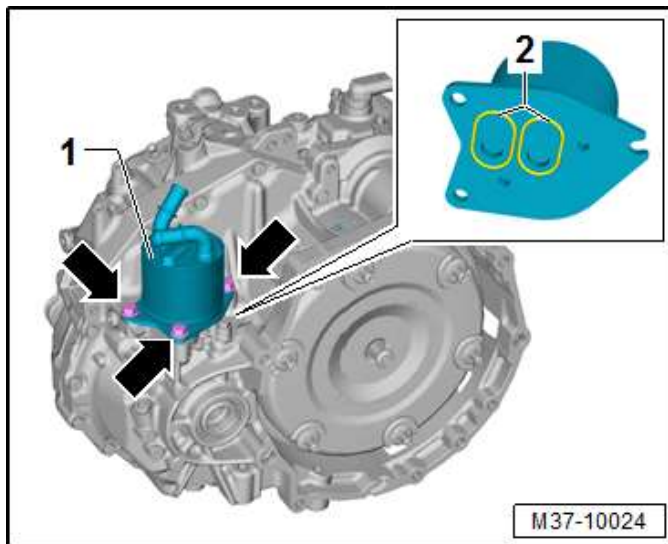
## Repair Overview

- Replace transmission oil cooler seals <2>.

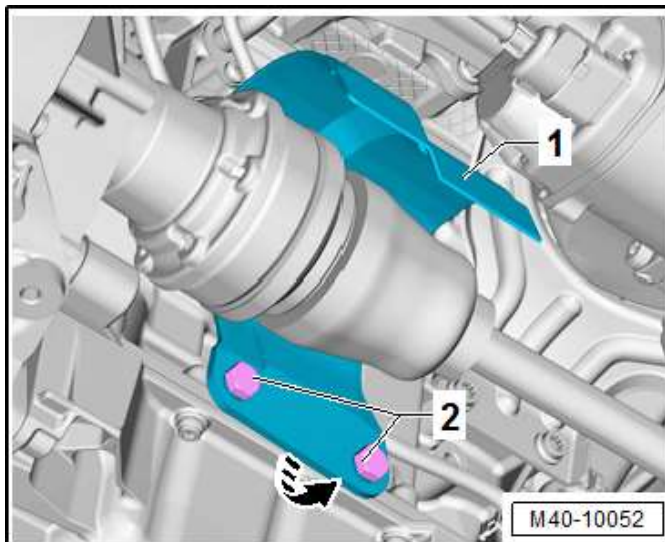
### Remove drive axle heat shield:

- Remove front noise insulation:
  - See ELSA Repair Manual: *Repair manual > Body > Body Exterior > 66 Exterior Equipment > Noise Insulation > Overview - Noise Insulation*
- Remove bolts <2> and remove drive axle heat shield <1>.

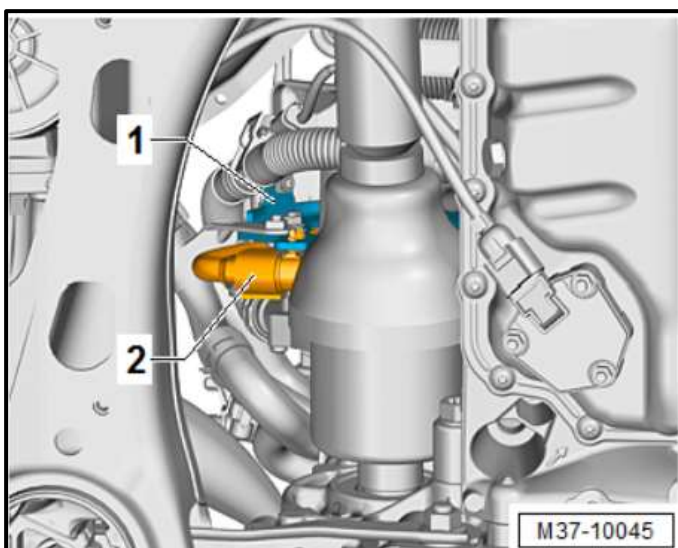
### Unclip secondary air injection pump motor from underneath the vehicle:

- The connector <2> remains connected.
- Unclip the secondary air injector pump motor connector housing <2> from the bracket <1>.

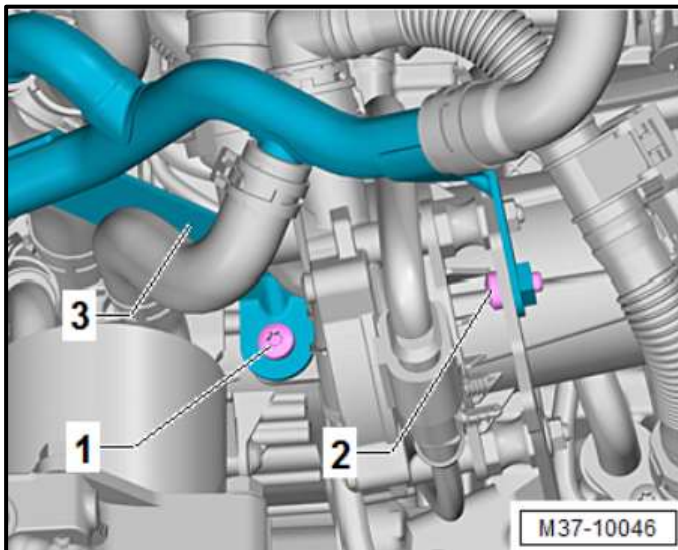
**Loosen coolant pipe bracket from underneath the vehicle:**

- Remove bolts <1> and <2>.

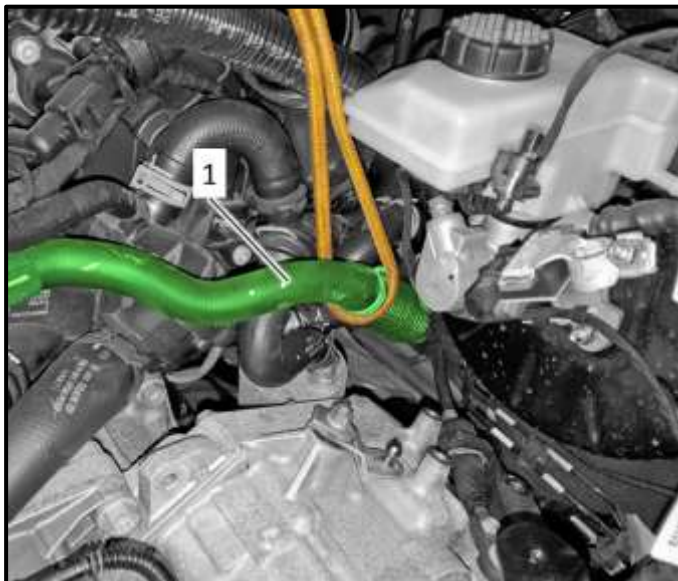
**Secure coolant line out of the way:**

- Tie up coolant line <1> upward to gain better accessibility to ATF cooler.

Shifter cable shown removed for clarity. It is possible to perform this repair without removing the shifter cable.

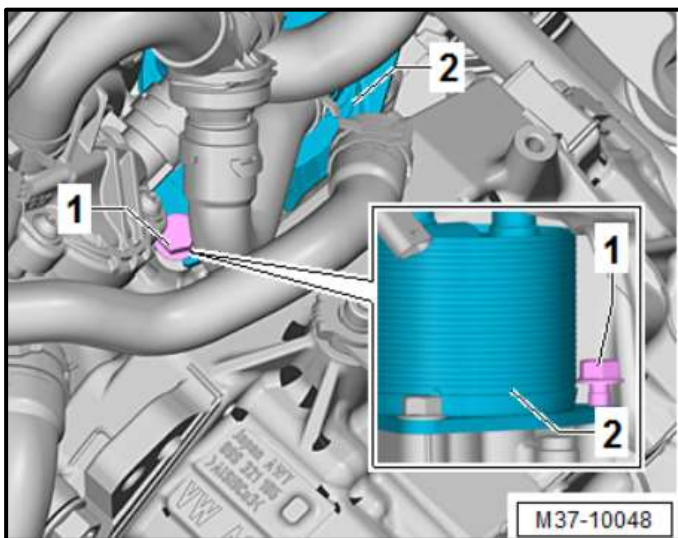
**Unbolt ATF cooler:**

- DO NOT remove the coolant hoses from the ATF cooler!!
- The area around the ATF cooler must be free of dirt and debris before removing the ATF cooler.
- Dirt and foreign objects must not enter the ATF system.
- Loosen bolt <1> a few turns.

The ATF cooler is slotted at bolt <1> so the bolt does not have to be removed completely.

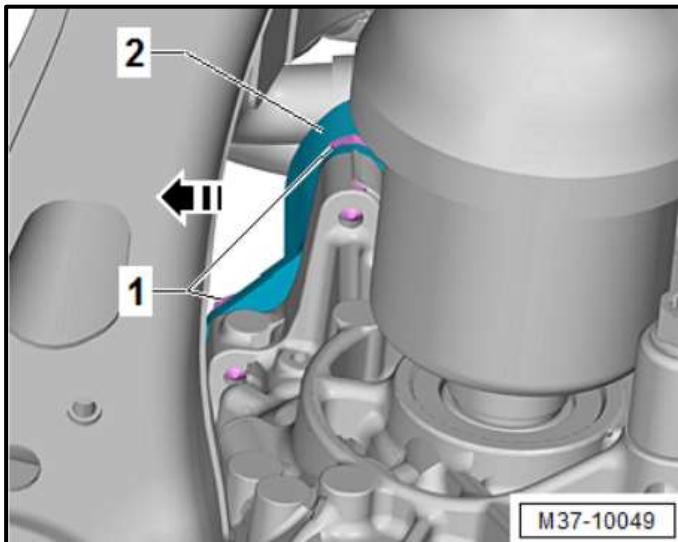
- From below, remove bolts <1> and <2>.
- Reposition ATF cooler with the coolant lines still attached toward the rear.
- Replace the ATF cooler seals.

**Risk of leaks due to twisting the seals.**  
Do not slide the ATF cooler along the surface of the transmission.

- Torque bolts to 20 Nm.

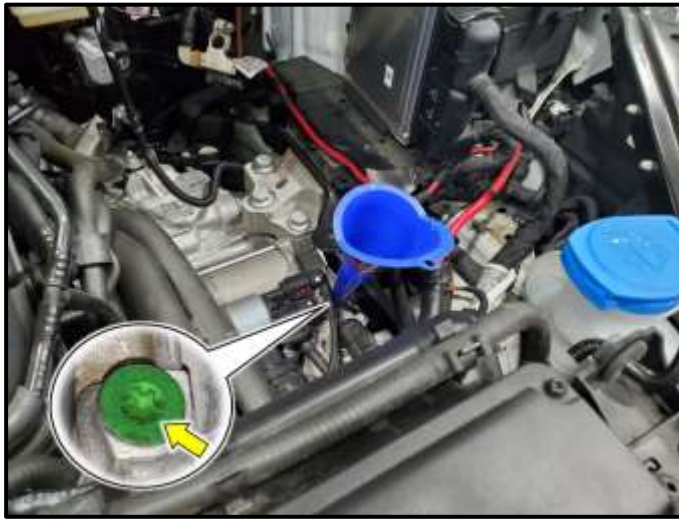
**Top off ATF before reassembling the vehicle:**

- Top off ATF after the ATF cooler has been reinstalled.
- Remove fill plug <arrow> from top of transmission.
- Insert a clean funnel into the fill hole.
- Shake the fluid container before opening and fill transmission with 200 ml of ATF.

- Reinstall fill plug and torque to 40 Nm.

If the fill plug O-ring is damaged, it must be replaced.

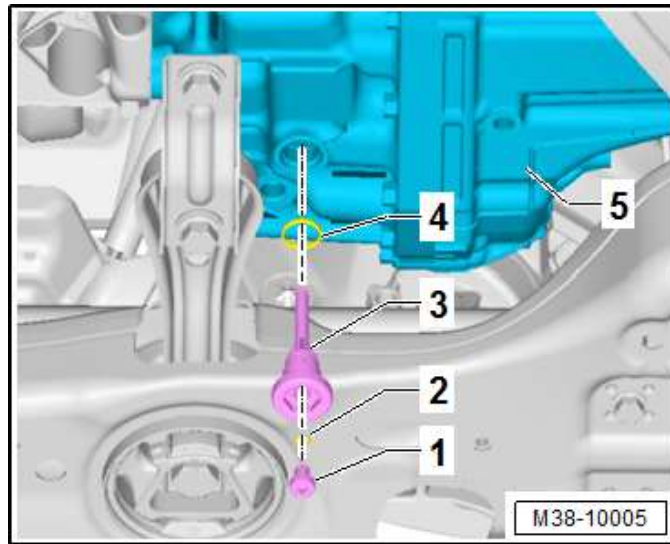
- Start the Transmission Control Module Guided Functions test plan “0002 – Check ATF level” and follow the on-screen prompts.
- When prompted by the test plan and when the test temperature is reached, remove drain plug <1>.
- Let the excess fluid drain.
- Install ATF drain plug with a new O-ring and torque to 9 Nm as soon as the excess fluid has drained out (fluid will start to drip).

- If no oil flows out, more ATF must be added.
- The ATF drain plug with the overflow tube <3> and seal <4> must stay in the transmission <5>.

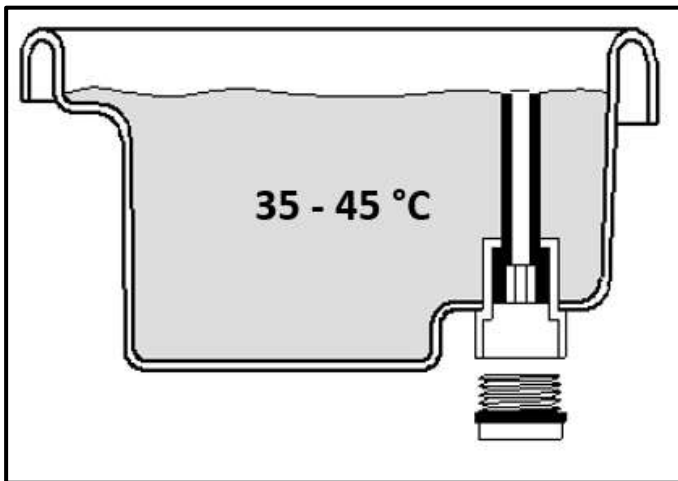
**⚠ CAUTION**  
Too little or too much fluid will impair the function of the transmission.
