Technical Service Bulletin

01 MIL on, DTC P218100, P017B00, P308100, and/or P01E400 are stored in the ECM

01 20 52 2058767/2 March 26, 2020. Supersedes Technical Service Bulletin Group 01 number 20-48 dated March 11, 2020 for reasons listed below.

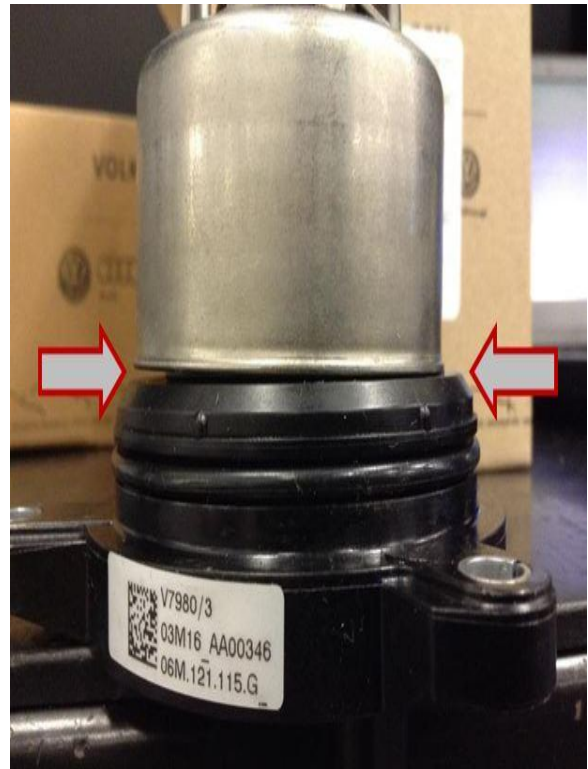
Figure 1. Gap between chamber and seal.

1. Remove the thermostat and check whether it closes completely. If the coolant is still warm, put the thermostat in cold water to restore its original condition. If there is a gap between chamber and seal, the thermostat is faulty and needs to be replaced.
2. Attach photos to the repair order which clearly shows that the thermostat does not close neatly.
