**Title: Lytx Video Monitoring Camera Inoperative****Applies To: LT's equipped with Lytx Camera System**

This document will guide the user through re-connecting the appropriate harness to allow the camera to function for the Lytx Video Monitoring System, located in the overhead panel.

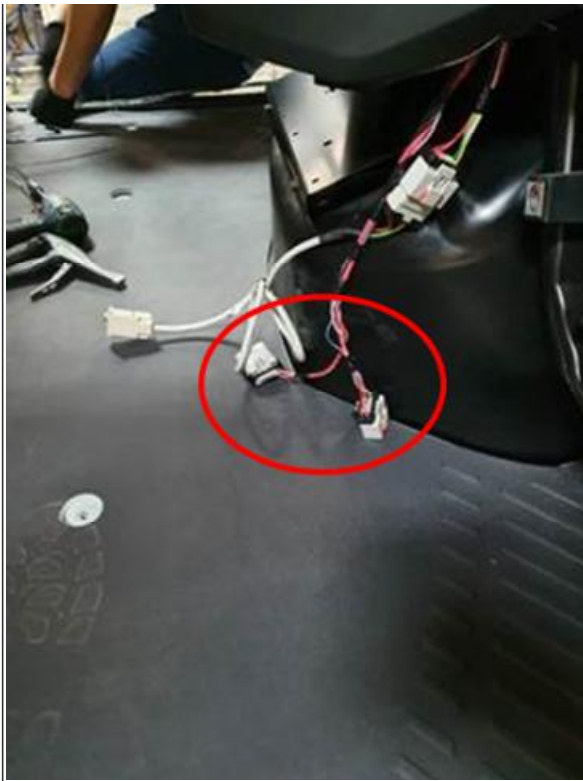
**Figure #1: Connector(s) Location**

1. Bring vehicle into shop and park on a flat surface
2. Shift transmission into park or neutral, set parking brake and install wheel chocks
3. Remove the engine cover, if necessary, and locate connectors 1947 and 1948 (6114576c1 and 6114577c1) under the dash on the passenger side of cab (Figure 1)

4. Connect the two connectors circled in red in Figure 1.
5. Verify camera operation
4. Remove wheel chocks
5. Return vehicle back to service
