| Title | AMT-F With Crawler Gears - <b>During Gearbox Removal From The AMT:</b> Input Shaft Slips Out Of The Gearbox Or Becomes Loose In The Gearbox |

| <b>Mack Model</b> | MRU - TerraPro , TE - TerraPro , AN - Anthem , CHU - Pinnacle, Axle back , CXU - Pinnacle, Axle front , GR - Granite , GU - Granite , PI - Pinnacle |

| <b>Volvo Model</b> | VN , VNL , VNR , VNX , VAH , VHD |

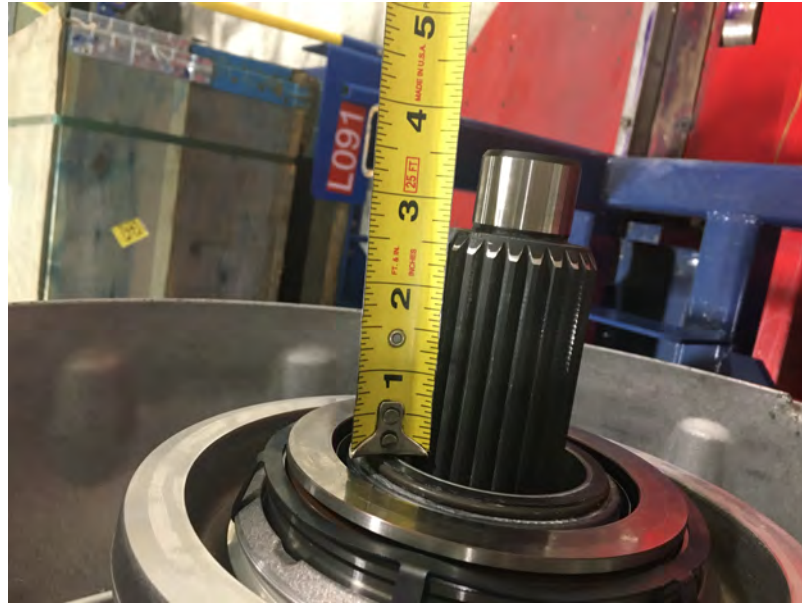
- Shaft protrusion from the front of the Clutch Control Actuator (CCA) on ALL gearboxes is approximately **3 5/8" (92 mm)** as shown below:

Always check the shaft after removing the gearbox.

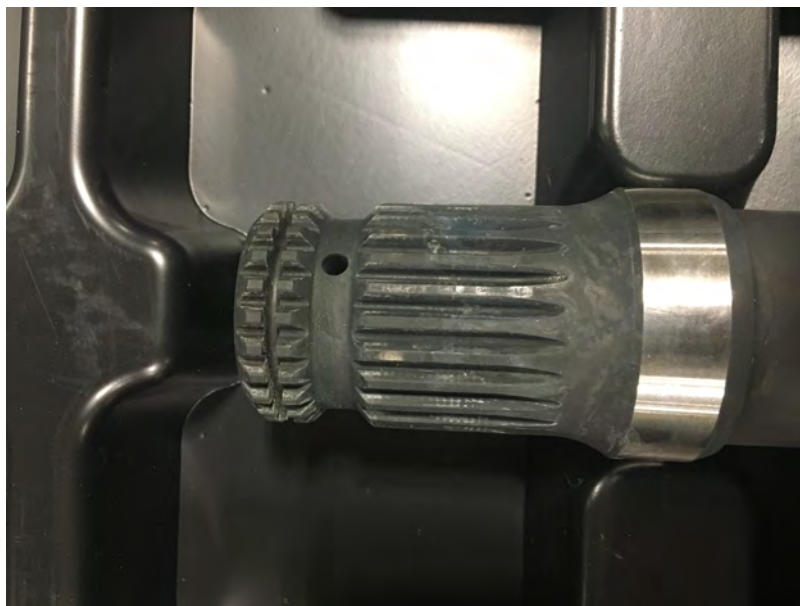
The ring fits in the small groove on the rear end of the shaft as shown below:

1. **Clean and inspect the input shaft, clip and splines.**
2. **Reinstall the clip.**

**NOTE:** The clip fits loosely.

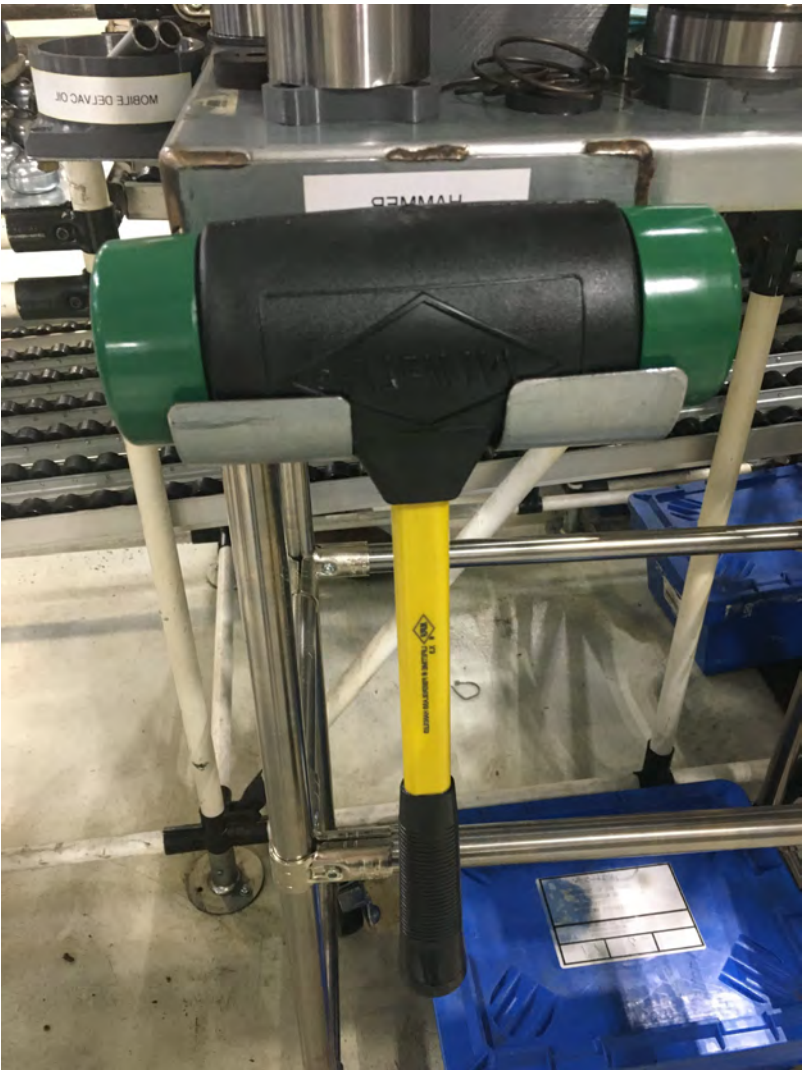
A rubberfaced deadblow hammer may be used to get the shaft started, as it can be difficult for

the ring to start into the gears.

**3. Apply oil to the shaft and splines in the rear input shaft as needed and reinstall the front input shaft into the rear input shaft.**

4. Replace the front input shaft seal.
