March 2020
By Jim Parrett

adventure, inspired by
AIRSTREAM
INTERSTATE / ATLAS

Atlas Project 2000 Double Step Guide

Instructions for pairing JBL Bluetooth Headphones with the MEE Audio Connect Hub and proper configuration of Samsung TV's

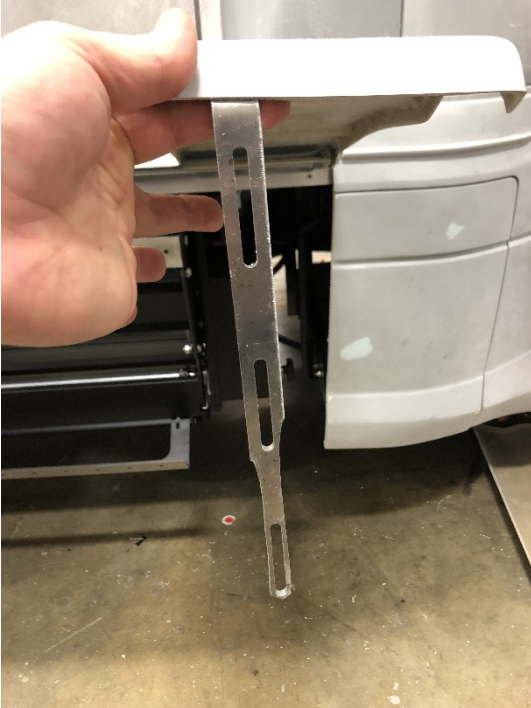
Issue: *The step will not move, they just “flop” up and down freely when in the down position.*

Locate the bracket(s) under the edge of the fiberglass skirt, shown to the left. Remove the screws securing the brackets to the frame. This will allow the fiberglass panel to swing up.

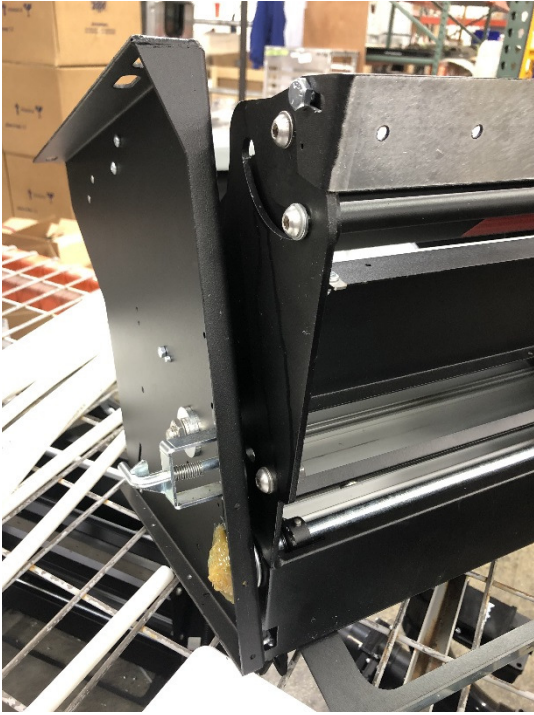
To the left of the step is a manual lock which will hold the step in the stowed position. Using this lock will allow easier access to the motor area to the right.

This lock is spring-loaded; pushing the lever up will “spring” it into the lock hole on the step.

In the event that the step is unable to stay in the stowed position use the manual lock to hold the step in place for travel to the nearest service shop for further repair.

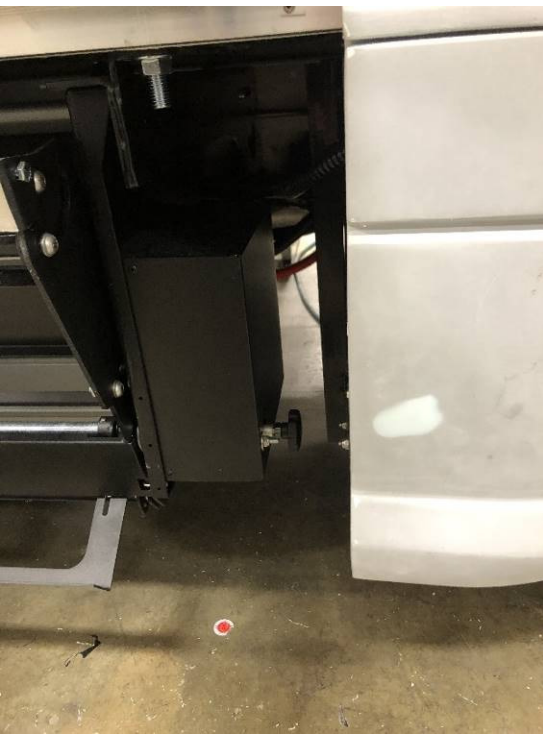
The motor and shear pin are located to the right of the double step. You will need to remove the black knob and two 3/8" nuts; one is next to the knob (shown) and one is on the backside lip.

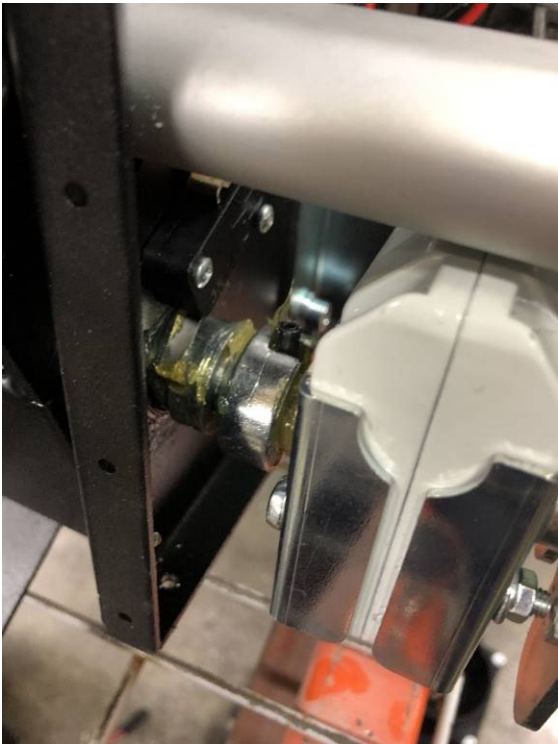
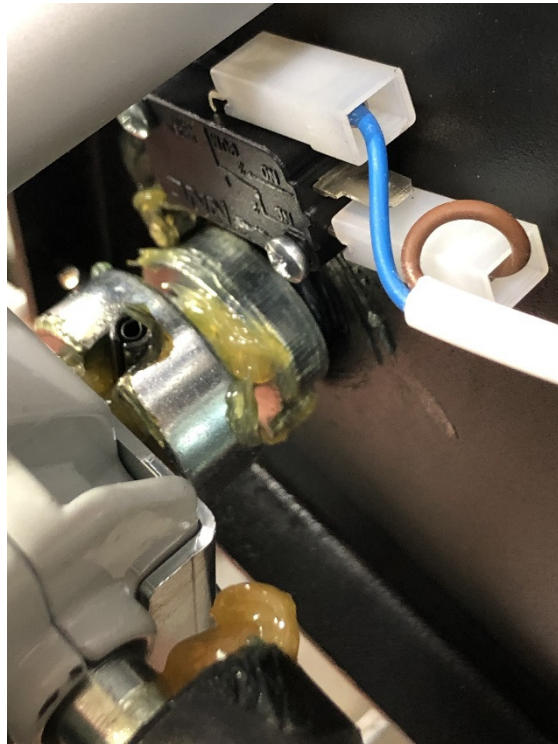
Pictured above is a shear pin that is broken and needs to be replaced.

420 Stainless Steel Coiled Spring Pin 3/16" Diameter, 1" Long

Squeeze pins closed and install them in a hole slightly smaller than the pin. Tension holds them tight against the hole wall. The chamfered ends aid insertion.

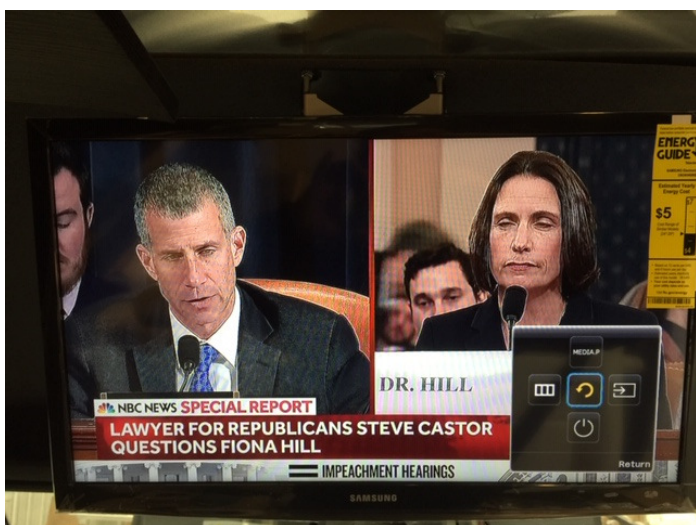
Figure 1: Menu displayed after the control on the back of the TV is pressed once.

1. Behind the TV in the lower right corner, is a short, joystick-like control, allowing the user to navigate different options without the remote. Press the joystick in to turn ON the TV. Once the TV is ON, pressing the button again will display a menu, shown in Figure 1.

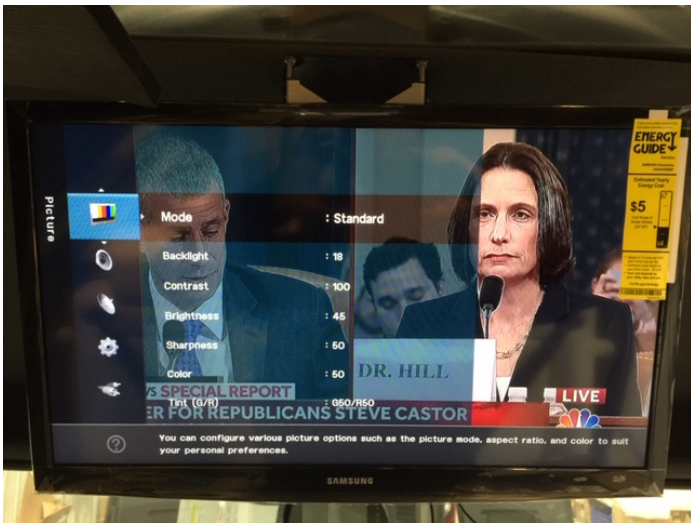
Figure 3: Menu displayed after selecting the rectangular icon.

3. Press the joystick in once to select. The menu, shown in Figure 3, will appear.

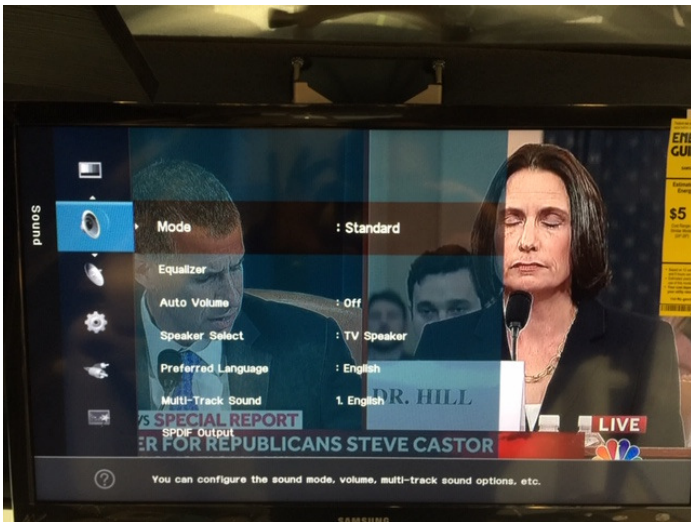
Figure 4: Menu displays sound options.

4. Use the joystick to move down once. This will display the sound options of the TV, shown in Figure 4.

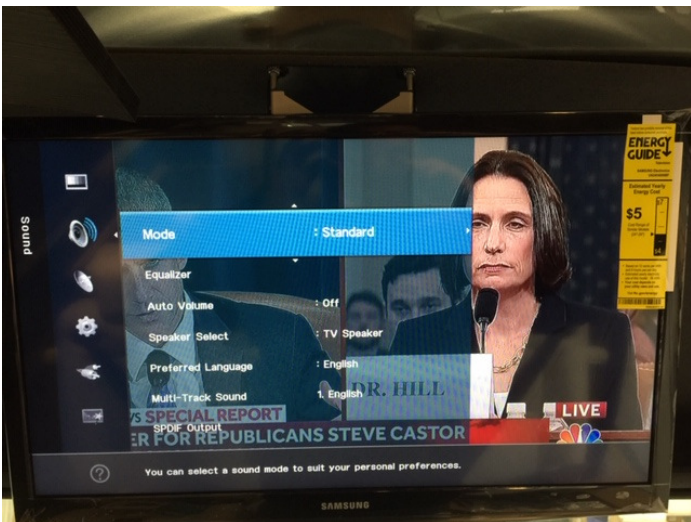
Figure 5: Sound options can be navigated through once selected.

5. Move the joystick to the right once. This will move the highlight over to the sound options, shown in Figure 5.

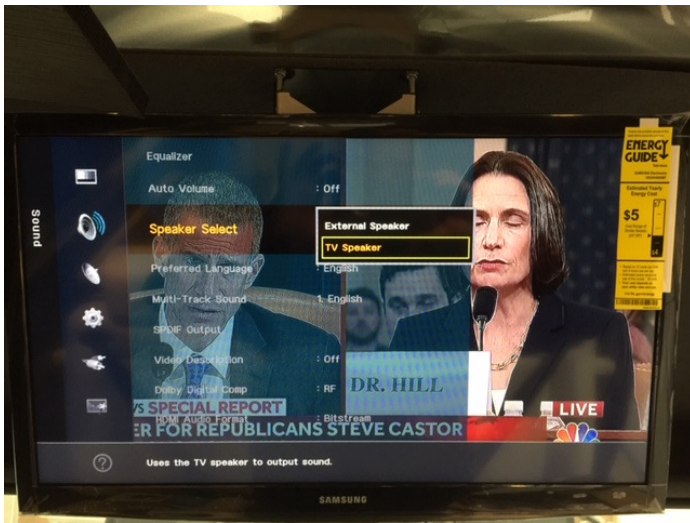
Figure 6: Speaker Select options shown. TV Speaker is highlighted with a yellow box to show it is currently in use.

6. Move the joystick down 3 times. This will put the blue highlight over the “Speaker Select” option. Press the joystick to select, and bring up two options for audio output; TV Speaker or External Speaker (an audio source connected to the optical audio output on the back of the Samsung TV). Move the joystick up once and select External Speaker. This will switch the TV audio to an external audio output source, shown in Figure 6.

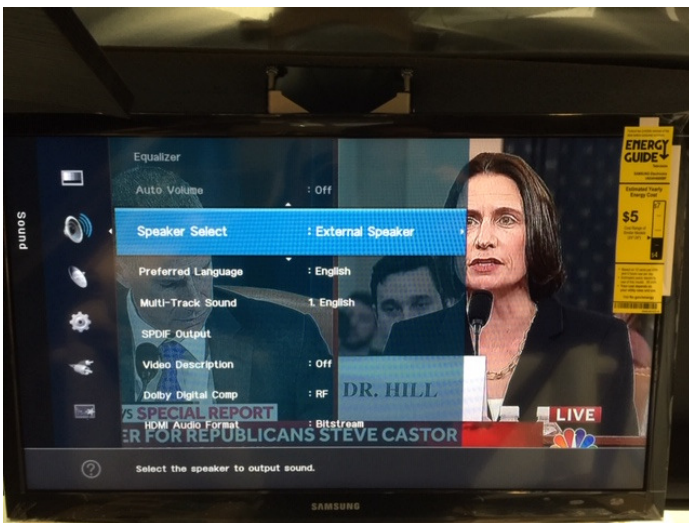
Figure 7a: Screen after choosing “External Speaker”

7. The screen should now look like it does in Figure 7a. From this position, move the joystick down 3 times to highlight the “SPDIF Output” option, shown in Figure 7b.

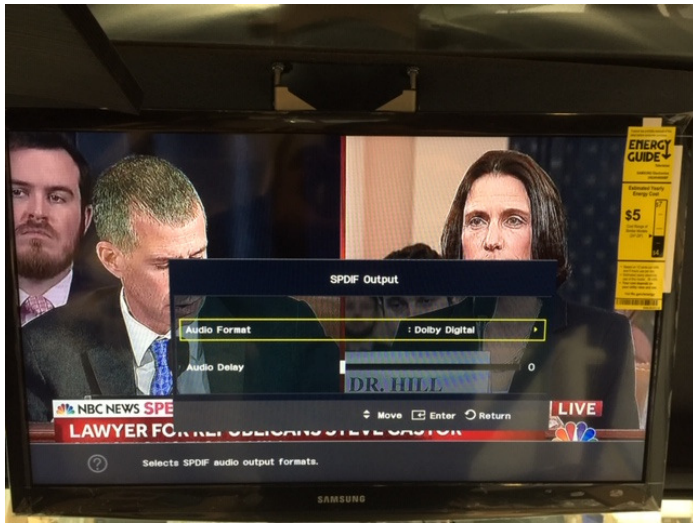
Figure 8: SPDIF Output options displayed.

8. Press the joystick to select SPDIF Output. This will display the screen shown in Figure 8.

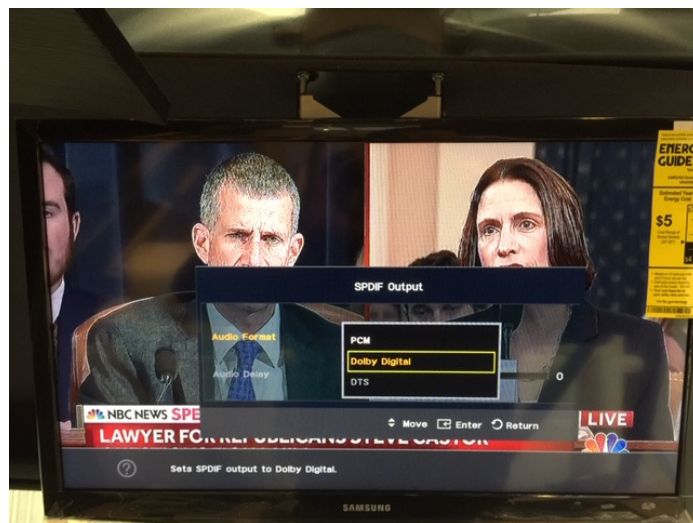
Figure 9: SPDIF Output menu showing 3 options, with PCM needing to be selected.

9. Press the joystick once. This will display 3 options under the “Audio Format” option; PCM, Dolby Digital, and DTS. The current audio format should be Dolby Digital, shown in Figure 9. Move the joystick up once to highlight “PCM” and select.

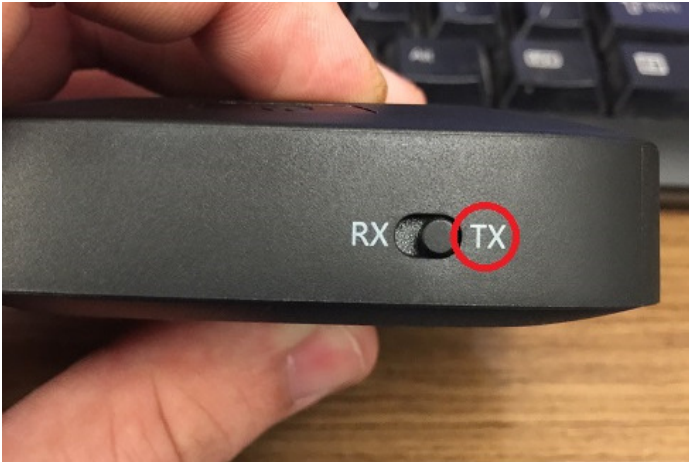
Figure 1: MEE Audio Connect Hub switched to TX.

1. Ensure that the switch on the Connect Hub is switched to the “TX” mode, shown in Figure 1. This will allow for audio to be transmitted via Bluetooth, rather than be received (RX).

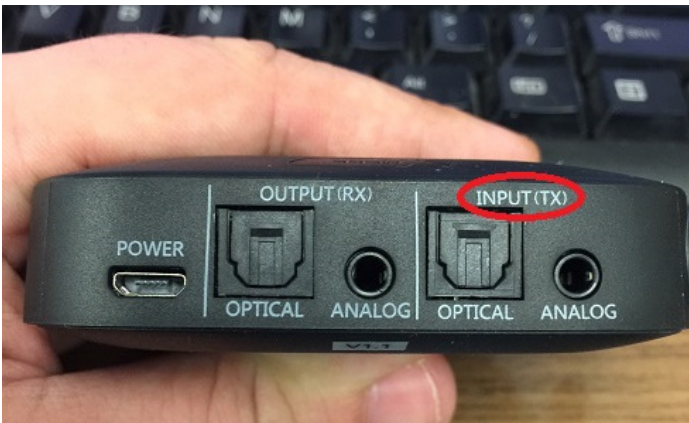
Figure 2: Location of the INPUT (TX) port on the Connect Hub.

2. Ensure that when connecting an optical audio cable to the MEE Audio Connect Hub, that the cable is connected to the port labeled “INPUT (TX)”, shown in Figure 2. This will correspond with the switch being in the TX position from step 1. Additionally, the USB power cable should be plugged into the back of the Samsung TV to power the Connect Hub.

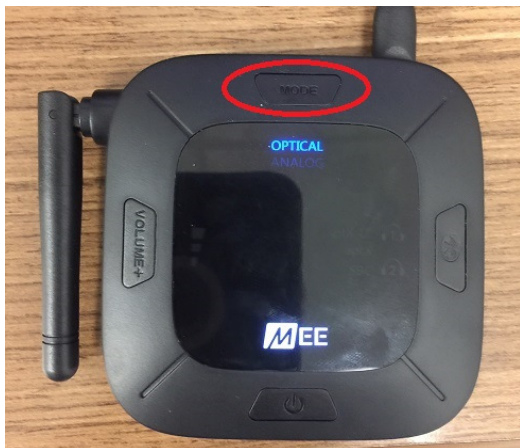
Figure 3: Proper audio mode for the Connect Hub, with OPTICAL lit up in blue and the Mode button shown.

3. Once the Connect Hub is powered ON, it should look like Figure 3, with the word OPTICAL lit up in blue. If it is not lit up in blue, press the Mode button. Pressing the Mode button, a second time will light up ANALOG in blue. To go back to OPTICAL, press the Mode button again.

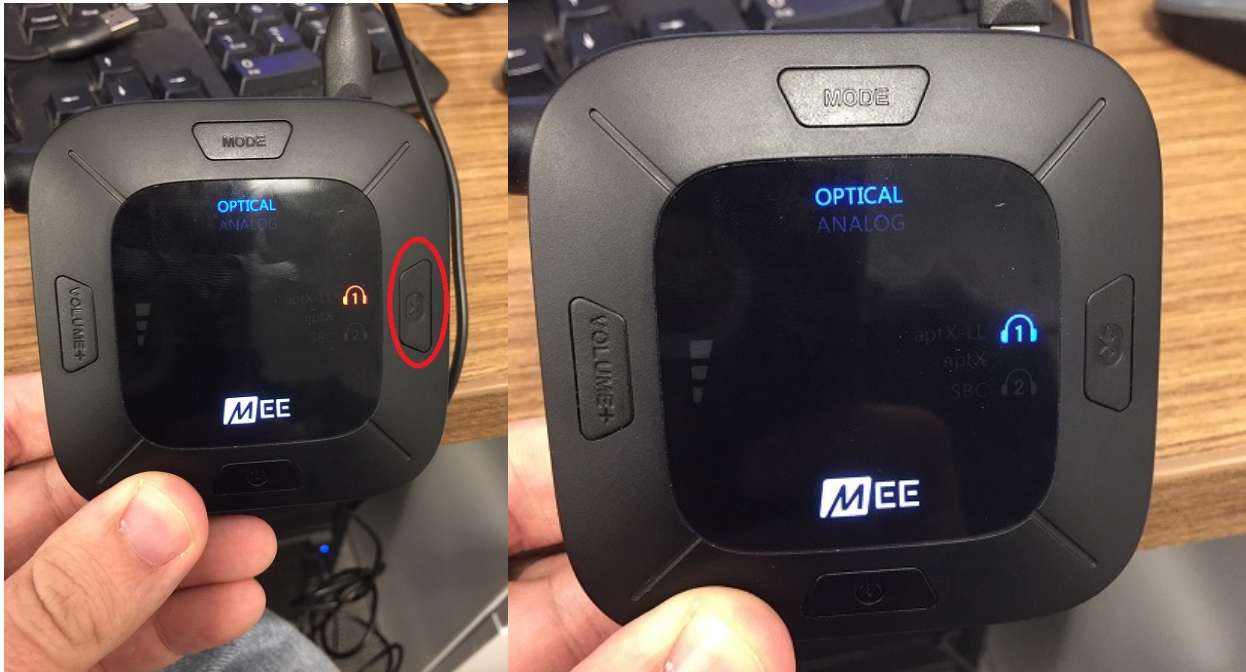
Figure 1a/b: Connect Hub in pairing mode, with the headphone icon flashing between red and blue and location of pairing button shown.

1. When pairing a set of wireless headphones for the first time, hold the Pairing button on the Connect Hub for 4 seconds. This will put the Connect Hub in pairing mode, with an icon of a headset flashing between red and blue, shown in Figure 1a/b.

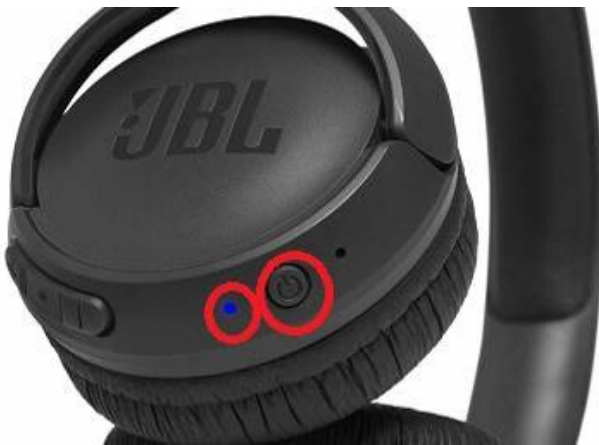
Figure 2: JBL Bluetooth headphones Power button and solid blue light, indicating successful pairing.

2. Locate the Power button on the JBL Bluetooth headphones under the right side, shown in Figure 2, and hold for 3 seconds. This will put the headphones in pairing mode, indicated by the light, shown in Figure 2, flashing blue. A successful pairing will be indicated by the blue light becoming solid.

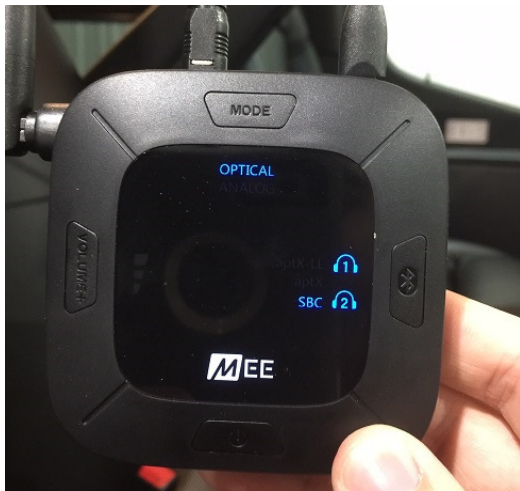
Figure 3: Connect Hub display when pairing of both headsets is successful.

3. Successful pairing on the Connect Hub will be indicated by the headphone icon, mentioned in step 1, remaining solid blue. Pairing a second set of headphones can be done by repeating the previous steps, starting at step 1. Figure 3, shows what the display of the Connect Hub should look like when pairing is successful with two sets of headphones.

Per testing during production, pairing the second set of headphones could take multiple attempts, as many as 5 to 6 times. Additionally, when pairing the second set of headphones, the Pairing button may have to be held for the duration of the pairing cycle, rather than the 4 seconds mentioned. In some scenarios, both the Connect Hub and Bluetooth headphones may need to be turned OFF, and the pairing instructions repeated. MEE Audio has stated that JBL currently does not support Qualcomm's aptX technology, the higher-end, aptX low latency specification that MEE Audio uses, and have also stated JBL is a brand their customers have issues with. However, in production testing, after the initial pairing process, the headphones paired much more readily, with only one instance where the headphones took an additional two times to pair. A different solution may be sought out, but preferably after the stock of JBL Bluetooth headphones that Riverpark has for Airstream is gone, considering the scrap generated from the previous Bluetooth transmitter solution (TROND BT-DUO II, also from Riverpark). Therefore, if Riverpark does not have stock that satisfies the EAU of 500, 2 per unit, a different solution can be sought. A different solution will not be sought for this model year, as long as they do have stock to satisfy the EAU, as to not generate more scrap.
