GROUP  
Product Improvement

NUMBER  
PI1802Y/Z

**ENGINE REPLACEMENT INSTRUCTIONS  
FOR DTC P1326 (PI1802Y/Z)**

This bulletin provides information related to the Technical Service Bulletin previously published in July 2018 (PI1802 Rev 10, 03/16/2020) titled "Knock Sensor Detection System - ECU Logic Improvement". Specifically, this bulletin provides instructions on which procedures to follow if, after installation of the KSDS, any one of the subject vehicles below return to the dealer with Diagnostic Trouble Code (DTC) P1326 (Knock Signal Range/Performance).

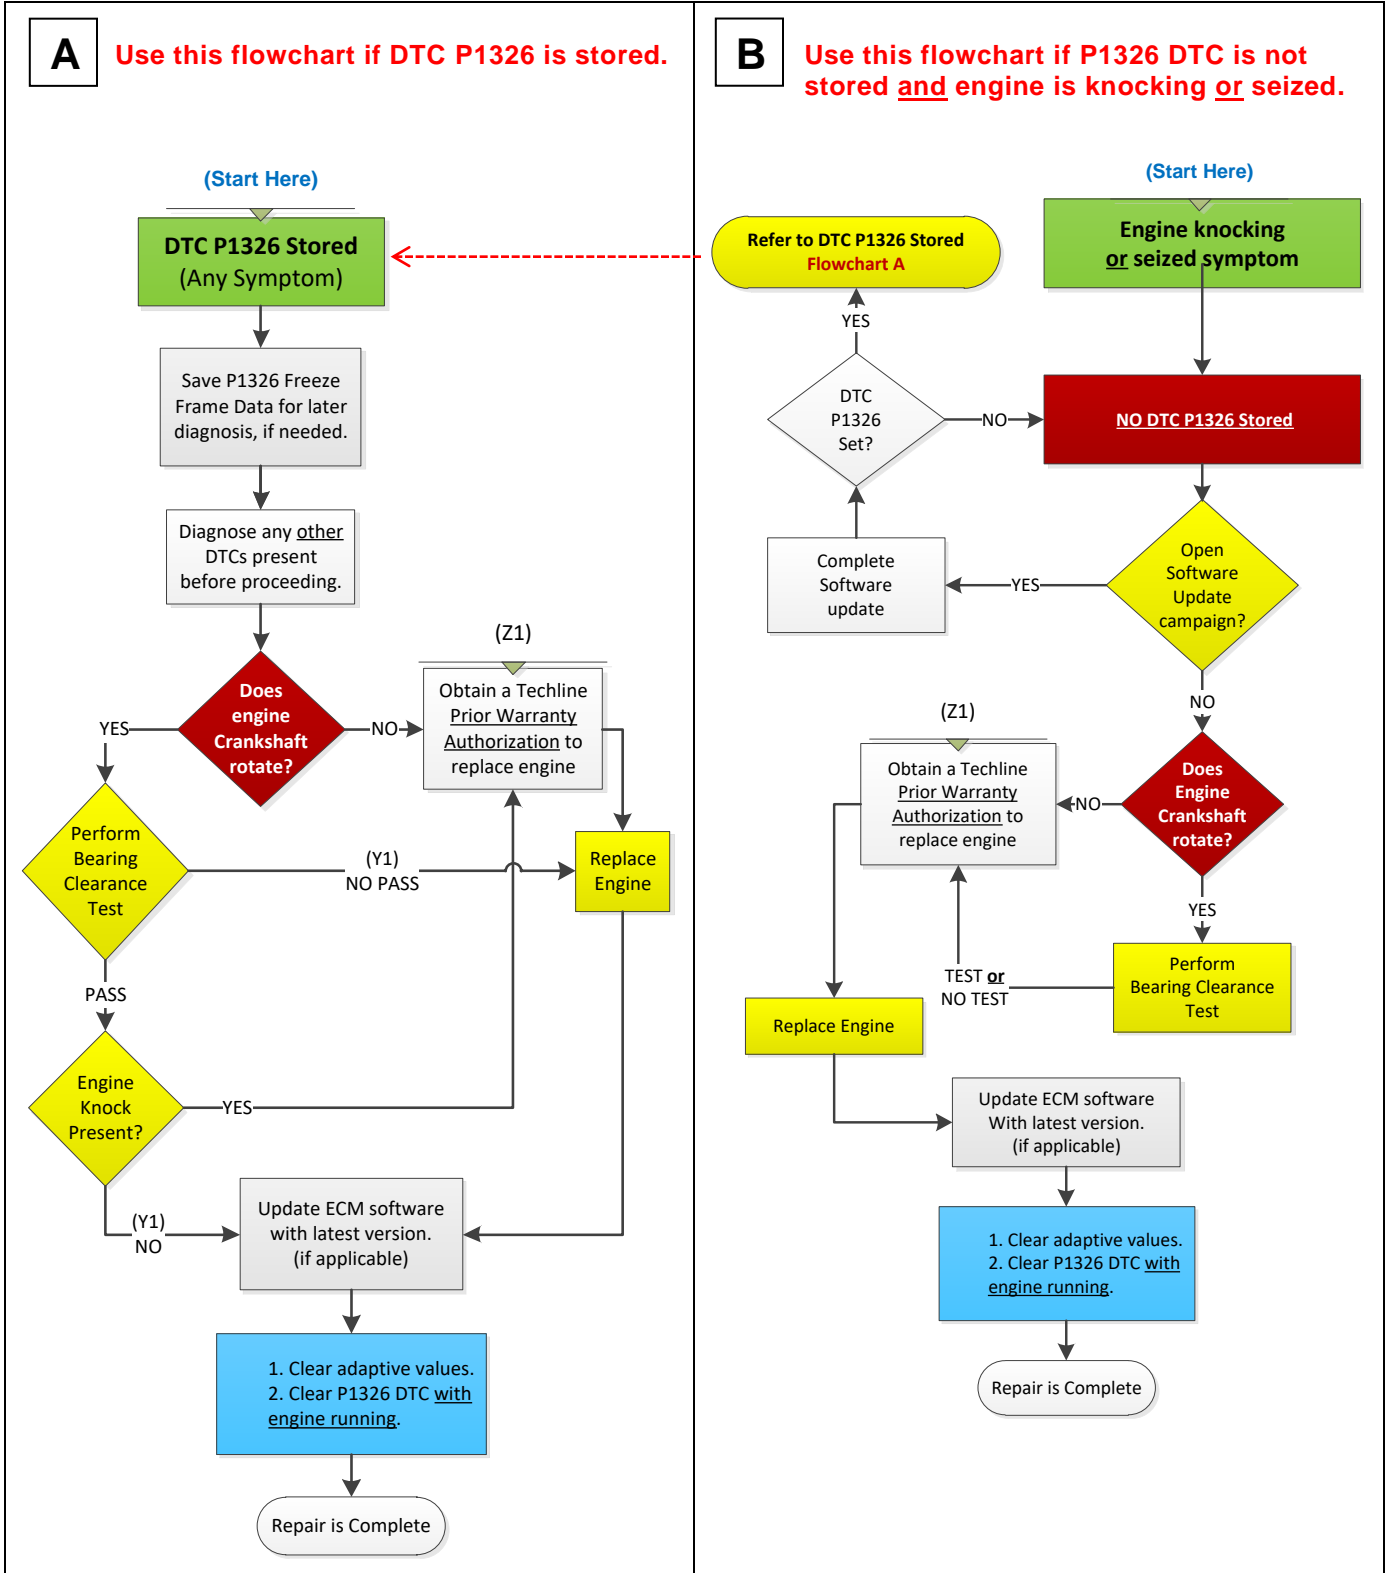
**Flowcharts:**

Choose the applicable flowchart based on the initial inspection:

- **Scenario 1** – Vehicle is in with DTC P1326 stored (A).
- **Scenario 2** – Vehicles is in with no DTC P1326 stored but engine is knocking or seized (B).
- **Scenario 3** – Vehicle is in with DTC P1326 stored and also engine is making noise or seized (A).

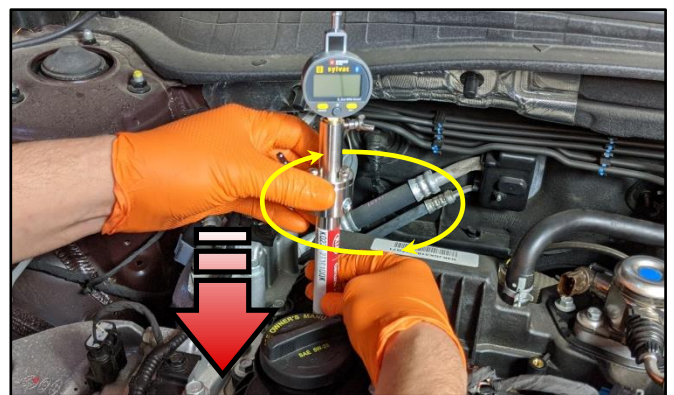
- 8. **Carefully**, insert the assembled SST Probe Rod and Dial Gauge into the Cylinder 1 spark plug hole and **carefully** turn the SST Crankshaft Rotator **by hand** clockwise until hand tight.

**CAUTION**  
**Damage to cylinder head can occur if spark plug hole is cross-threaded. DO NOT use a wrench to tighten the SST rod.**

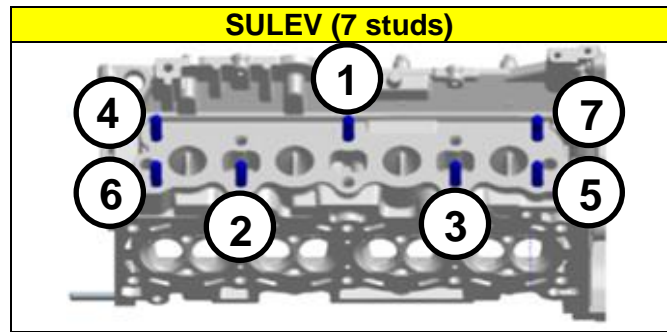
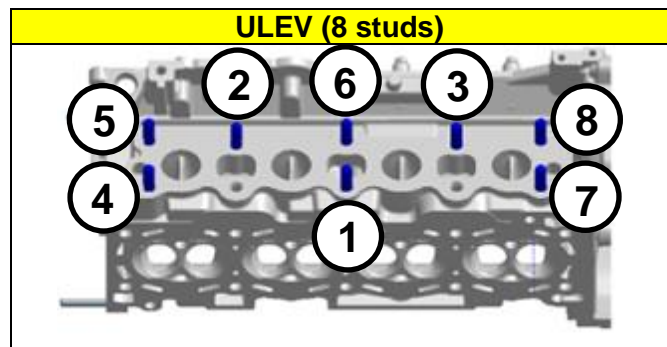
**Exhaust Manifold:**

- All engines supplied under this Product Improvement Campaign have the exhaust manifold studs configured for SULEV engines.
- Using the pictures to the right, check the exhaust manifold stud location and quantity. Relocate as required for ULEV engines and obtain one (1) extra from the removed engine.
- Prior to installation, replace the exhaust manifold gasket and front muffler gasket.
- Torque nuts in the sequence shown.

**36.2 – 39.7 lb.ft (49.0 – 53.9 N.m,  
5.0 – 5.5 kgf.m)**
