NUMBER  
PI1803Y/Z

## PRODUCT IMPROVEMENT CAMPAIGN

### ENGINE REPLACEMENT INSTRUCTIONS FOR DTC P1326 (PI1803Y/Z)

This bulletin provides information related to the Technical Service Bulletin previously published in July 2018 (PI1803, Rev 10, 03/16/2020) titled "Knock Sensor Detection System - ECU Logic Improvement". Specifically, this bulletin provides instructions on which procedures to follow if, after installation of the KSDS, any one of the subject vehicles below return to the dealer with Diagnostic Trouble Code (DTC) P1326 (Knock Signal Range/Performance).

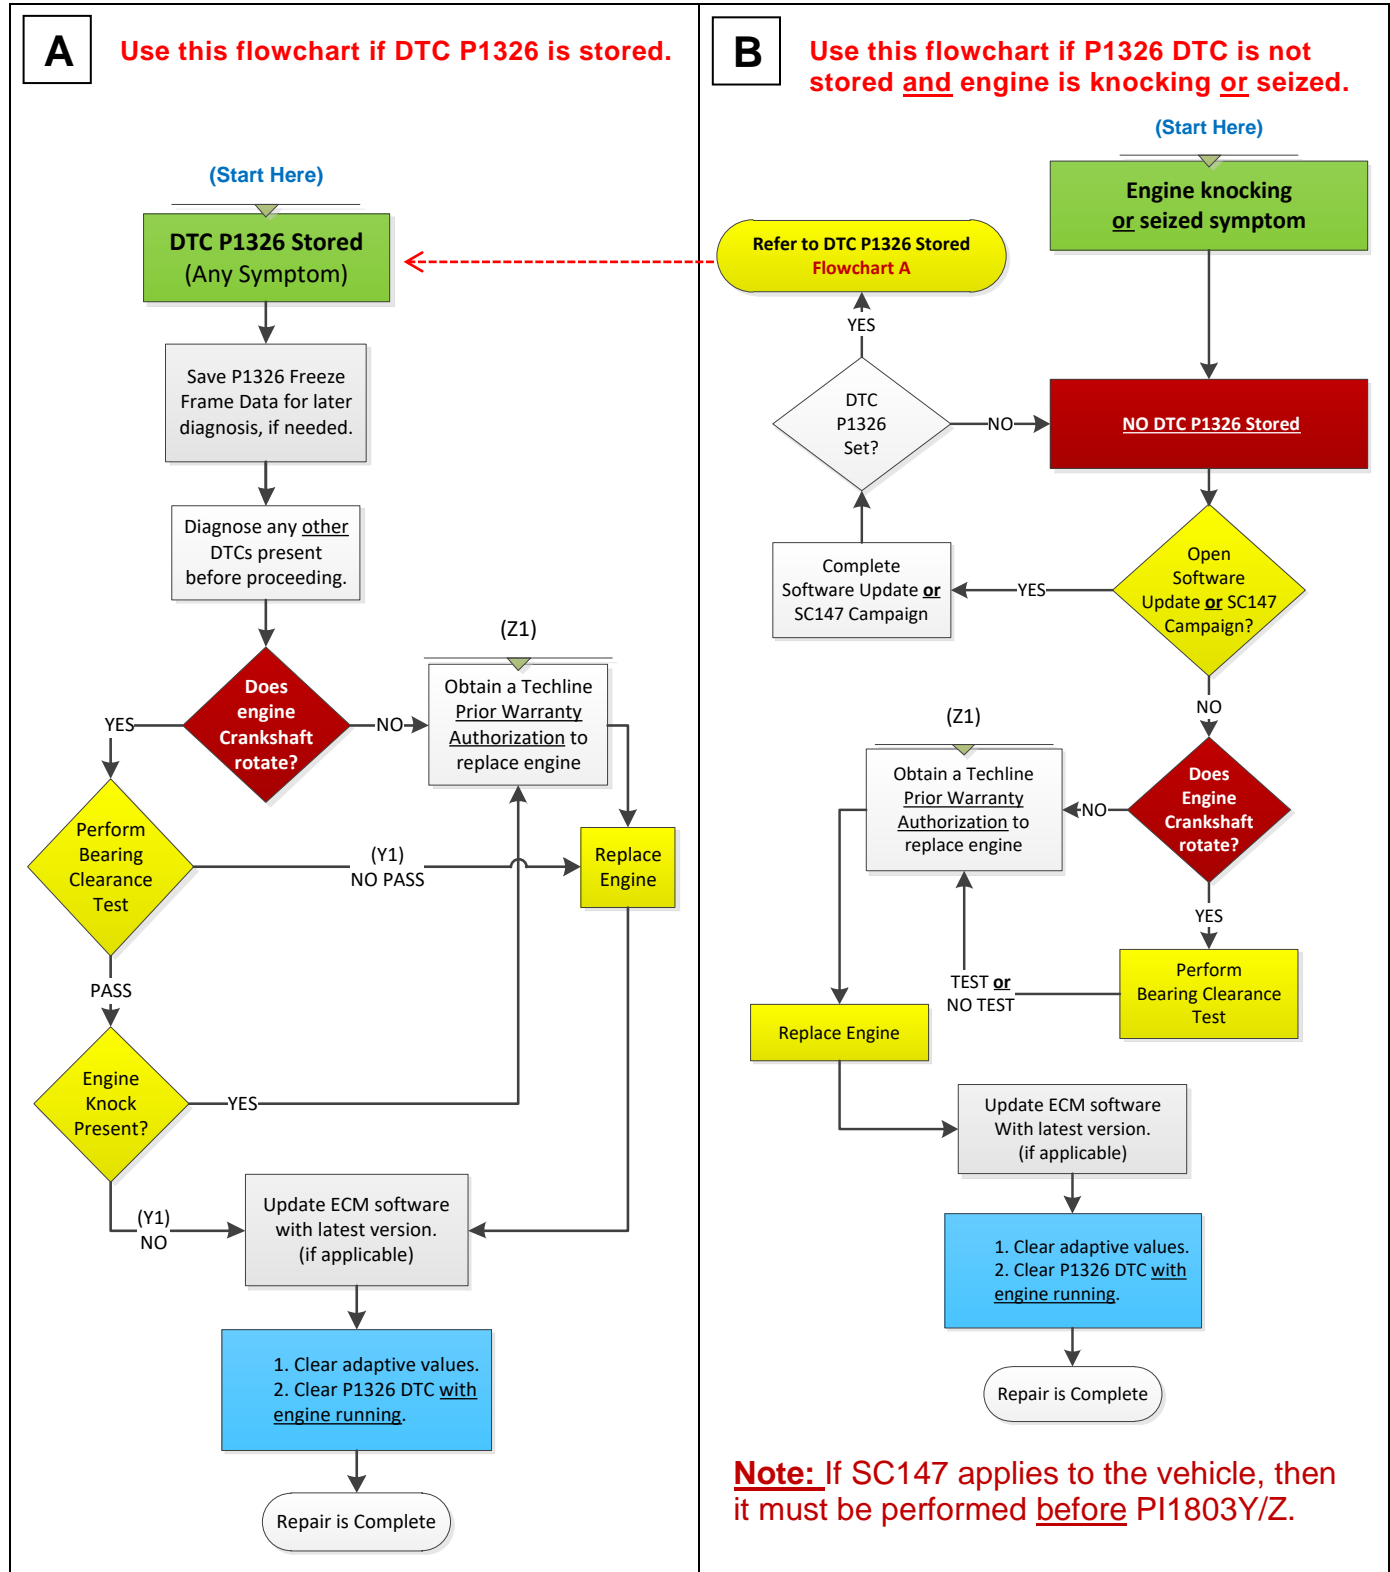
Choose the applicable flowchart based on the initial inspection:

- **Scenario 1** – Vehicle is in with DTC P1326 stored (A).
- **Scenario 2** – Vehicles is in with no DTC P1326 stored but engine is knocking or seized (B).
- **Scenario 3** – Vehicle is in with DTC P1326 stored and also engine is making noise or seized (A).

**Note:** If any concerns arise after completing the flow chart, open a Techline case online.

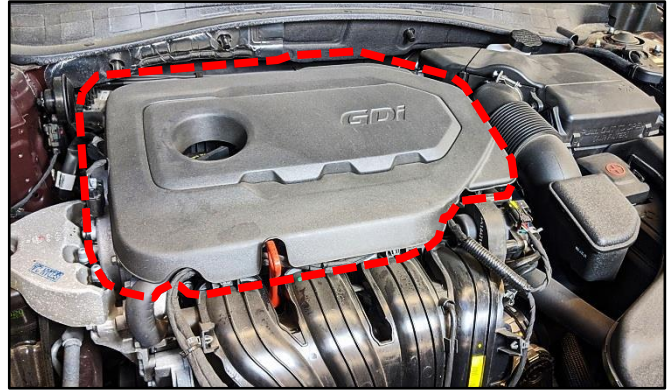
Have the SST Engine Bearing Clearance kit ready. Place it on a table/cart next to the vehicle and use a fender cover.

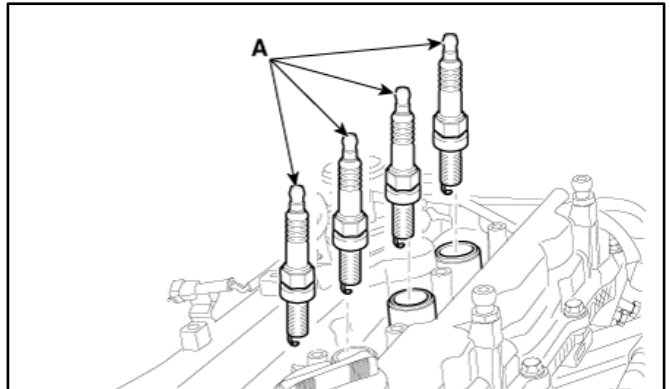
2. Remove the four (4) spark plugs (A) by referring to the “Maintenance → Power Train → Spark Plug → Repair procedures (Replacement)” in the applicable Shop Manual on KGIS.

**Tightening torque for Spark Plugs:**  
**10.9 – 18.0 lb.ft (14.7 – 24.5 N.m,**  
**1.5 – 2.5 kgf.m)**

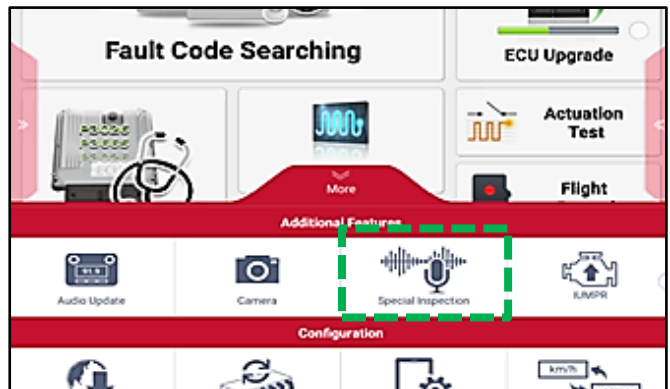
- 3a. Using KDS, connect the VCI-II to the vehicle's OBD-II port.
- 3b. Turn the ignition to 'ON'.
- 3c. On the KDS screen, select '**Special Inspection**' on the bottom tab of the Home screen.
- 3d. Select the applicable vehicle model/year.

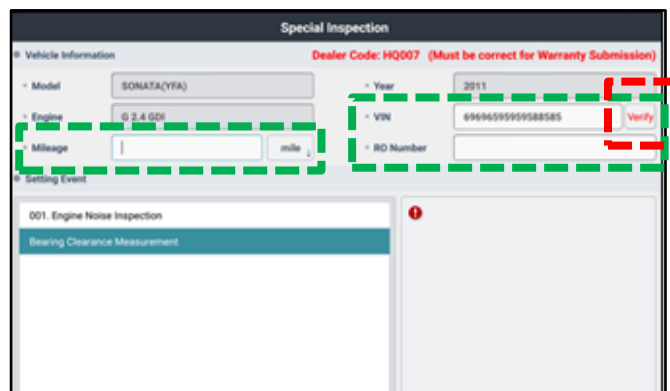
The VIN is recognized automatically and will populate the 'Model' and 'Year'.

- 4a. Enter the vehicle information: the vehicle mileage and RO number.
- 4b. Select 'Verify' to confirm the automatically detected VIN.

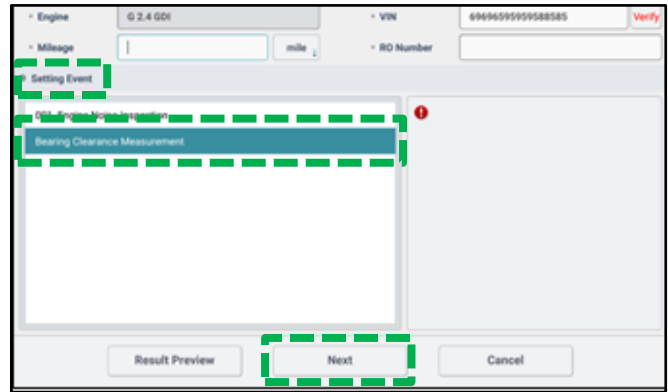
6. **STOP** on this screen, proceed to step 7 first before continuing to KDS.

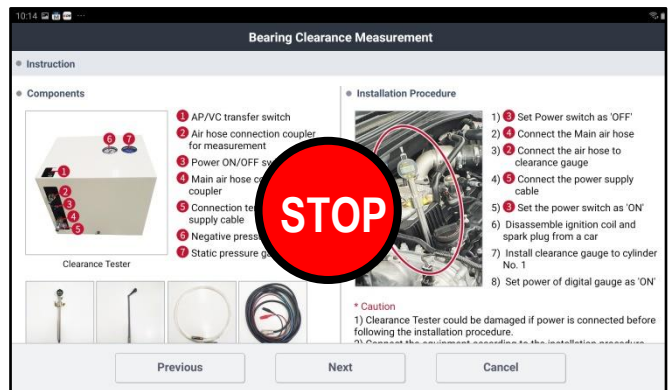
**DO NOT select ‘Next’ at this time. Proceed to steps 7 – 9 first and continue with KDS as instructed after installing the SST components.**

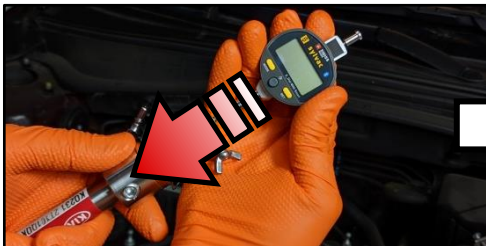
7. Install the Dial Gauge fully into the Probe Rod and secure together by hand tightening the locking wingnut.

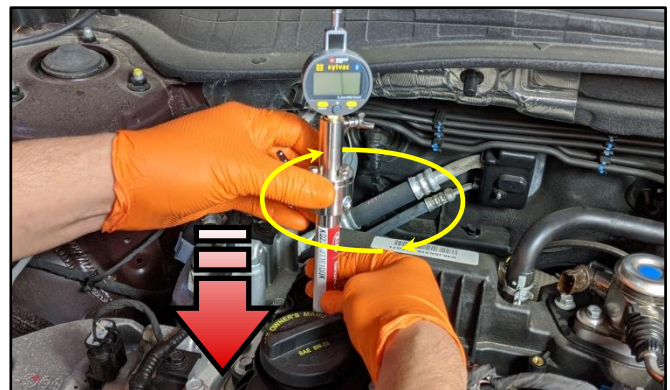
8. **Carefully**, insert the assembled SST Probe Rod and Dial Gauge into the Cylinder 1 spark plug hole and **carefully** turn the SST Crankshaft Rotator **by hand** clockwise until hand tight.

**Damage to cylinder head can occur if spark plug hole is cross-threaded. DO NOT use a wrench to tighten the SST rod.**

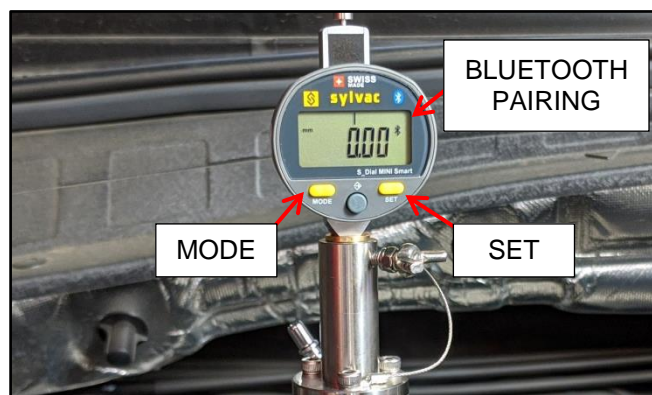
10. Using the KDS, select 'Next' on the screen to proceed and begin Top Dead Center (TDC) setup on the KDS.

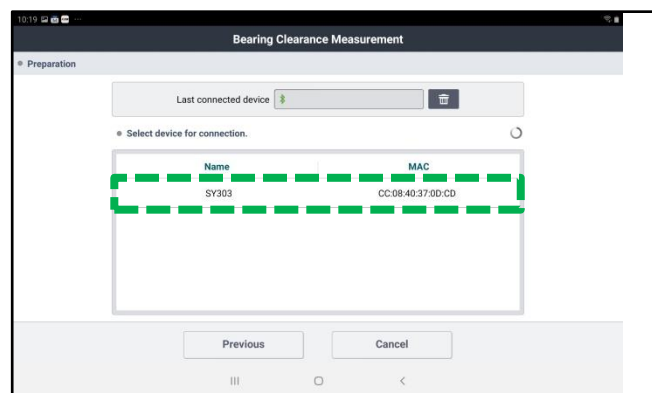
12. Once the Dial Gauge is paired to the KDS, the shown screen will appear instructing to insert probe rod into **Cylinder 1**.

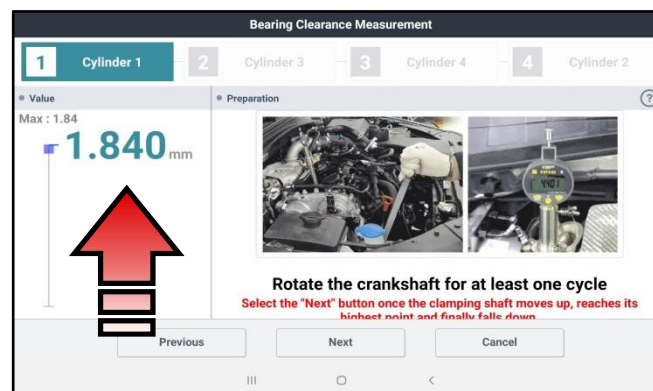
15. Once the ‘Max’ value is reached (sample shows Max: 2.86mm), continue to turn just past the ‘Max’ value reading and STOP rotating the crankshaft (sample shows 2.850mm value decreasing).

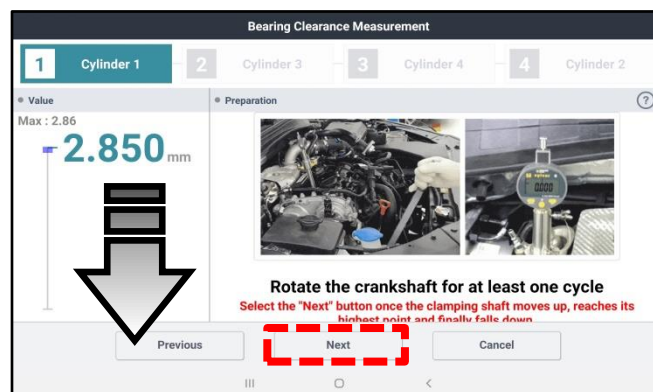
16. If TDC setup is completed successfully:

- **DO NOT** turn the crankshaft rotator.
- **DO NOT** select Start at this time.

**STOP** on this screen, proceed to step 17 to setup and connect the Engine Bearing Clearance Tester before continuing to the KDS.

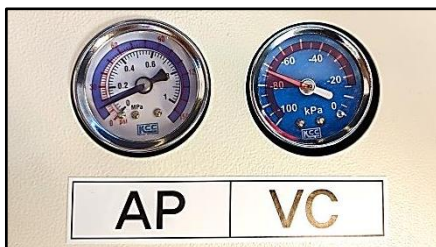
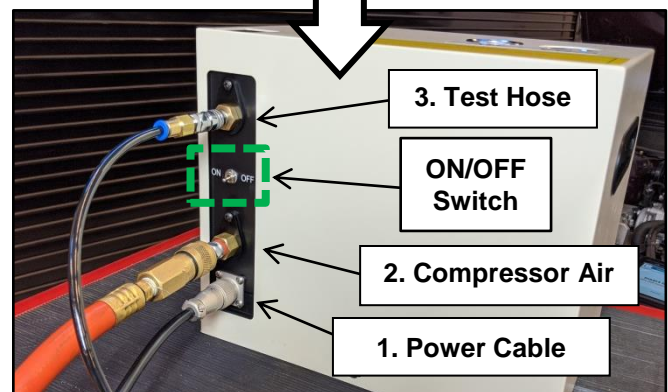
18. Turn the Bearing Clearance Tester power switch to the 'ON' position. Gauges should read as follow:

**AP (Pressure) Gauge:** (0.1 ~ .011MPa)  
**VC (Vacuum) Gauge:** (-73 ~ -83kPa)

**If the gauges do not read within specification**, calibration of the SST box is required. Refer to [TSB SST067](#) for details.

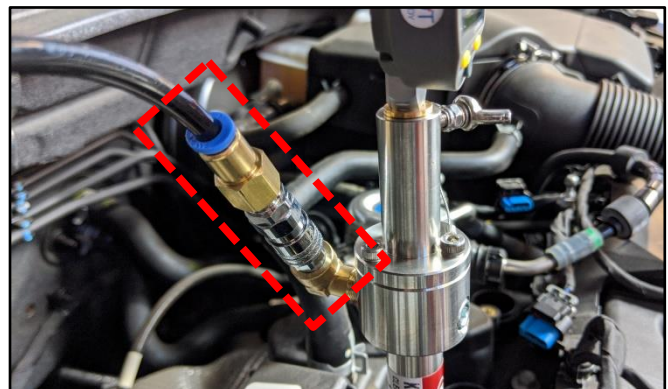
19. Carefully, insert and connect the other end of the Test Hose to the Probe Rod fitting.

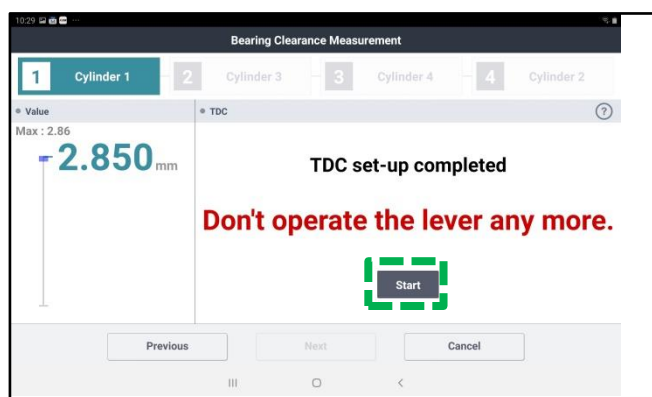
21. Locate the **'AP/VC'** switch on top of the Bearing Clearance Tester Box and switch it to the **'AP'** position. Select **'Next'** to begin **Cylinder 1** bearing clearance test.

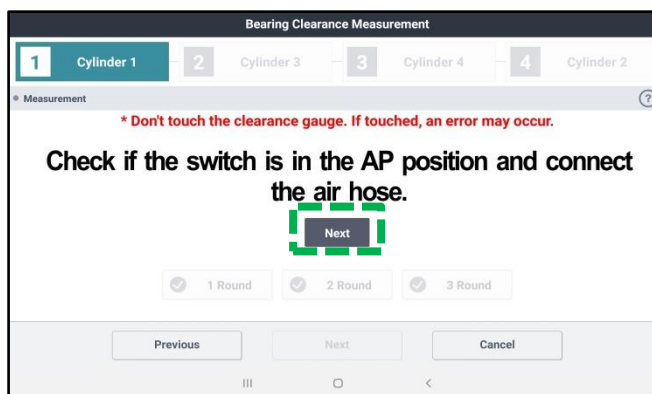
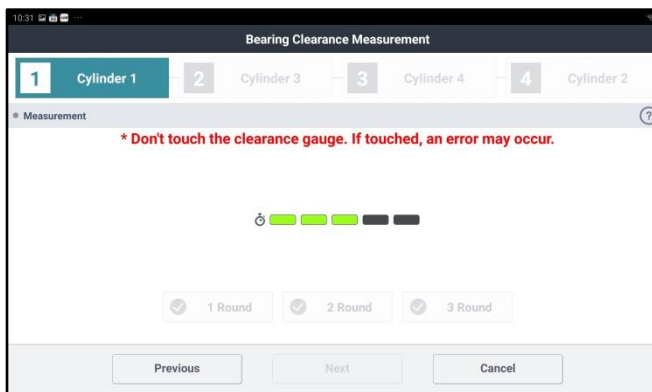
The toggle switch has a 3-way operation. The center is neutral. Always toggle past neutral.

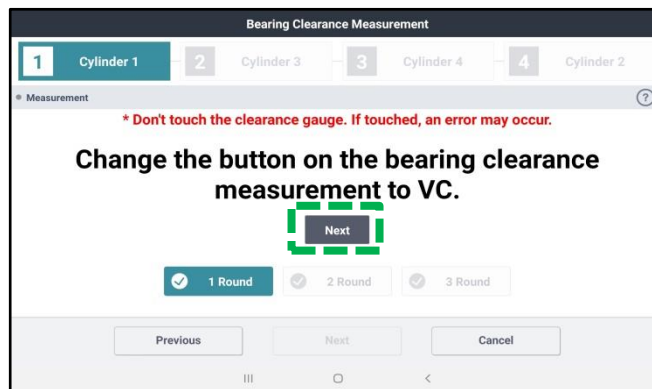
22. The KDS screen will prompt to change the **'AP/VC'** switch to the **'VC'** position.

Select **'Next'** to complete. There are three (3x) rounds per cylinder to complete.

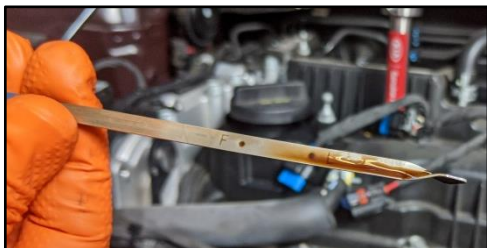
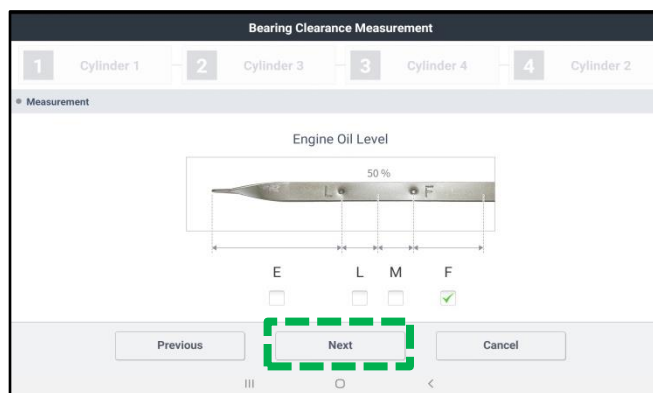
27. After completing the test of all four (4) cylinders, the KDS will prompt to check the crankcase oil level and to select the appropriate check box on the screen.

28. If the test result displays **"PASS"**, capture the screen image/screenshot for record keeping.

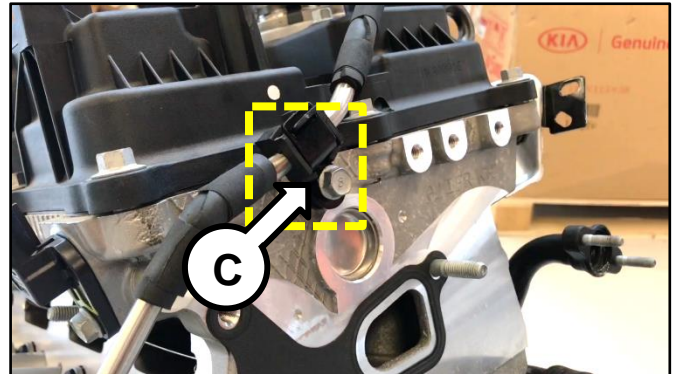
2. Install the pipe retaining bracket and bolt (C) and torque to specifications.

If the bracket and bolt are missing, order and install a new bracket and bolt.

**Tightening torque (bracket bolt):**  
5.8 – 8.7 lb.ft (7.8 – 11.8 N.m,  
0.8 – 1.2 kgf.m)

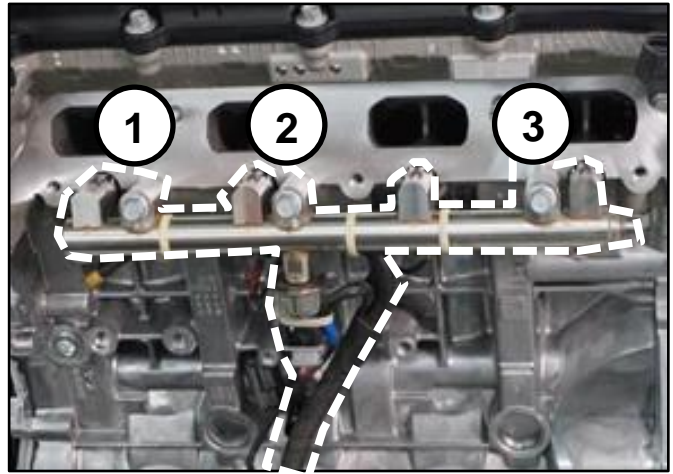
- Refer to [TSB ENG083](#) for special attention and handling procedures of GDI-specific components.
- Prior to installing the delivery pipe, be sure to replace all of the injector O-rings and injector retainers.
- Prior to installing the delivery pipe, apply engine oil to the injector O-rings.
- When installing the delivery pipe, use caution not to damage the tip of the injector.
- Be sure to replace the delivery pipe retaining bolts and torque them in the sequence shown.

**Tightening torque of bolts:**

**13.7 – 17.4 lb.ft (18.6 – 23.5 N.m,  
1.9 – 2.4 kgf.m)**

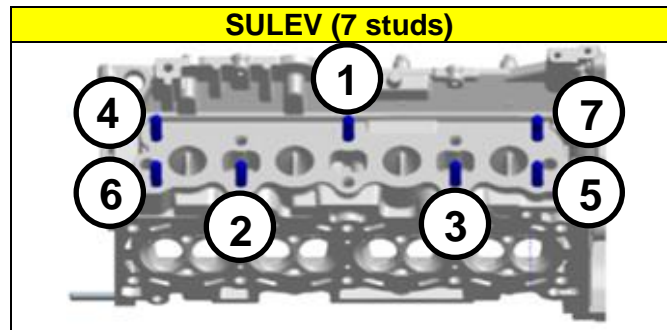
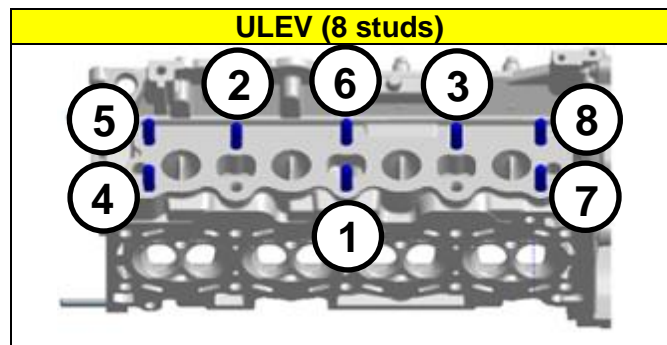
- All engines supplied under this Product Improvement Campaign have the exhaust manifold studs configured for SULEV engines.
- Using the pictures to the right, check the exhaust manifold stud location and quantity. Relocate as required for ULEV engines and obtain one (1) extra from the removed engine.
- Prior to installation, replace the exhaust manifold gasket and front muffler gasket.
- Torque nuts in the sequence shown.

**36.2 – 39.7 lb.ft (49.0 – 53.9 N.m,  
5.0 – 5.5 kgf.m)**

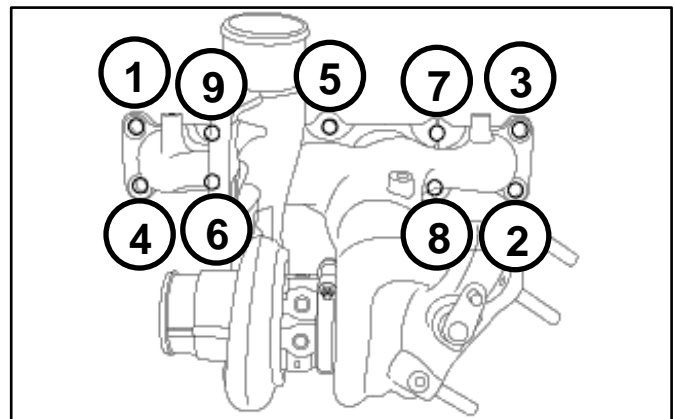
**Tightening torque of nuts:**

**36.2 – 39.7 lb.ft (49.0 – 53.9 N.m,  
5.0 – 5.5 kgf.m)**

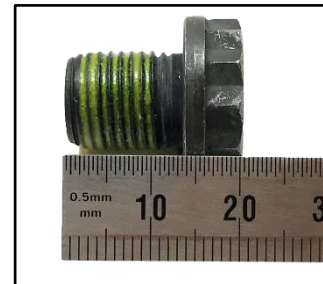
Drive Plate Bolt (A/T)

- Replace all seven (7) drive plate (AT) bolts.

**86.8 – 93.9 lb.ft (117.7 – 125.5 N.m,  
12.0 – 13.0 kgf.m)**

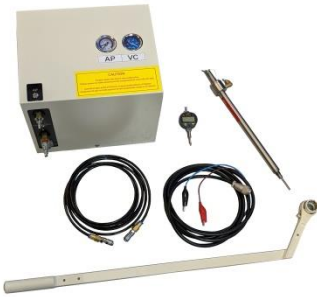
Locally Sourced
Bearing Clearance Tester Kit	KQ231 2T110QQK
