Case Number: S2023000012

Symptom/Vehicle Issue: Wind Whistle Noise From Glove Box Area Above 35 MPH

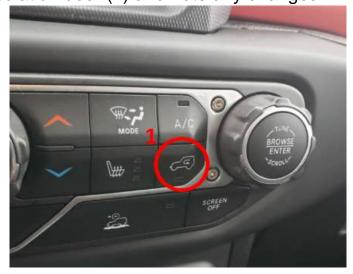
Bring Vehicle up to the speed until the wind whistle noise is audible. Cycle the HVAC recirculation door (1) and note any changes.

If the whistle noise changes when cycling the recirculation door, please follow the repair procedure detailed below.

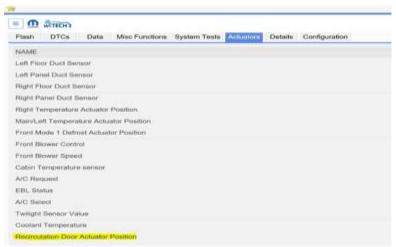
7. Select "Actuators" WiTECH tab. Then select Recirculation Door Actuator Position

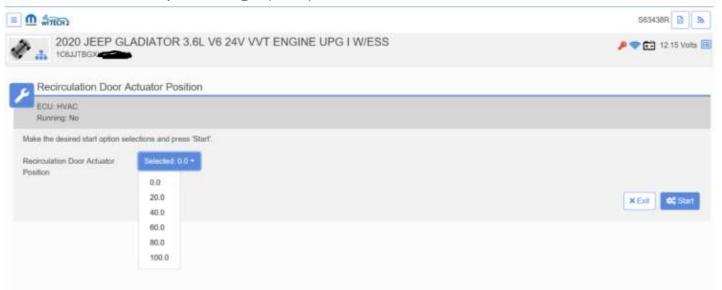
8. Set door to desired percentage (60.0). Select start to command door to 60%.

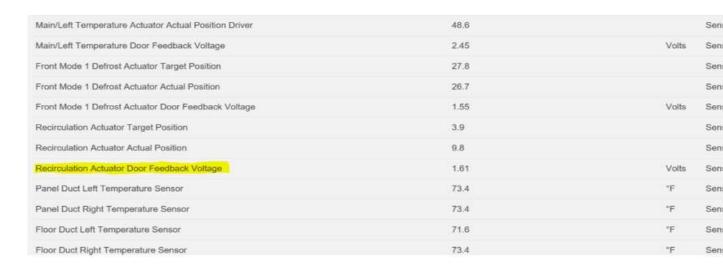
Go back to data tab, scroll to Recirculation Actuator Door Feedback Voltage, read new voltage. After repair is completed, voltage should change by ~0.01-0.02V from initial.

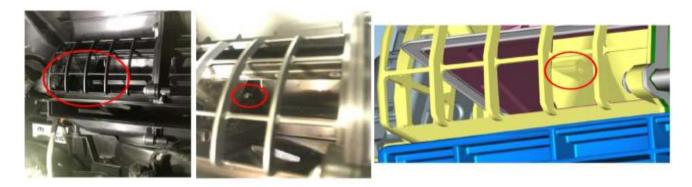
10. With the door at 60% travel, look behind the inlet door shaft on the left side of the recirc grill and you will see the door hard stop with a 1mm rib on the edge.
