Dealer Service Instructions for:

Customer Satisfaction Notification VE6 Missing Side Steps

2020 (DT) Ram 1500 Pickup

The side steps were not installed on about 110 of the above vehicles built with Laramie trim and the Built to Serve package.

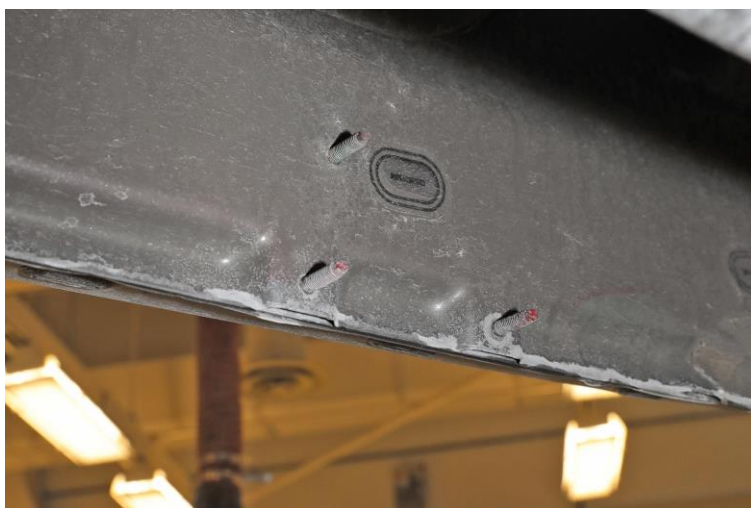
Figure 1 – Body Weld Studs

1. Lift and support the vehicle.
2. Locate and clean any accumulated debris from the weld studs on the back side of the rocker panel (Figure 1).

NOTE: The side steps mount on six studs per side, except on Crew Cab models with a 6'4" bed, which use nine studs per side.

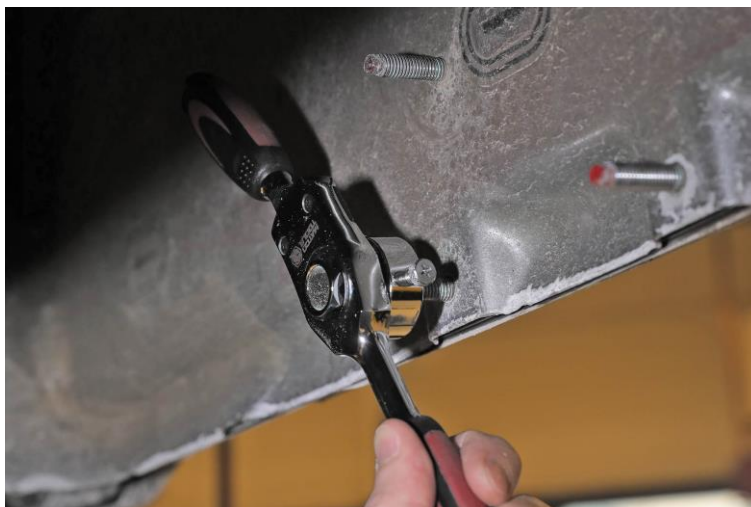
Figure 2 – Cleaning Threads

3. Using an 8 x 1.25 die, remove paint and coatings from the studs to reveal clean threads (Figure 2).

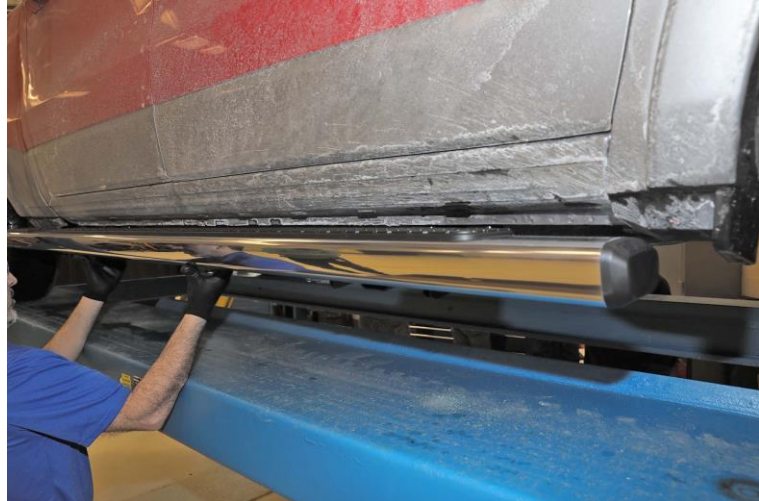
Figure 3 – Installing Side Steps

4. With help from an assistant, place the side step into position with the studs passing through the corresponding holes in the mounting brackets (Figure 3).

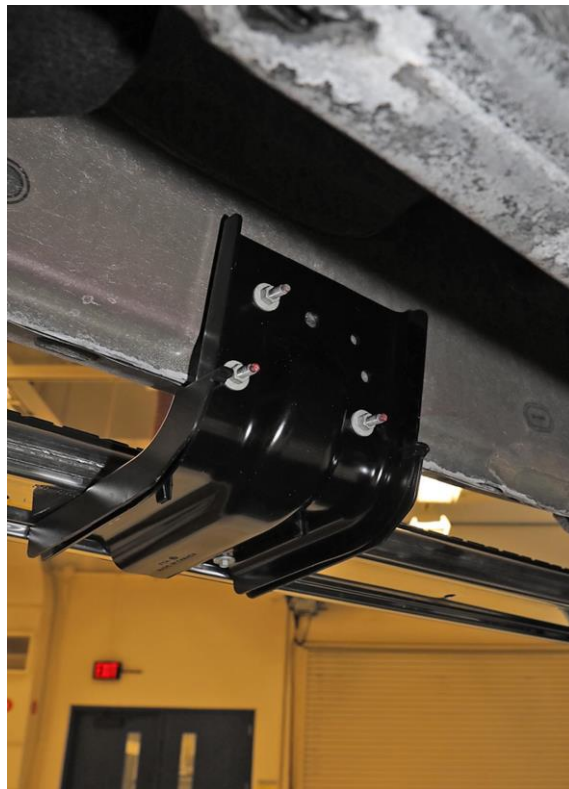
Figure 4 – Nuts Installed

5. Install a nut from the kit on each stud. Tighten the nuts to 16 N·m (12 ft. lbs.) (Figure 4).
6. Complete steps 2-5 for the other side of the vehicle.

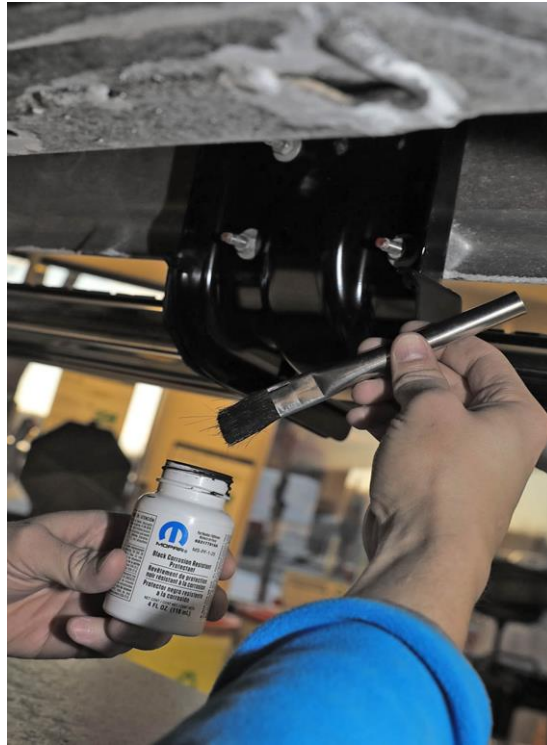
Figure 5 – Corrosion Resistant Protectant

7. Apply a complete coating of Mopar Black Corrosion Resistant Protectant 68317791AA (or equivalent) to the exposed studs and nuts (Figure 5).
8. Lower the vehicle, and return it to the customer.
