LTB00797NAS3

# TECHNICAL BULLETIN

Rear Bumper Cover To Body - Gap Evident

MODEL:	MODEL YEAR:	VIN:	ASSEMBLY PLANT:
Range Rover Sport (LW)	2014-2016	000001-583735	Solihull
Range Rover Sport (LW)	2015-2016	601763-650862	Solihull

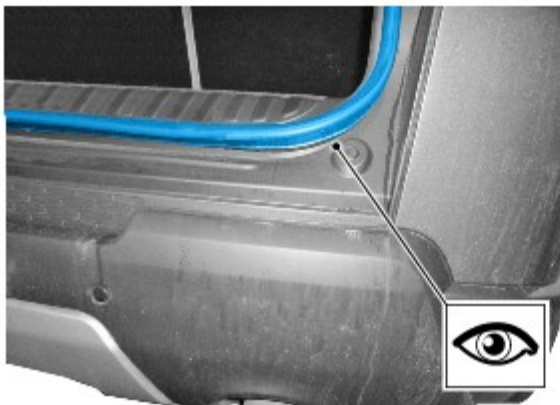
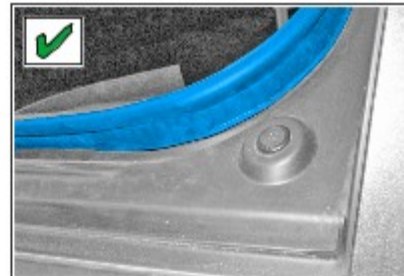
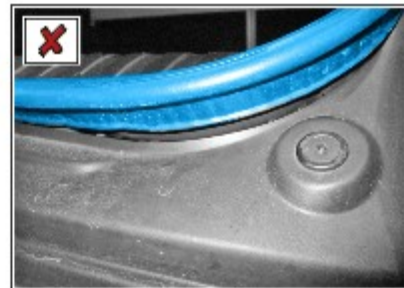
E263177

The illustration shows an example of an **OK (✓)** and a **NOT OK (X)** rear bumper cover to body gap.
