HYUNDAI

Technical Service Bulletin

GROUP CAMPAIGN	NUMBER 20-01-012H
DATE MARCH, 2020	MODEL TUCSON (LM)

SUBJECT: CANISTER INSPECTION AND AUXILIARY CANISTER KIT INSTALLATION - (VOLUNTARY EMISSIONS SERVICE CAMPAIGN 958)

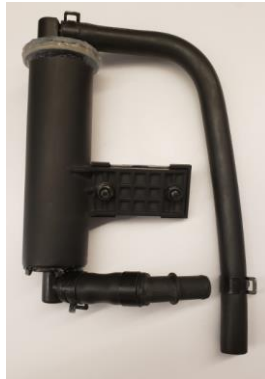
MODEL	PART NUMBER	DESCRIPTION	PHOTO	REMARK
	31410-2S510QQH	AUXILIARY CANISTER KIT

Canister 1EA Hose 1EA Clamp 1EA
Tucson(LM)	00305-SC958	Campaign Sticker

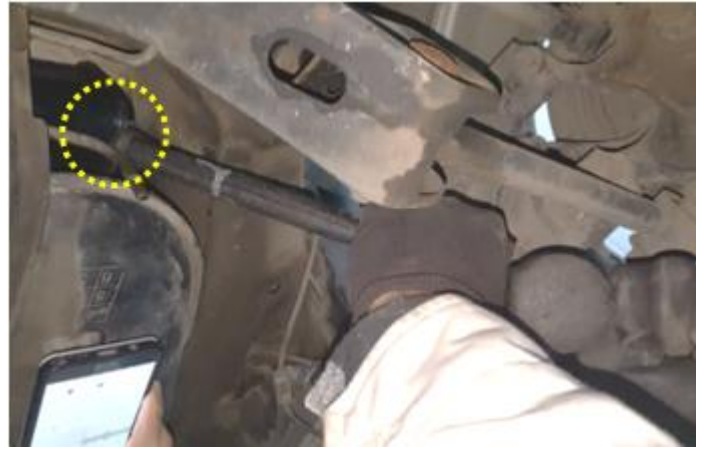
3. Canister Inspection Step:

Place the handle end of a rubber hammer to the canister right edge as shown in the picture.

Tap the hammer head rapidly at an approximate rate of 10 times over 2 seconds and inspect for noise inside the canister.

PASS:

- Only rubber hammer hitting noise and canister body vibration is heard.
- ***Service Procedure is complete with Inspection only performed.***

NO PASS:

- Loose charcoal shaking noise is heard from inside the canister. (NOTE: It may sound similar to sand shaking around)
- ***Proceed to additional steps below to install the Auxiliary Canister Kit.***

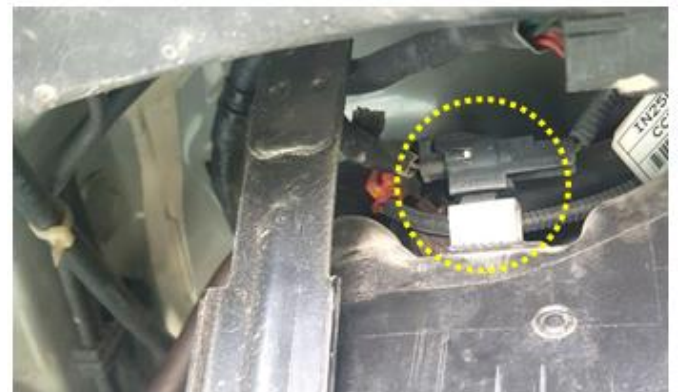
5. Remove the CCV extension wire clip.

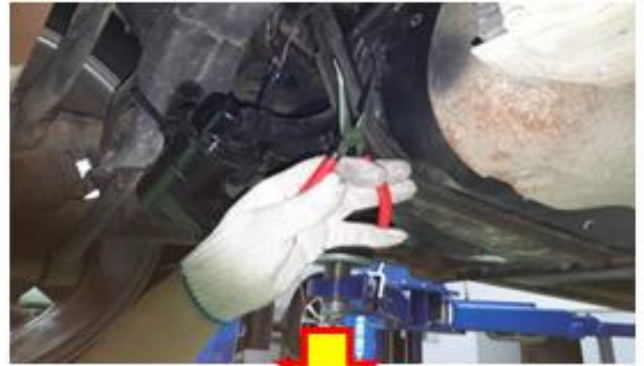
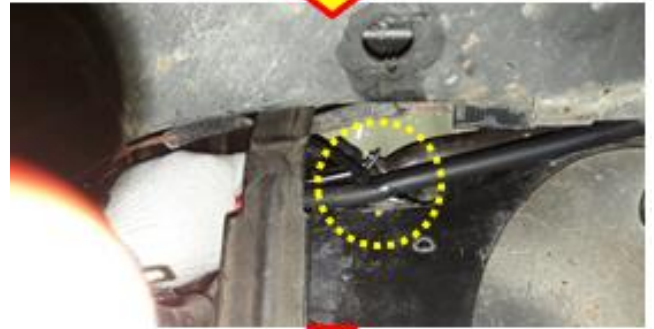
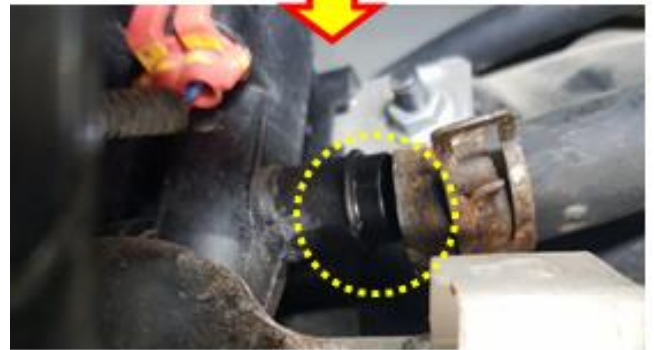
6. Disconnect the vapor hose from the CCV using needle nose pliers.

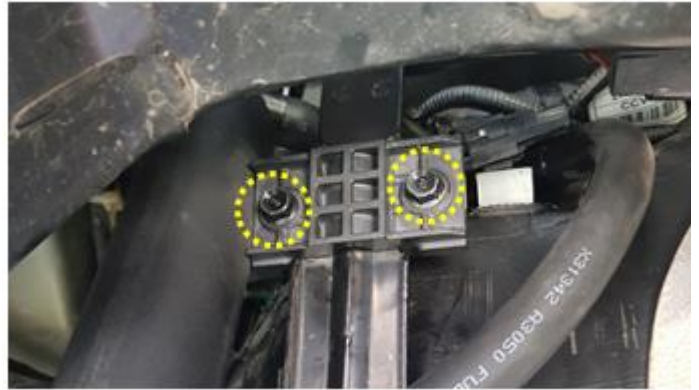
8. Install the supplied auxiliary canister to the left hand fuel tank band and temporarily tighten the bolts.

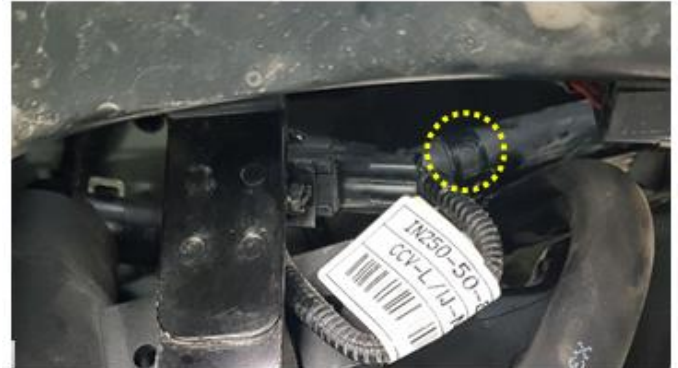
9. Connect the existing vapor hose to the auxiliary canister nipple.

NOTE: Remove the existing clamp and install the supplied clamp.

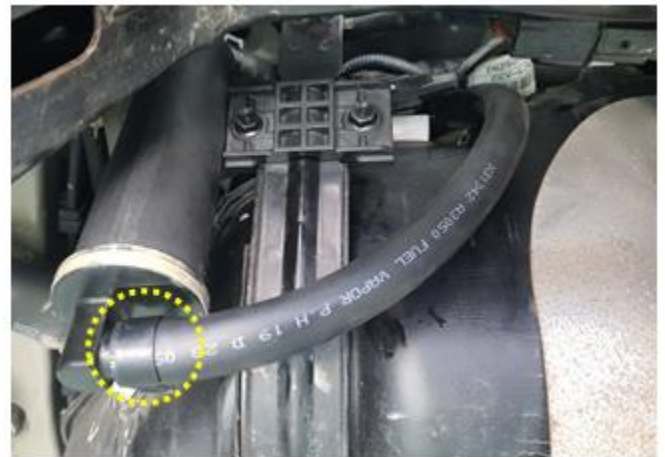
10. Connect the supplied hose to the bottom nipple of the auxiliary canister.

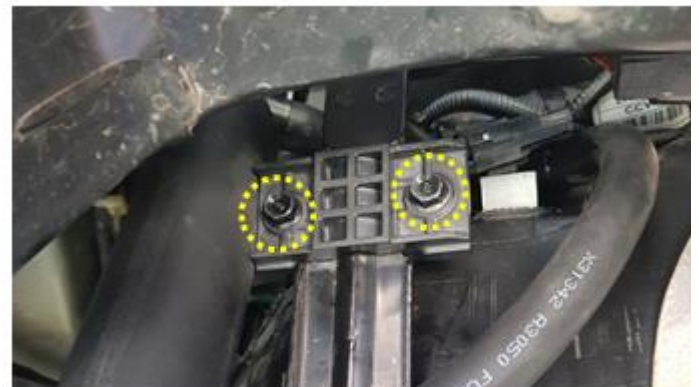
11. Tighten the auxiliary canister mounting bolts.

Tightening torque:

3.9 ~ 5.9N.m (0.4 ~ 0.6kgf.m, 2.9 ~ 4.3lb-ft)

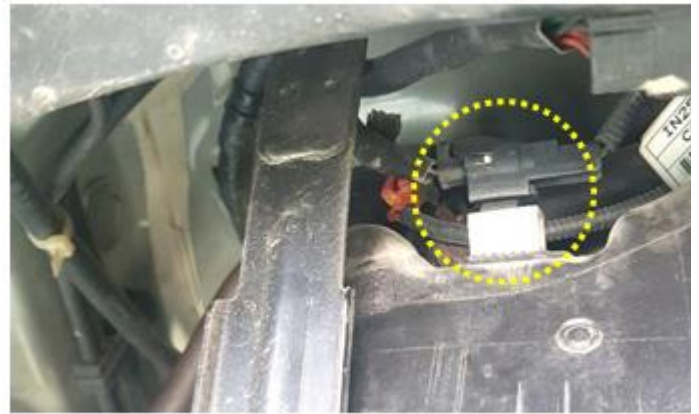
12. Install the CCV extension wire clip.
