GROUP	NUMBER	
Body	20-BD-006H	
DATE	MODEL(S)	
March, 2020	Veloster (JS)

SUBJECT: DOOR LATCH GREASE APPLICATION

Description: This bulletin describes the procedure to apply grease to the coupling lever of a door latch that has difficulty opening.

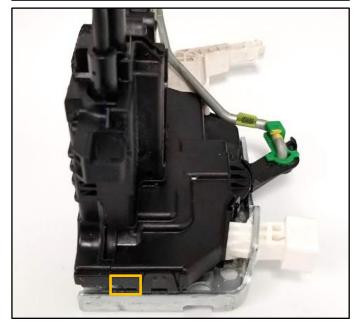
2. Locate the drain hole located at the bottom of the door latch assembly.

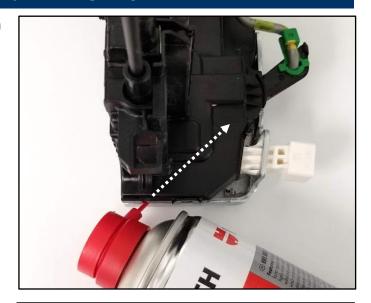
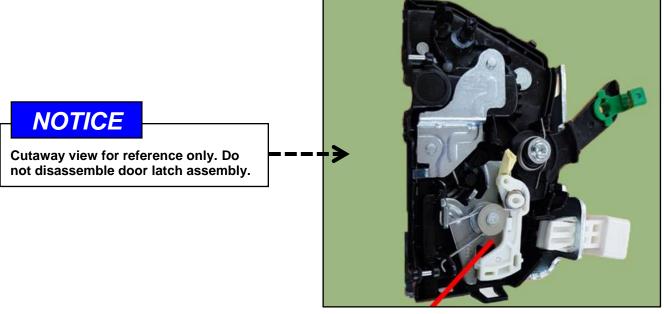
3. Insert the grease nozzle straw into the drain hole, and apply grease inside the door latch assembly. Apply grease generously.
