HYUNDAI Technical Service Bulletin	GROUP BODY ELECTRICAL	NUMBER 20-BE-004H
	DATE MARCH, 2020	MODEL(S) ELANTRA (ADa)
SUBJECT: HEADLAMP REPLACEMENT AND AIMING ADJUSTMENT

Description: Some 2019 & 2020 Elantra (ADa) vehicles equipped with halogen headlights may experience intermittent operation of the high beam. This bulletin provides the service procedure to replace the left and right headlamp assemblies and perform aiming adjustments.

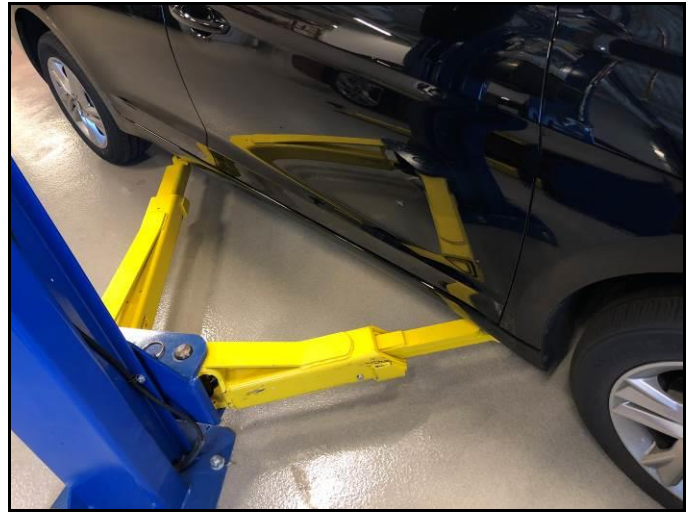
1. Align the vehicle onto the lift. Do not lift the vehicle up.

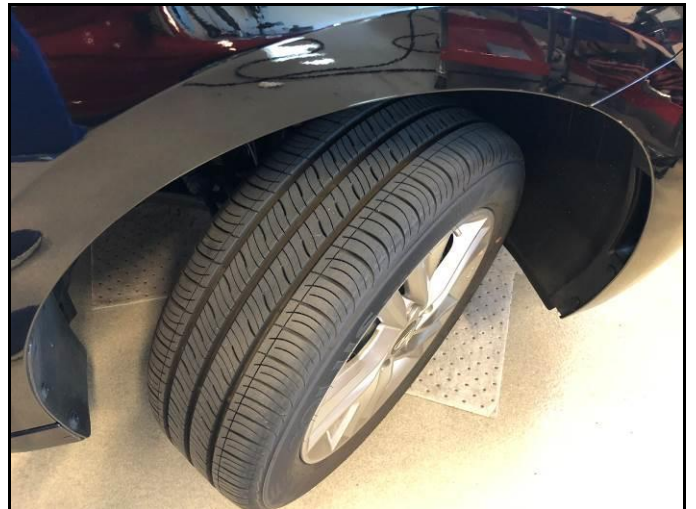
2. If applicable, record the customer's radio preset stations for AM/FM/XM.
3. Turn the wheel fully to the left or the right.

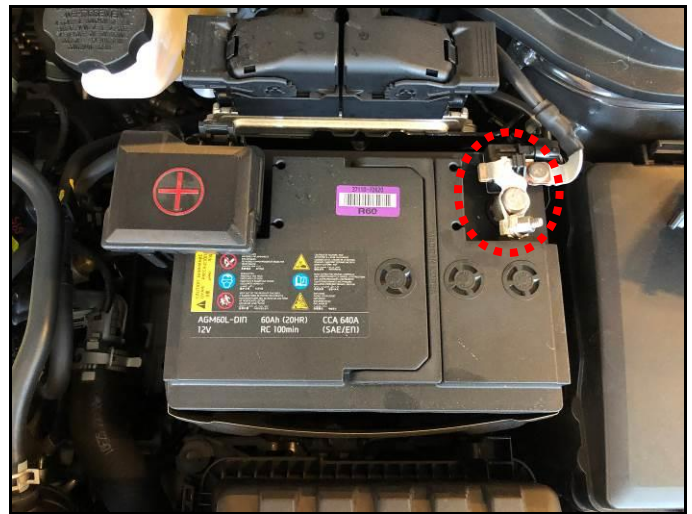
4. Open the hood and disconnect the negative (-) cable on the battery.

**Negative battery terminal tightening torque:
3.0~4.4 lb-ft (4.0~6.0 Nm, 0.4~0.6 kgf.m)**

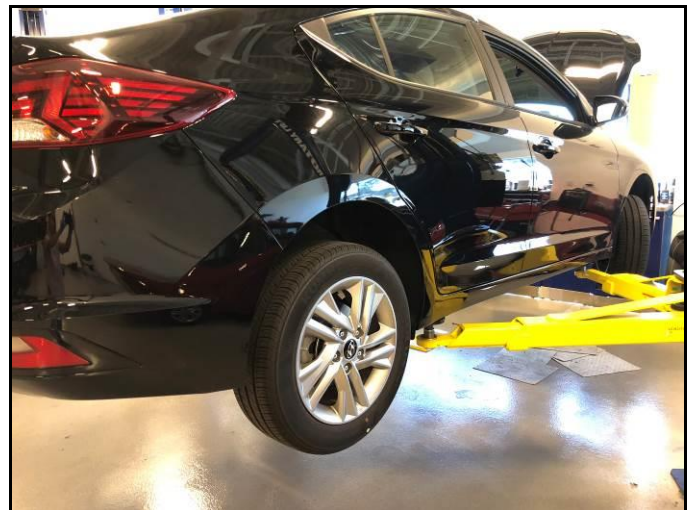
7. Remove one Phillips screw and three mounting clips from front inner fender liner.

Perform the procedure to both the driver and passenger side.

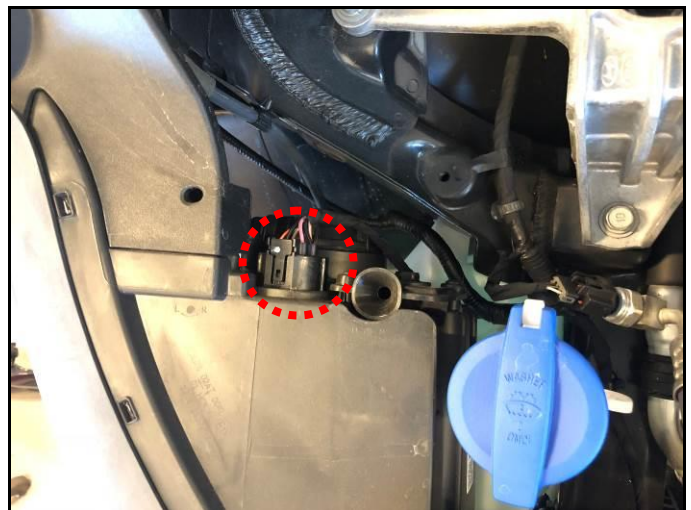
12. Disconnect the driver and passenger headlamp connectors.

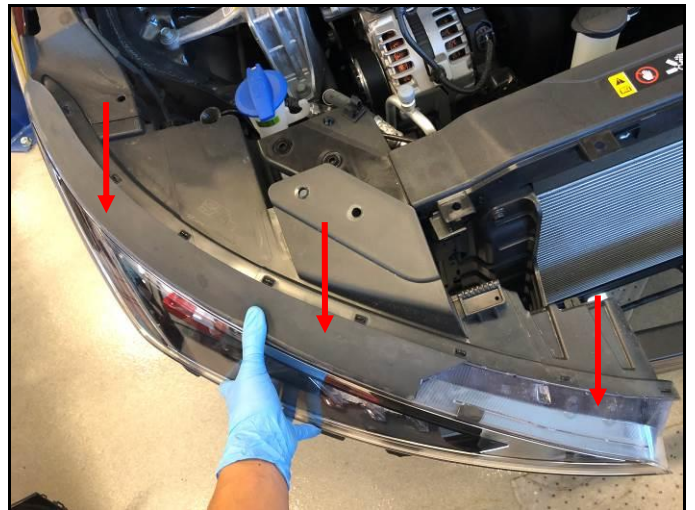
14. Remove the headlamp by carefully pulling it outward.

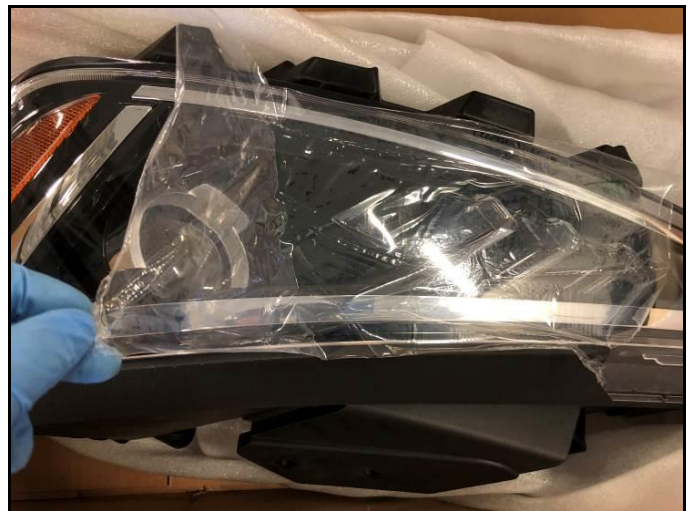
15. Remove the protective plastic film from the new headlamps.

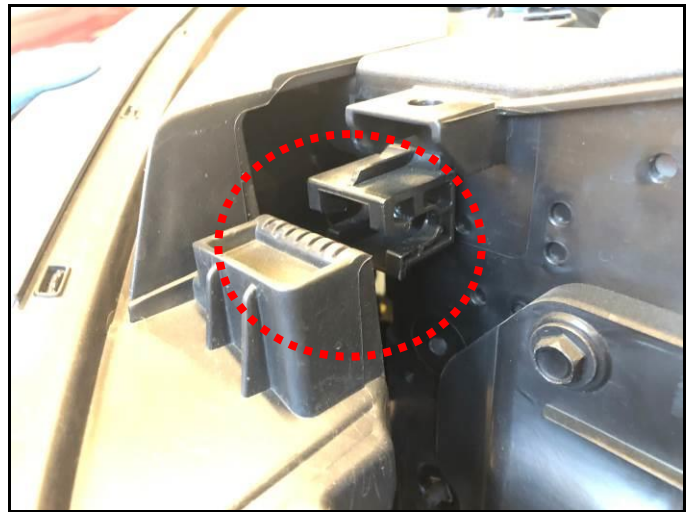
16. Install the new headlamp and reinstall all removed parts in reverse order.

When installing the driver and passenger headlamps, align the three headlamp tabs and hooks. Carefully push forward. Ensure the locking tabs are fully inserted into the hooks.

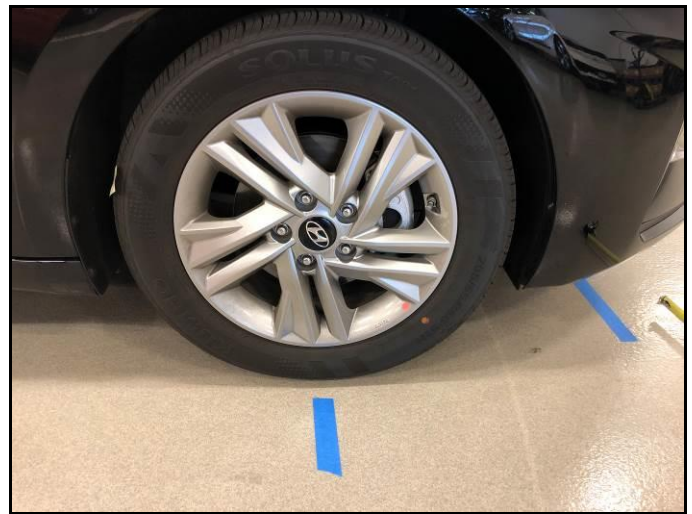
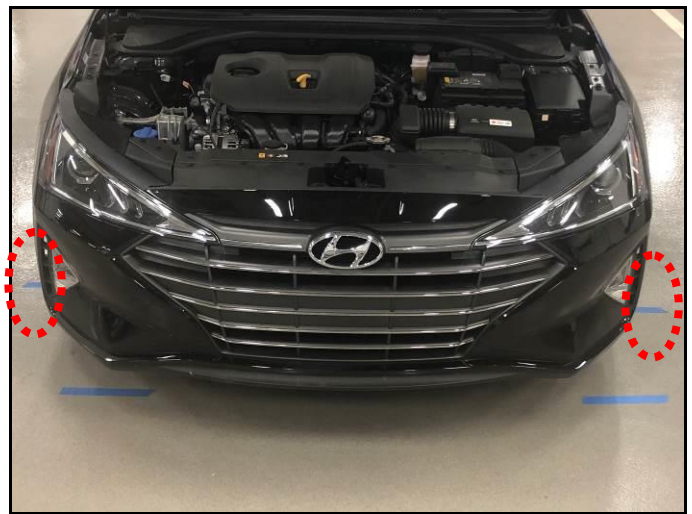
For ease of adjustment for another Elantra (ADa), make a mark or tape on the floor using the alignment of the wheel center cap.

It is easier to align the wheel center cap than center point of the headlamp light bulb.

Mark both sides of the vehicle as shown in the picture to the right.
