BODY INTERIOR	20-BD-009H	
DATE March 2020	MODEL(S) Genesis (DH)

This TSB supersedes 19-BD-006H Front Seat Noise Repair and 17-BD-003 Front Seat Tilt Pipe Housing Replacement to include wobble movement as a possible condition.

Description: Some vehicles may experience seat noise and/or possible wobble movement from the seat bottom when the vehicle is turning. This bulletin describes the procedure to install an e-ring clip to the tilt pipe housing on the front seat.

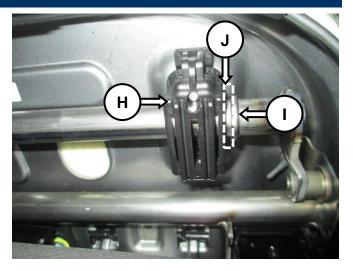
7. Inspect the gap (J) between the tilt housing (H) and pipe edge (I) on both sides of seat.

8. Insert the E-ring (K) between the tilt housing (H) and pipe edge (I).
