RECALL CAMPAIGN BULLETIN

EM19-010
 NTB20-025
 March 31, 2020

VOLUNTARY EMISSIONS RECALL CAMPAIGN 2018 ALTIMA AND ROGUE; CYLINDER HEAD

CAMPAIGN ID #: PC716

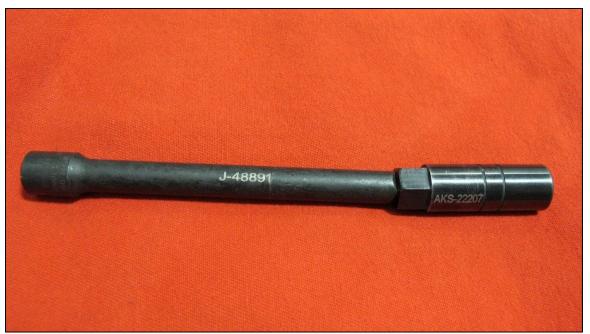
Figure 1

Spark Plug Tool J-48891

- 9. The spark plugs are **OK**: Reinstall the spark plugs into the same cylinders they were removed from using tool J-48891.
 - Spark plug torque: 19.6 N•m (2.0 kg-m, **14 ft-lbs**)
 - Altima: For spark plug installation procedure, go to the ESM, section ENGINE-ENGINE - MECHANICAL - QR25DE - PERIODIC MAINTENANCE - SPARK PLUG.
 - Rogue: For spark plug installation procedure, go to the ESM, section ENGINE-ENGINE - MECHANICAL - PERIODIC MAINTENANCE - SPARK PLUG.

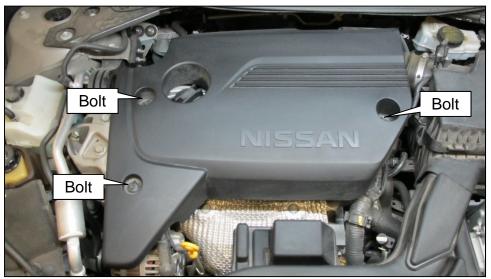
Figure 4

1. Altima (if applicable): Remove the three (3) bolts, and then remove the engine room cover.
