Subject: ZF Brake Chamber Rework			
Field Change Program: Field Campaign	FCP Number: 478	Revision: A	Date: 03/20/2020
Coach Section: 04-Brakes & Air system	P/N: 02-01-1418, 02-01-1420		Type: Product Integrity

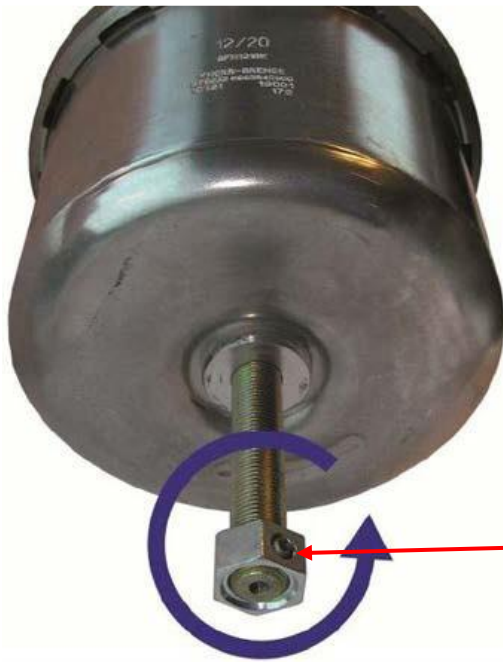
Cage the brake chamber by rotating the caging bolt counter-clockwise

Release and cage the brake chamber by rotating the caging bolt counter-clockwise. The force to compress the spring must not exceed 33 FT-LBS during the caging process.

Do not use impact tools to cage the brake chamber

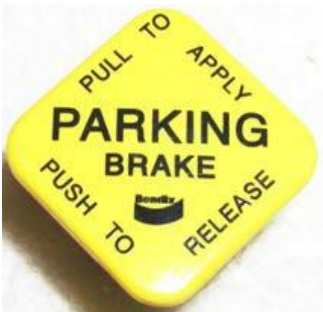
Release the parking brake.

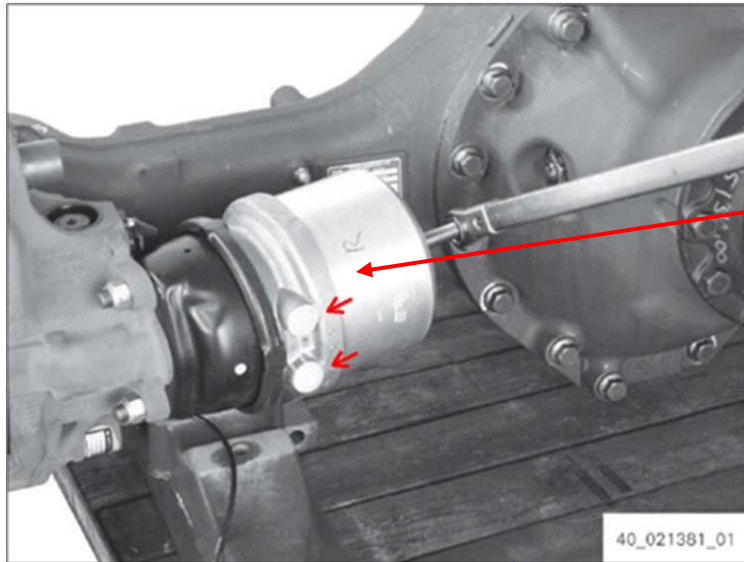
Curbside brake chamber

Locate the curbside and driver side brake chamber air lines on the drive axle.

Disconnect air lines on ports 11 and 12 of the curbside and driver side brake chambers.

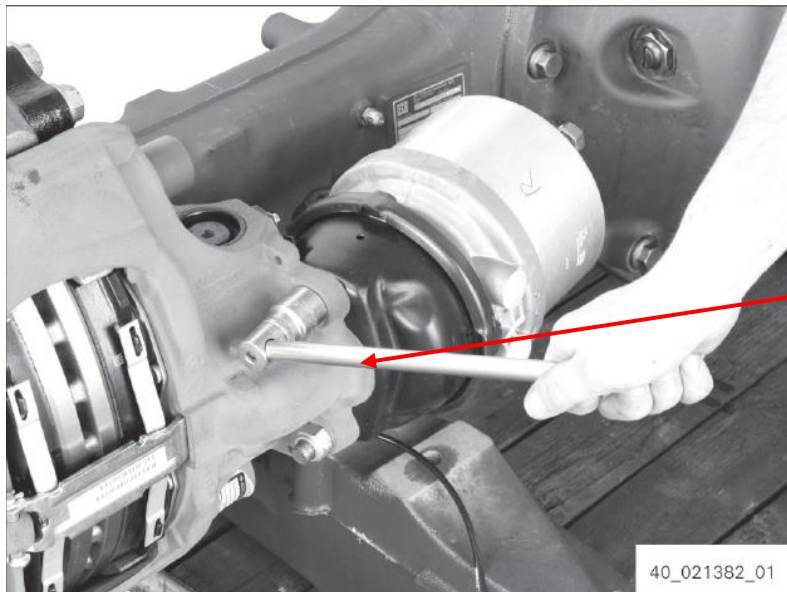
Remove and discard mounting nuts

Remove and discard mounting nuts from each brake chamber.

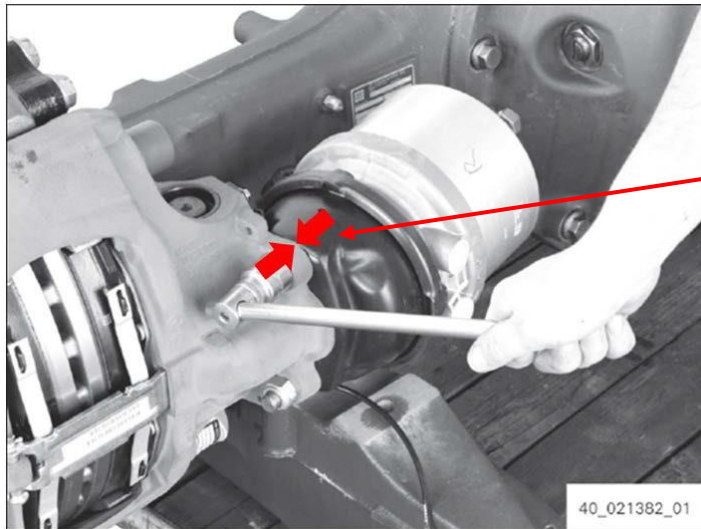
Position the RH
brake chamber, MCI
P/N: 04-01-1250

Using the previously made markups position the RH brake chamber, MCI P/N: 04-01-1250, on the curbside and LH brake chamber, MCI P/N: 14-01-1249, on the driver side.

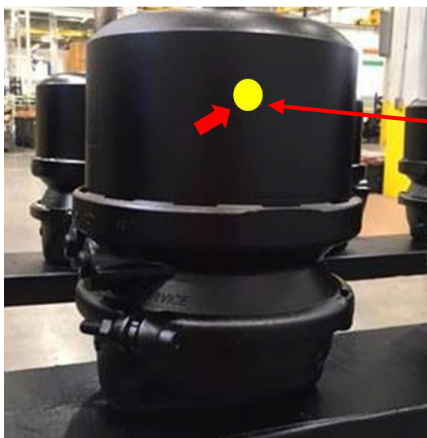
Yellow sticker on the
brake chamber

NOTE: Replacement brake chambers should come from ZF with a yellow sticker. Verify that the sticker is present before installation.

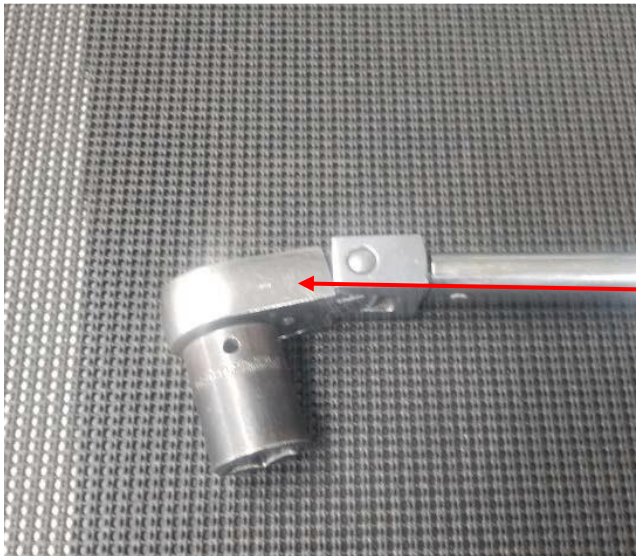
Using a flexible head torque wrench secure the brake chambers

Secure brake chamber to wheel caliper housing using new mounting nuts, MCI P/N 6407942. Using a flexible head torque wrench (24mm socket), apply an initial torque of 25 FT-LBS and a final torque of 143 FT-LBS.
