# Technical Journal

Trunk lid, water intrusion

REF NO:  
TJ 35409.3.0

## Luggage Compartment Lid Moulding

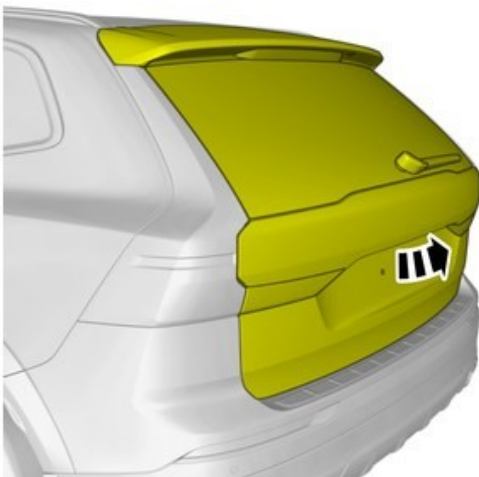
Open the tailgate.

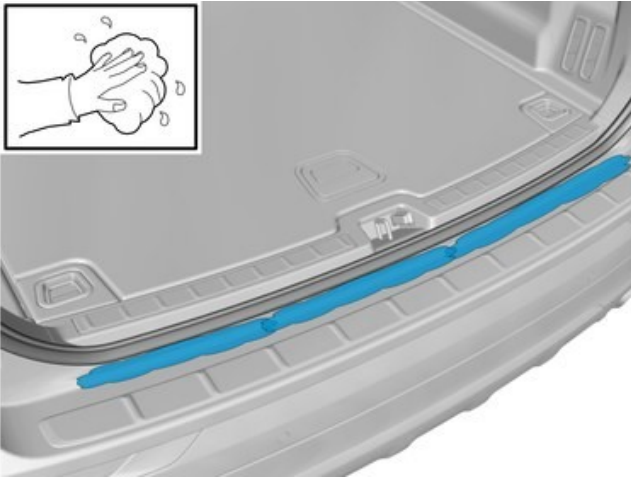
Clean the marked area.

Wipe dry.

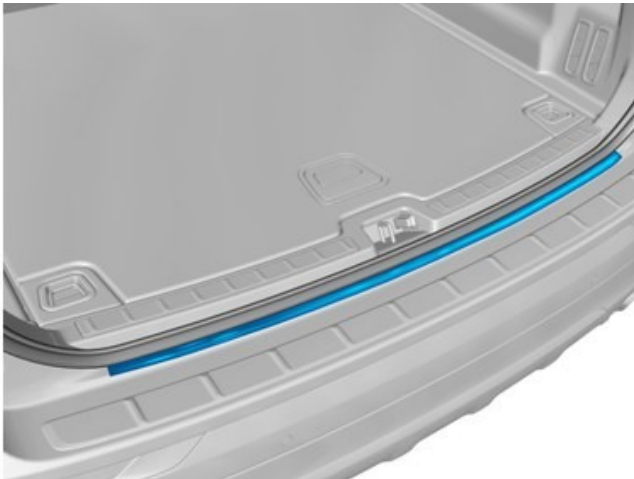
**Note!**

**Make sure that the component is centred.**

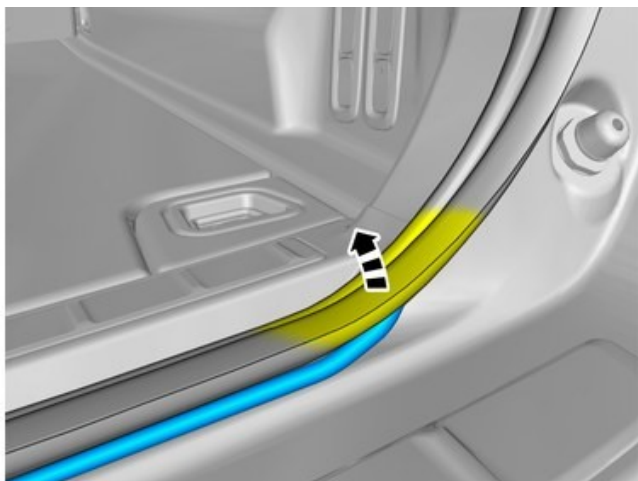
Lift the marked component up

Install the marked component.

On both sides.

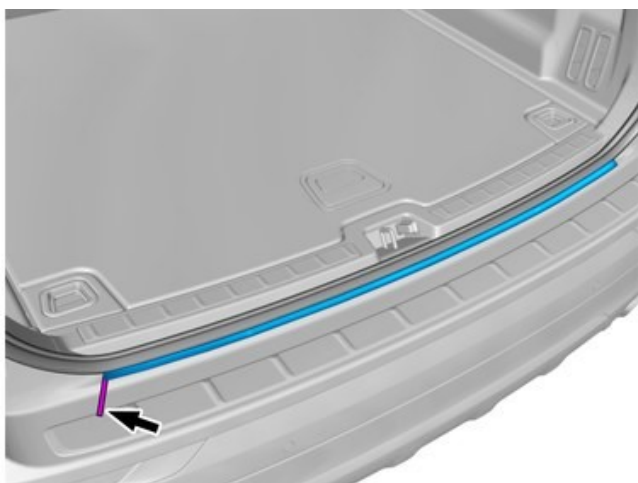
**Note!**

**Make sure that the component is centred.**

Install the marked component.

Remove the protective film.
