# Technical Journal

**Blown fuse, compressor - air suspension**REF NO:  
**TJ 31423.17.1**ISSUING DEPARTMENT:  
**Technical Service**CAR MARKET:  
**United States and Canada**PARTNER:  
**3 US 7510 Volvo Car USA**ISSUE DATE:  
**2019-04-11**STATUS DATE:  
**2020-03-16**FUNC GROUP:  
**7641**FUNC DESC:  
**Level control, complete**

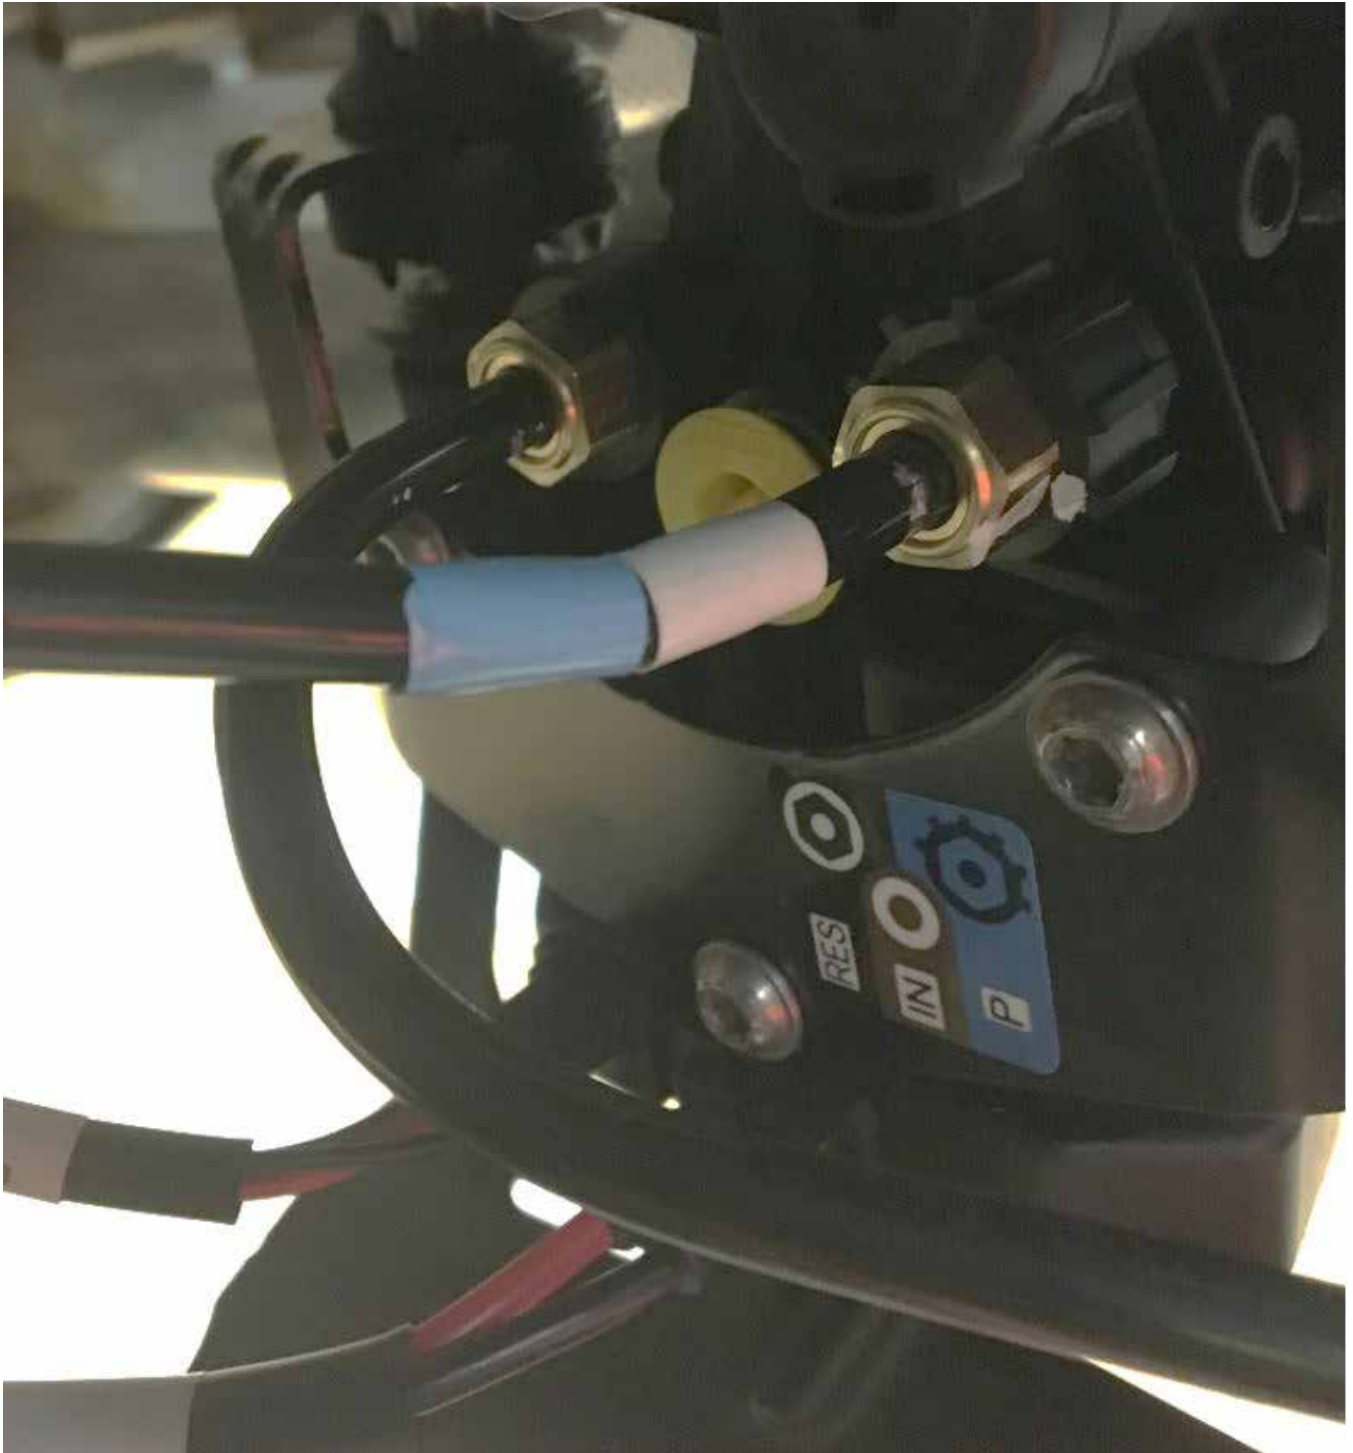
**Note:** Pay attention to which hose is connected to where on the compressor. See attached picture, [Air suspension hoses to compressor.jpg](#).

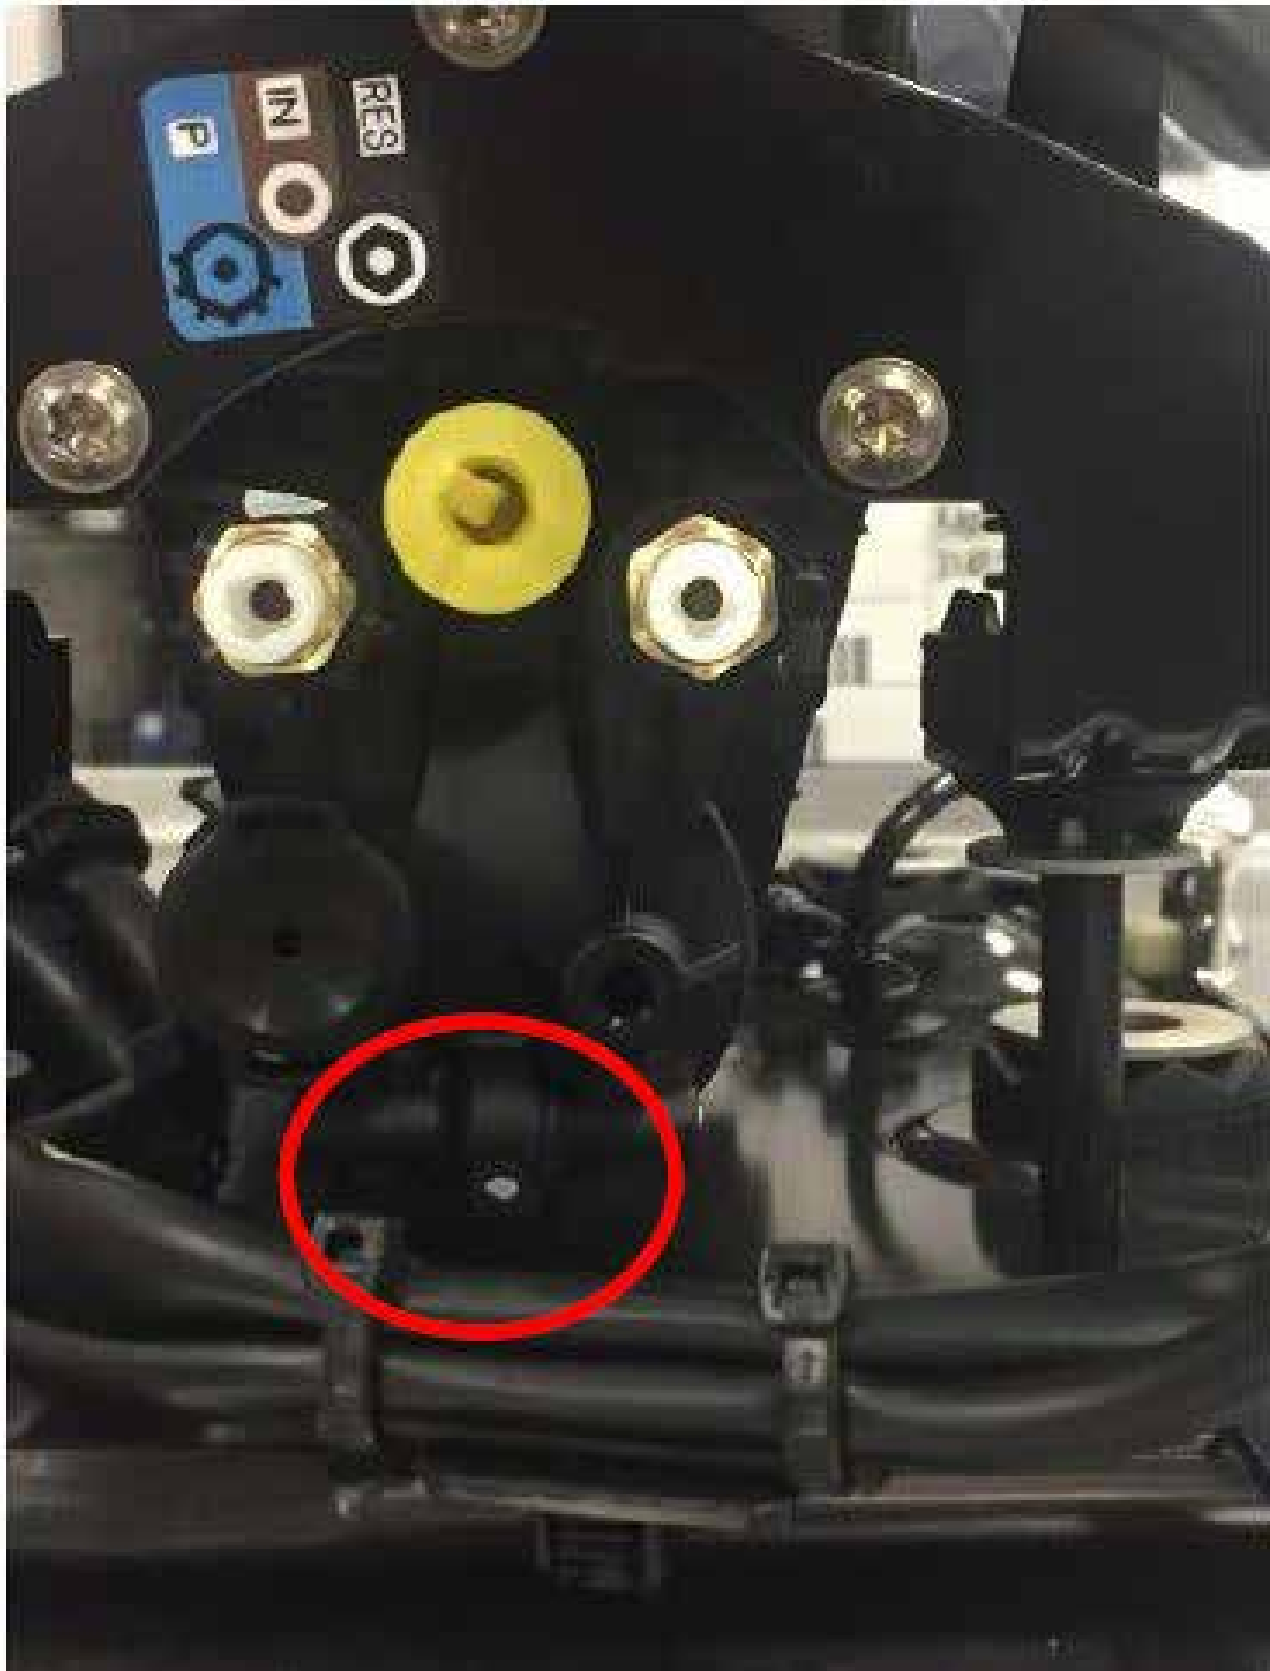
**Note:** The concerned fuse is located in the cargo area right side under the storage compartment, fuse number 3, refer to picture [TJ 31423 - 2.jpg](#).

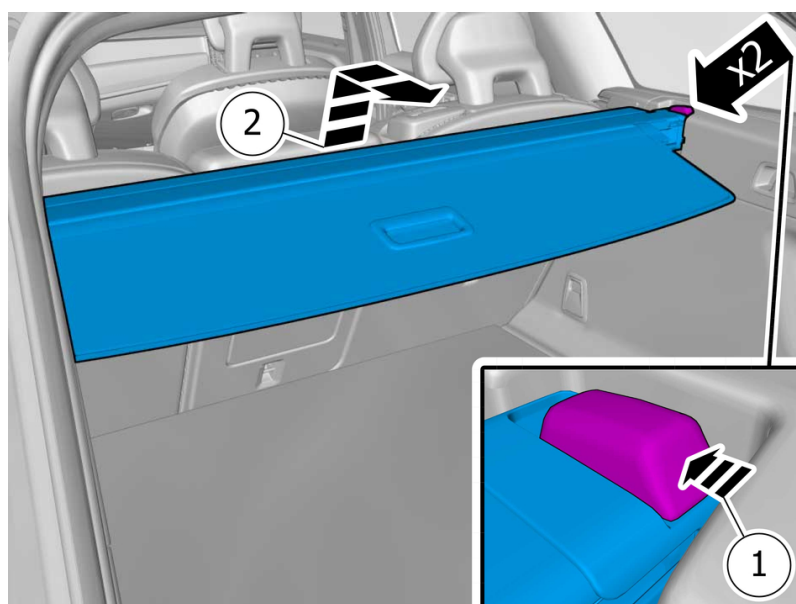
Remove the marked part.

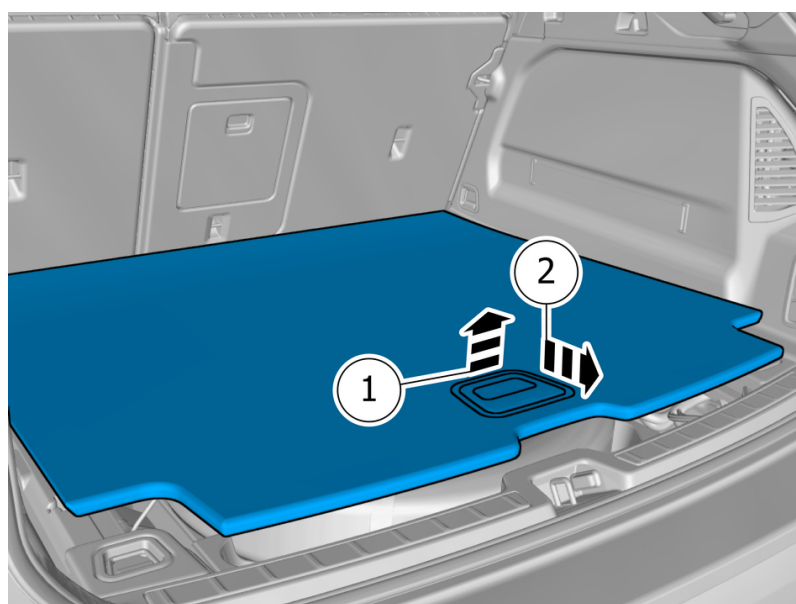
**Caution! Observe caution when carrying out this step.**

Remove the marked part.

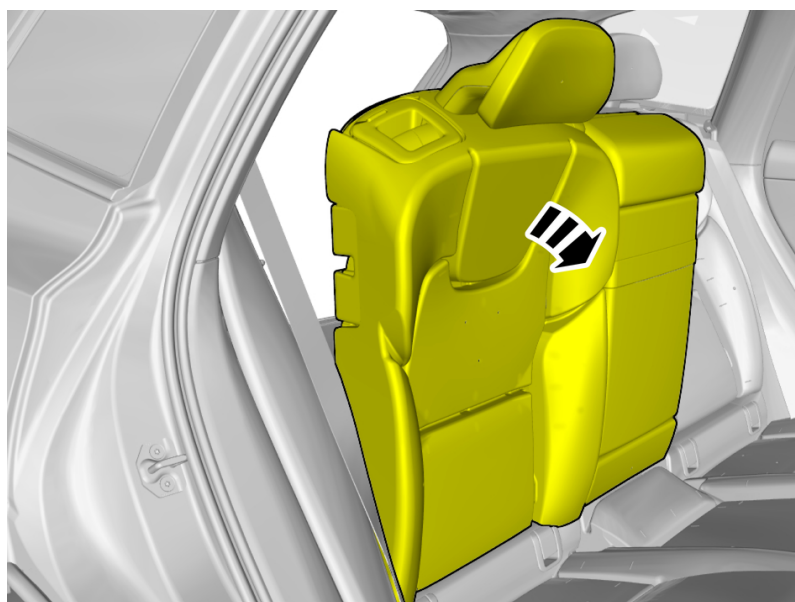
Fold marked part to one side.

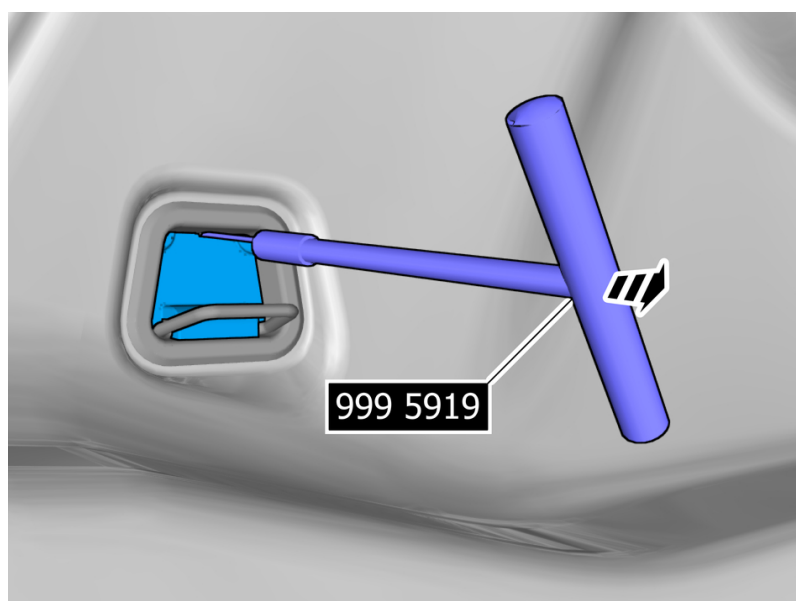
Remove the marked part.

Special Tool: T9995919, PULLER (SEAL-PINION,CAM-CRANKSHAFT)B200-6304

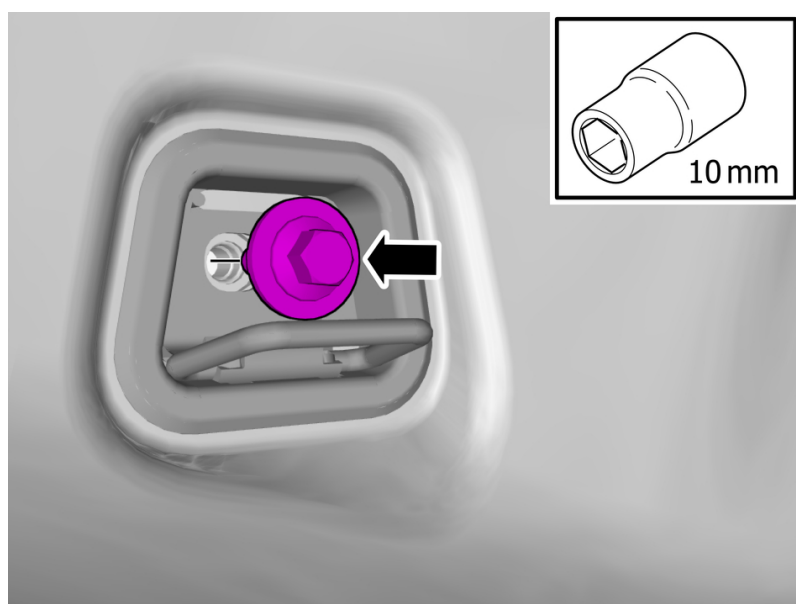
Remove the screw.

**Torque:**

M8 , 24 Nm

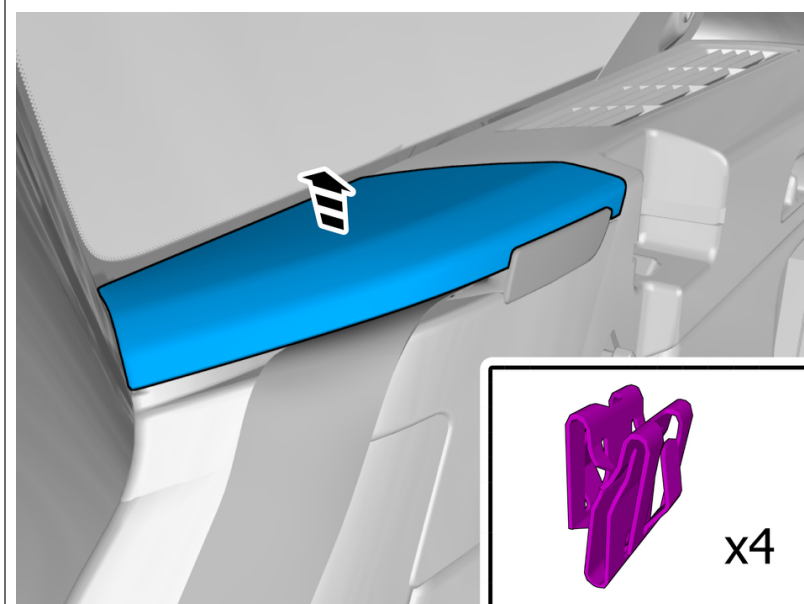
Remove the marked part.

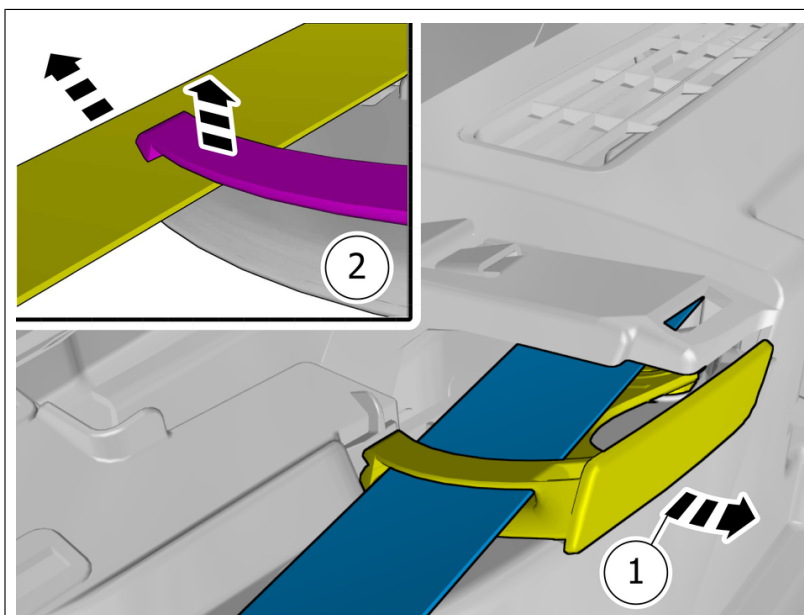
Fold marked part to one side.

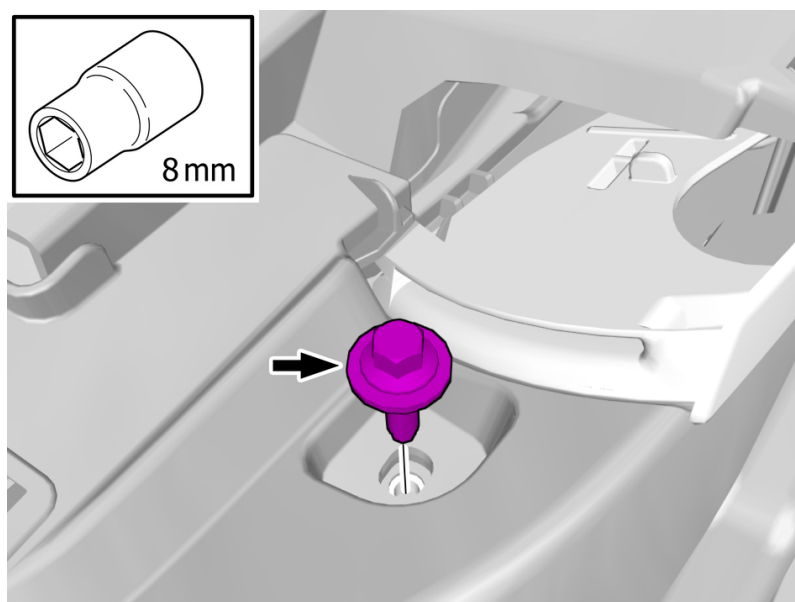
Remove the screw.  
Use hands only.

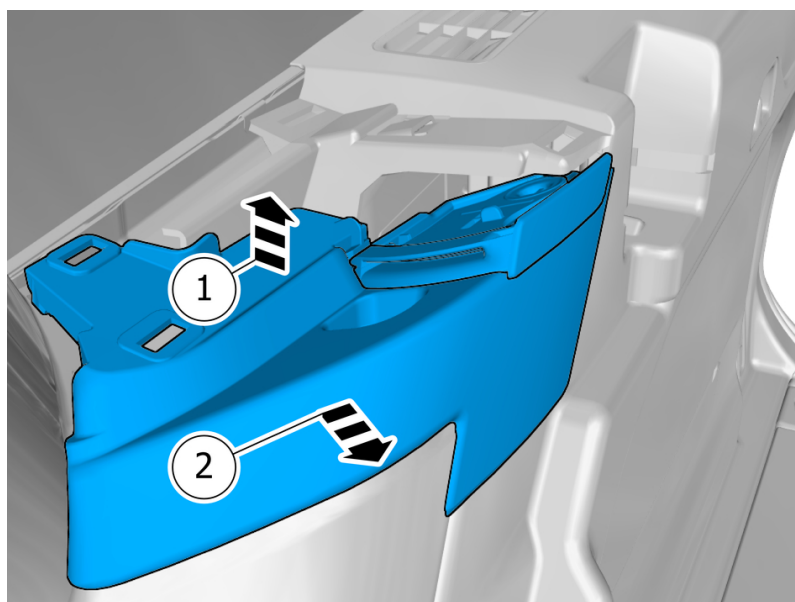
Remove the marked part.

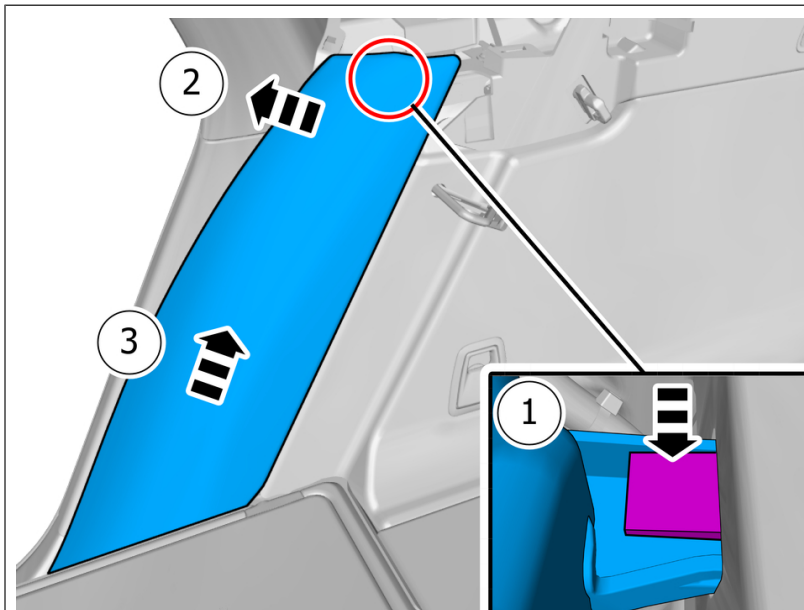
Release the catch.  
Remove the marked part.

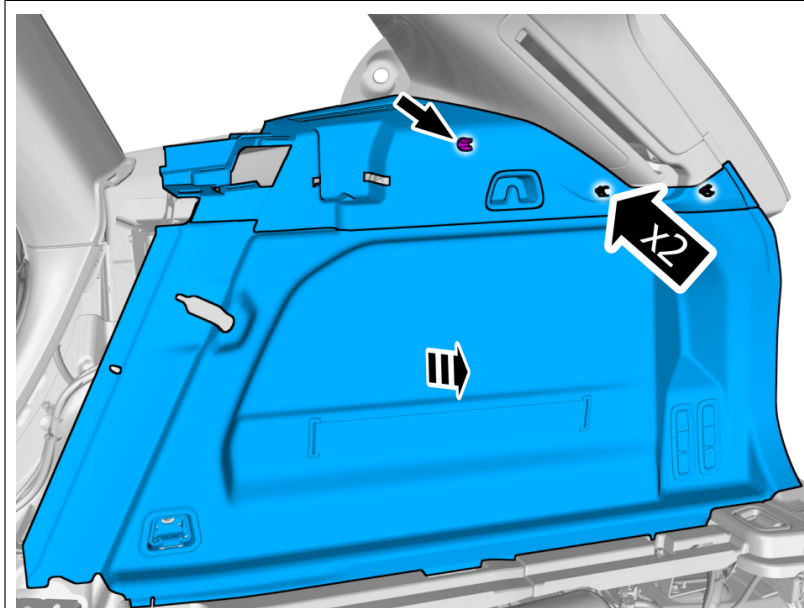
Loosen the clips.  
Remove the marked part.

Disconnect the connector.

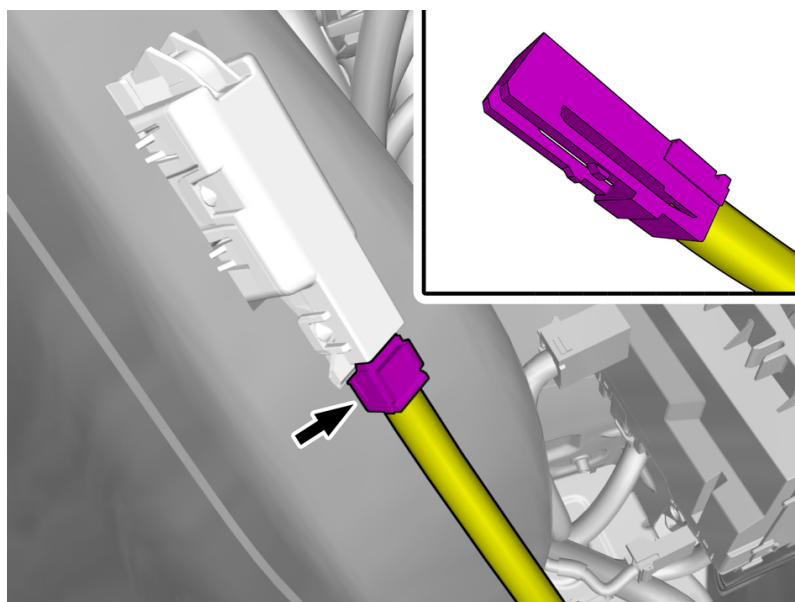
Loosen the clip.

**Use:** Interior trim remover

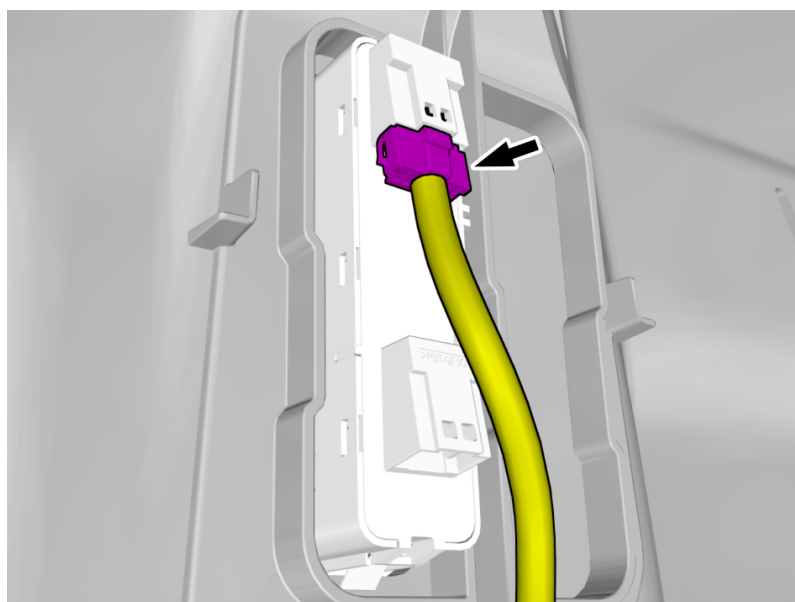
**Note!** The number of connectors may vary depending on the vehicle's equipment level.

Disconnect the connector.

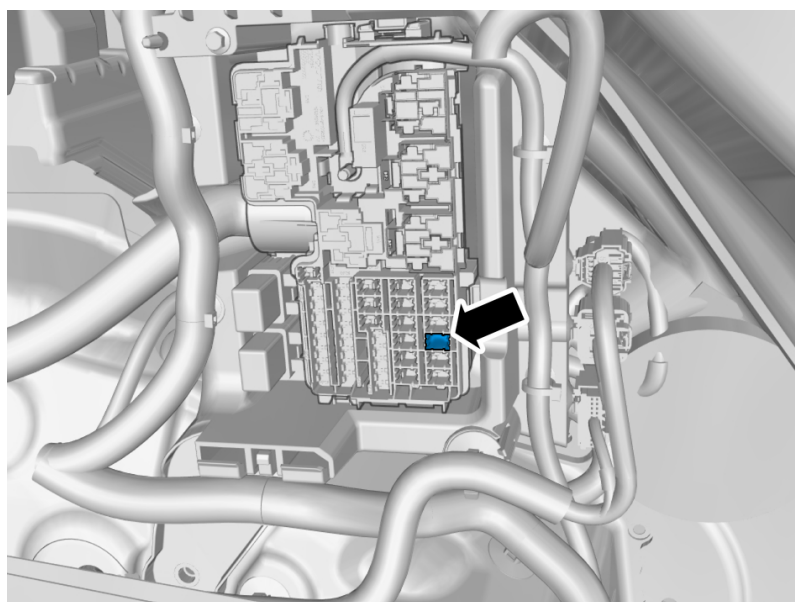
Remove the marked part.
