# Technical Service Bulletin

## 39 Oil leak from the rear differential

39 20 29 2059112/1 April 3, 2020.

Model(s)	Year	VIN Range	Vehicle-Specific Equipment
Q7	2017 - 2019	All	Standard rear differential
Q8	2019	All	Standard rear differential

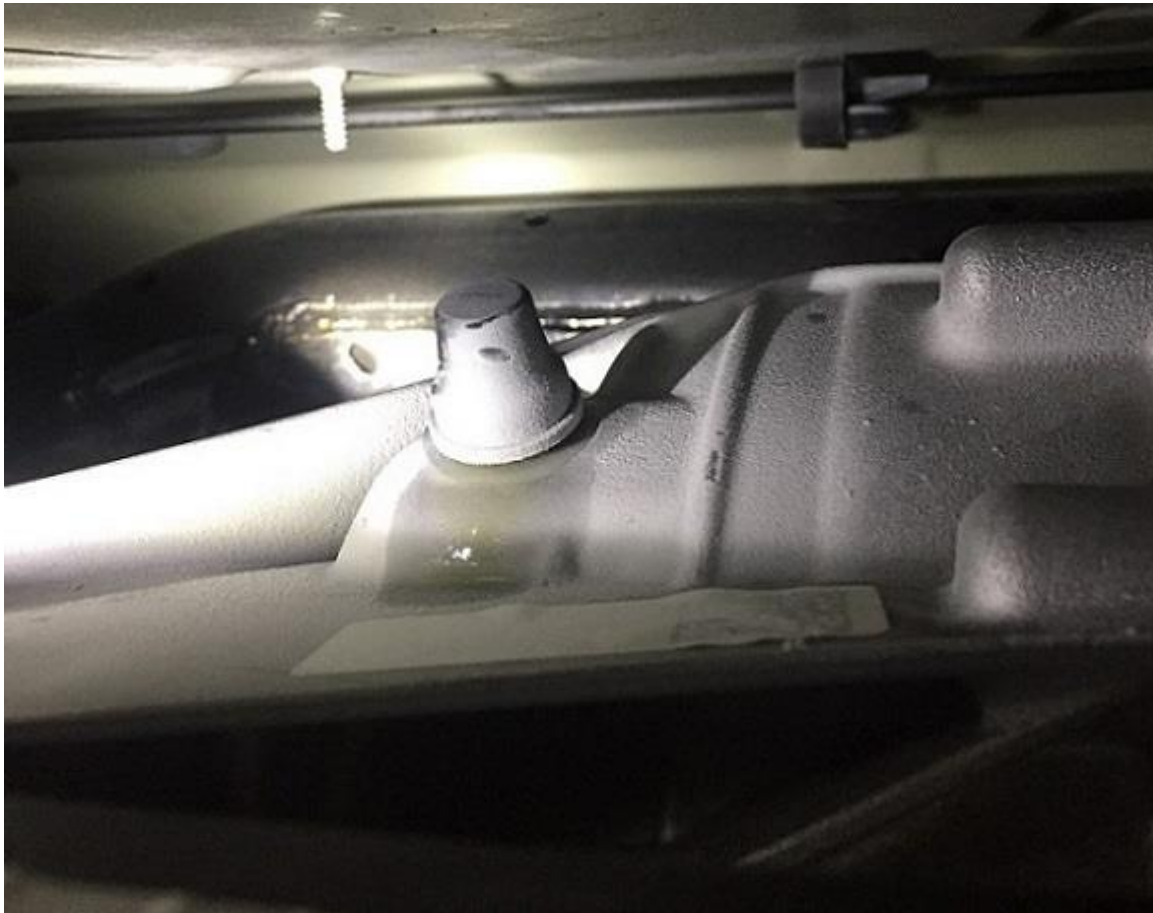
- Oil leaking from top of the rear differential.

Manufacturing issue.

**Figure 1.** Oil leaking from differential vent tube.

1. Take photos of the actual condition and attach it to the Repair Order.
2. Clean the oil off the differential thoroughly including the area around the differential vent tube with brake clean and make sure it is dry before proceeding.
3. Apply oil leak detection spray (Part # G 001 900 A1 or a locally available talcum based oil leak detection spray equivalent) to all suspected areas (including the differential vent tube).

4. Perform a thorough test drive and reassess the oil leak after the test drive.
5. If the oil is found leaking from the differential vent tube as shown below (Figure 1) document your findings with photos and replace the rear differential.
