# Product Emission Recall

## N192273600 Emissions Pipe May Rub Against A/C Hose Connector

**Release Date:** March 2020

**Revision:** 01

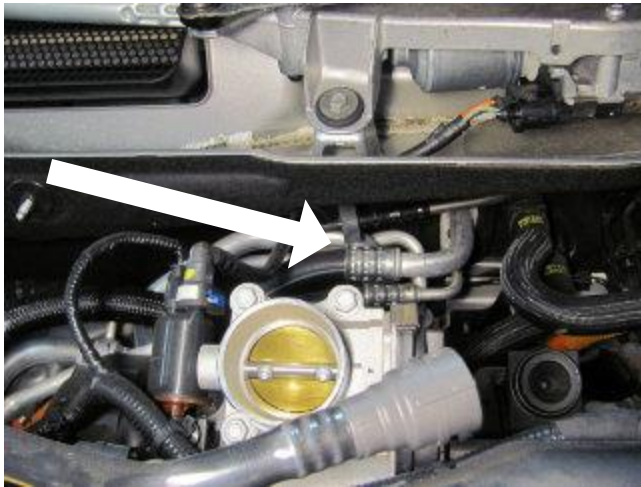
5500271

1. Remove the air cleaner outlet duct. Refer to *Air Cleaner Outlet Duct Replacement* in SI.

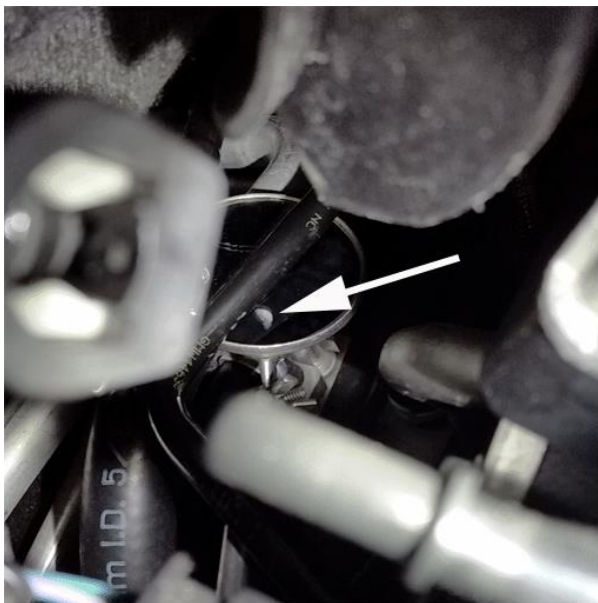
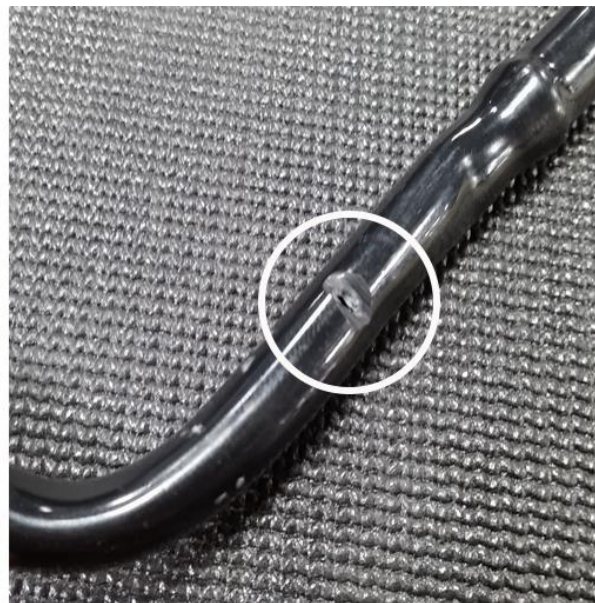
4806962

2. Locate the area where the evaporative emission pipe passes over the A/C metal pipe to rubber hose crimp.

**Note:** Most vehicles will have a rubber protector (bumper) on the emission pipe in this area. Slide the pipe bumper toward the passenger side of the vehicle to perform the inspection.

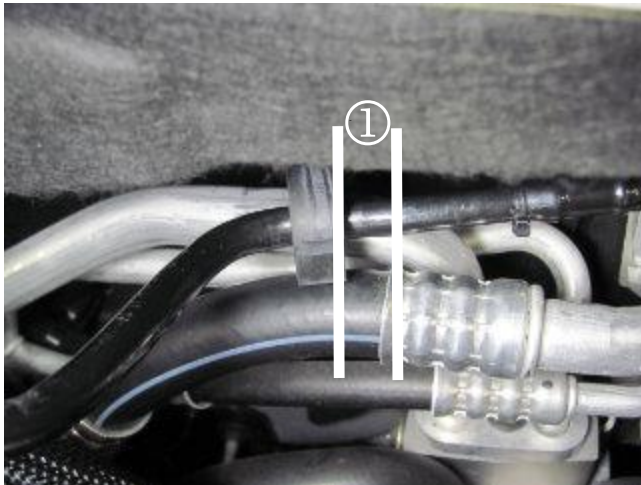
5509348

3. Using a mechanics mirror, inspect the underside of the evaporative emission pipe for physical damage such as grooves, cuts or nicks. Minor scuffs, scratches and smears are acceptable. The damage will be right above the flare on the A/C pipe crimp.
  - If **no damage** is found, proceed to step #4.
  - If **damage is found, replace the evaporative emission pipe**. Refer to *Evaporative Emission Pipe Replacement* in SI. After the pipe is replaced, proceed to step #4.

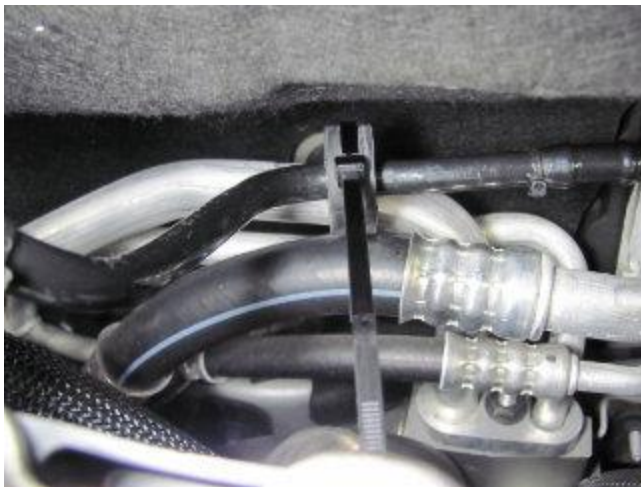
5509349

4. Position the bumper on the evaporative emission hose 13mm (1/2in.) inboard of the lip on the A/C line crimp (1).

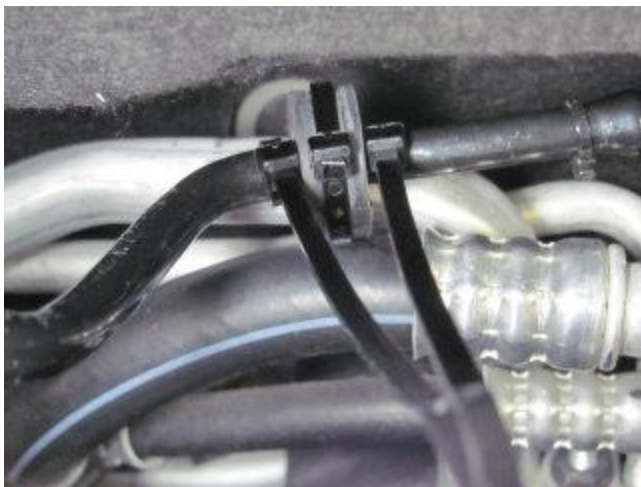
5509351

5. Secure the bumper with a tie strap, center the tie strap as shown. Tighten and trim the tie straps as required.

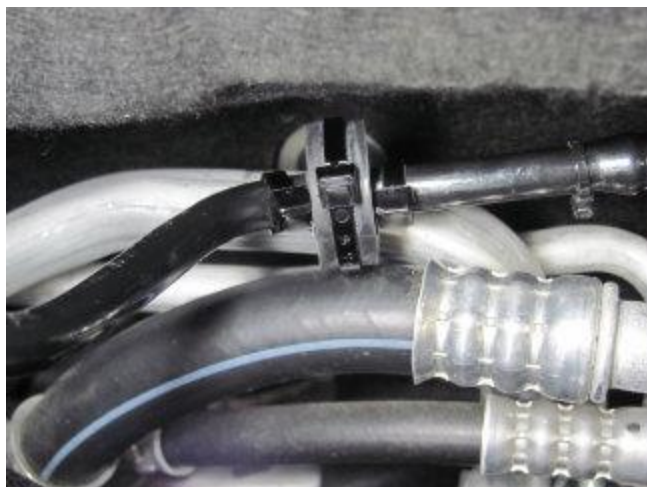
5509353

6. Install two additional tie straps on both sides of the bumper. Using needle nose pliers, tighten the tie straps as securely as possible. Trim as required.
