GLOBAL SAFETY FIELD INVESTIGATIONS  
DCS5366  
URGENT - DISTRIBUTE IMMEDIATELY

Subject: A192219310 - Special Coverage  
Radiator Leaks - Maven Vehicles

Models: 2015 – 2019 Chevrolet Trax

## A192219310 Radiator Leaks – Maven Vehicles

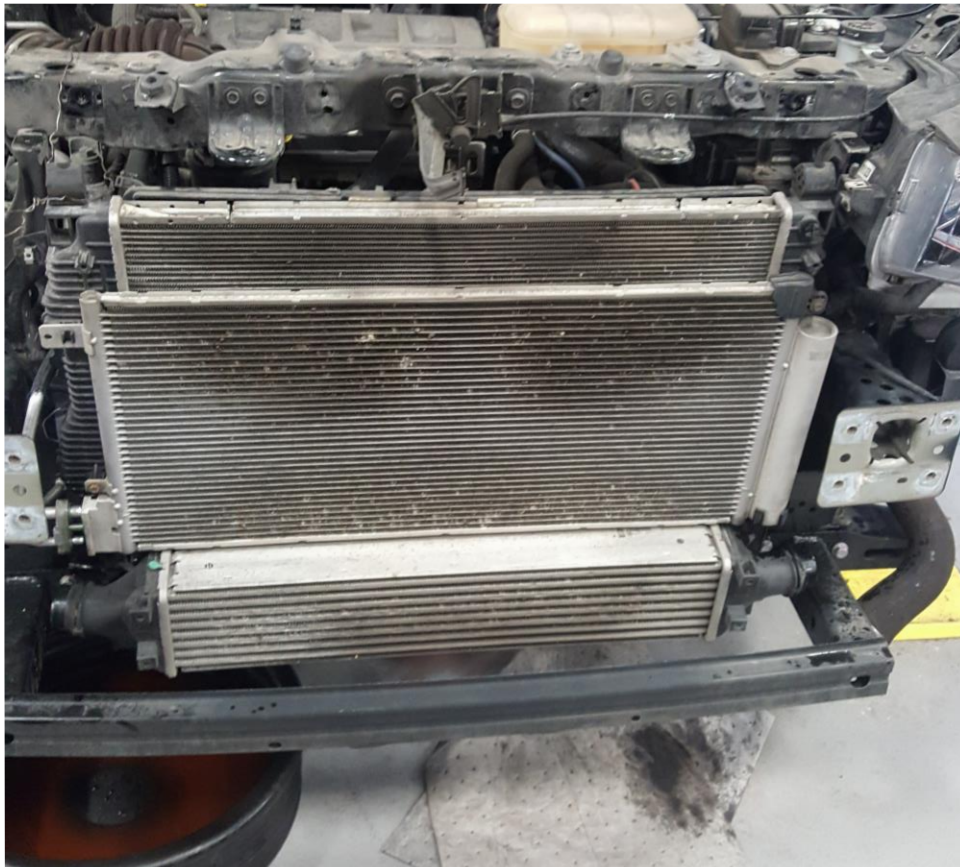
5537030

14. At this point, the vehicle should look as shown above. The entire Condenser-Radiator-Fan-Module (CRFM, including the Charge Air Cooler), should now be removed together as one unit through the front of the vehicle.

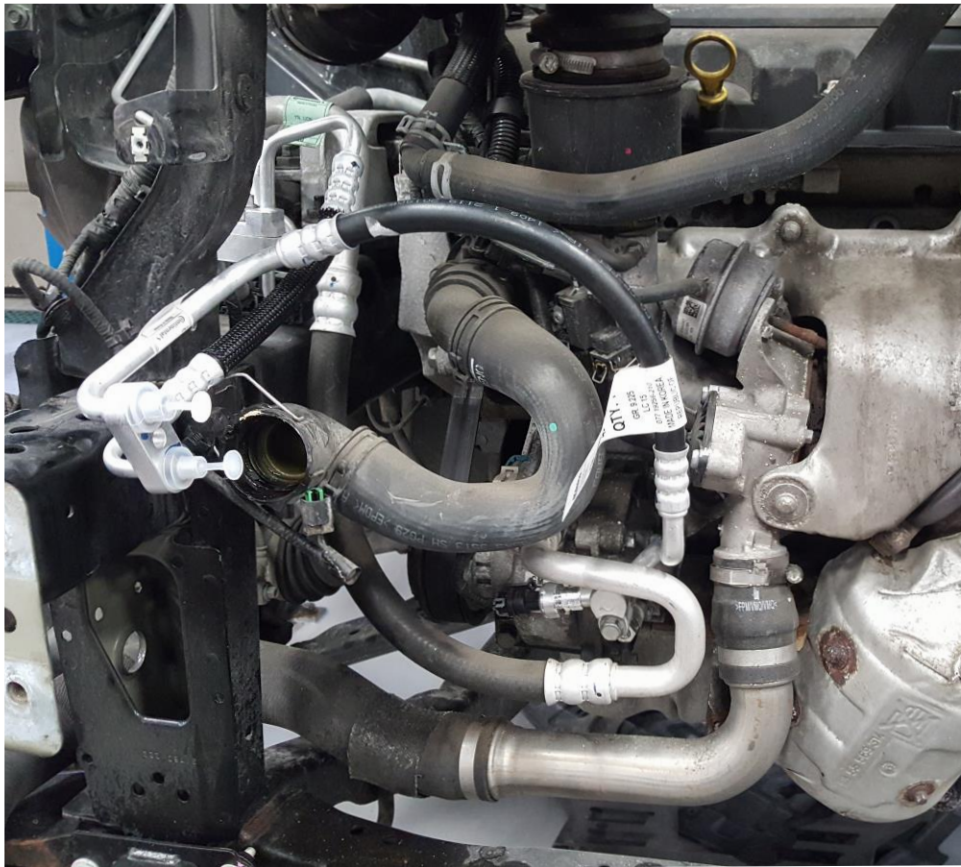
5537607

15. Replace the Air Conditioning Condenser Hose with the new part provided as shown.

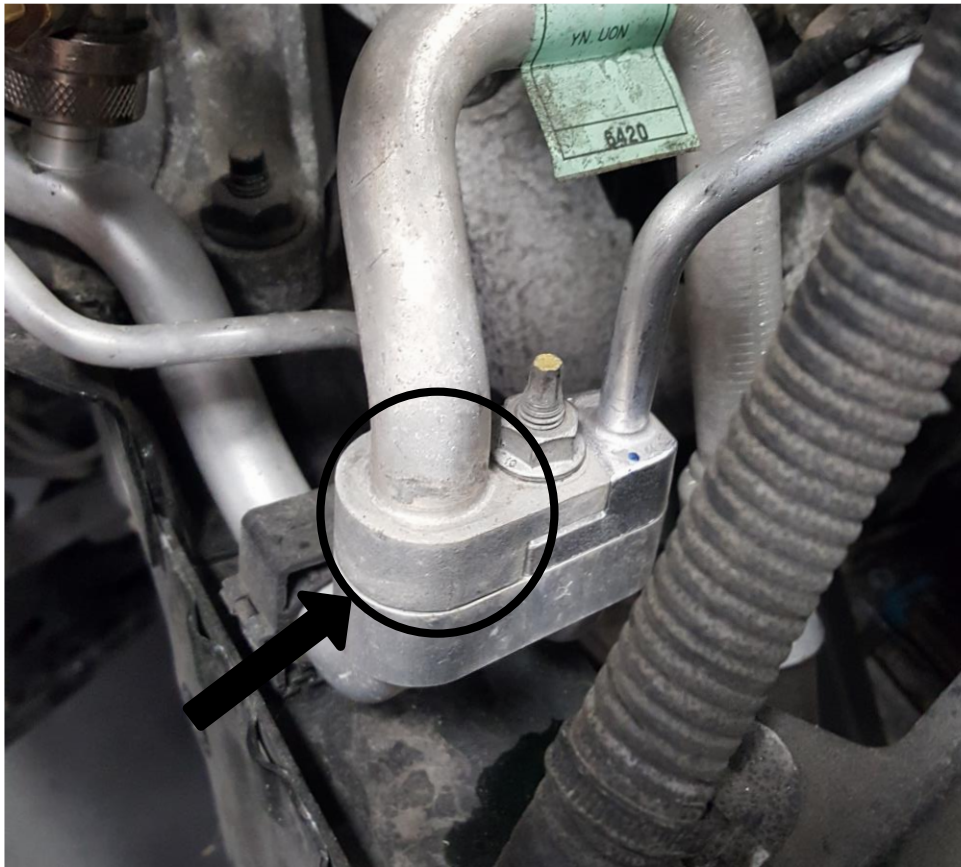
5537611

- Be sure to replace the accompanying A/C Compressor Hose Seal (circled above) while replacing the Condenser Hose.

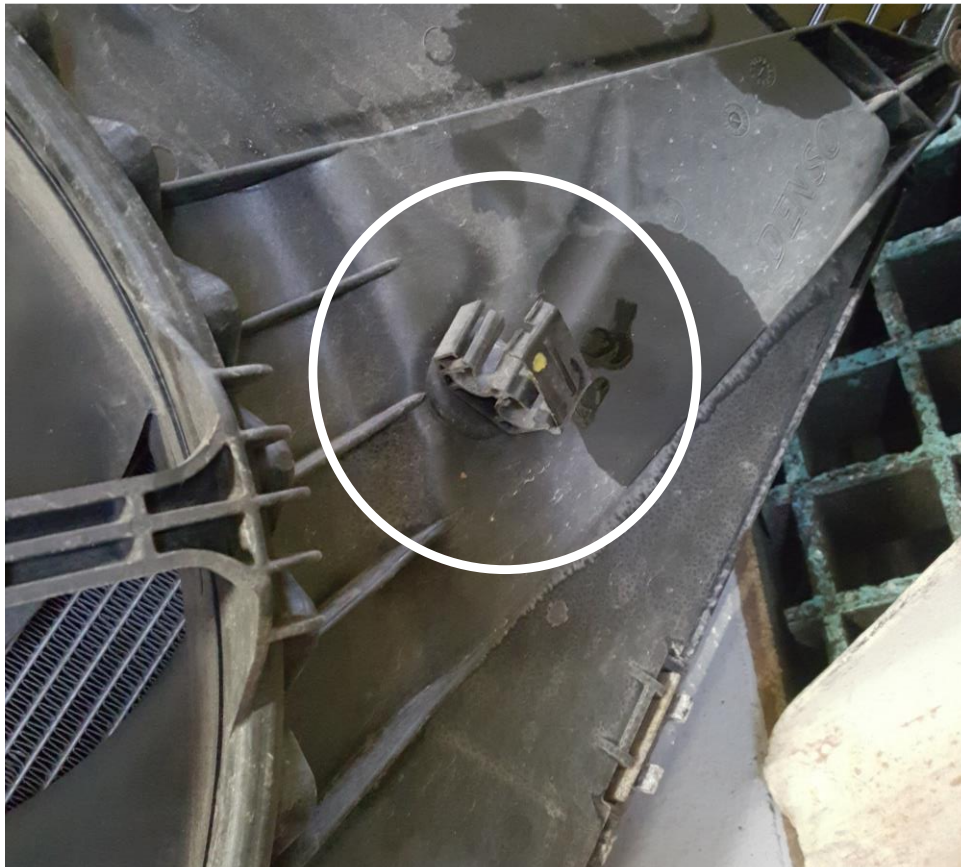
5537614

16. Transfer the transmission cooler line clip from the fan shroud of the old CRFM to the fan shroud of the new CRFM.
17. Install the new CRFM assembly in the same manner as the old one was removed.

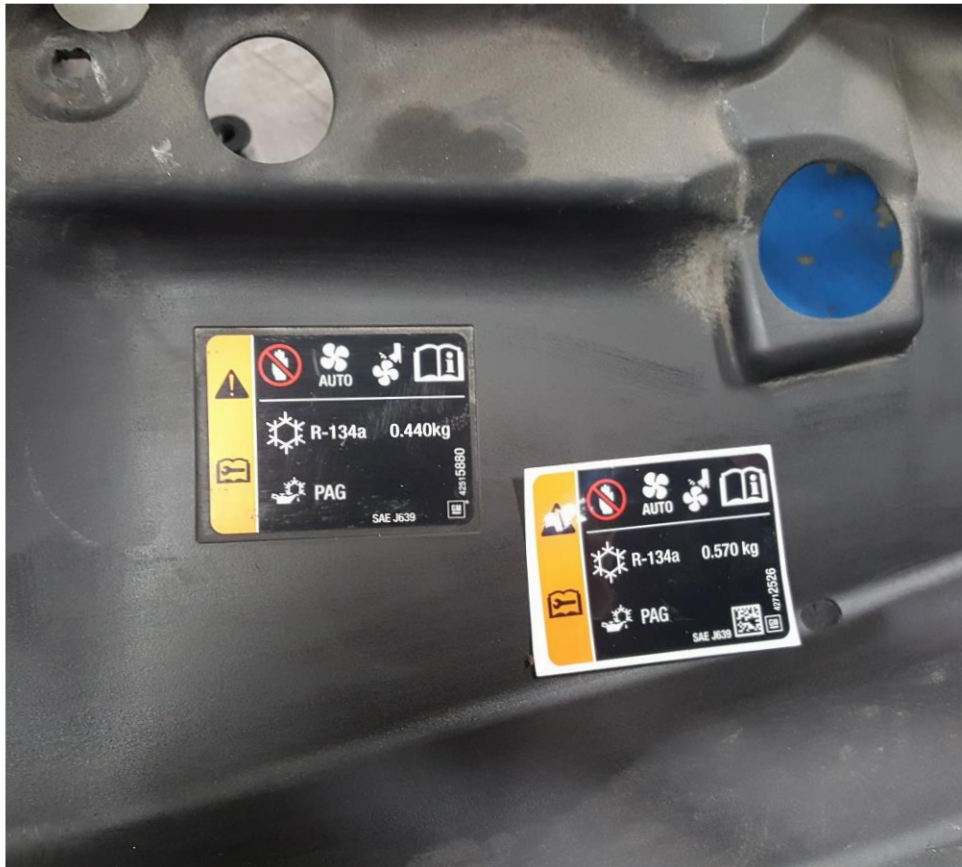
5536953

32. Install the new A/C Refrigerant label (reads 0.570kg) over the old label (reads 0.440kg).
33. Fill the air conditioning refrigerant. Refer to *Refrigerant Recovery and Recharging* in SI. Be sure to fill to the amount indicated on the new label – the refrigerant fill has increased from .440kg to .570kg.
34. Check the transmission fluid level and add transmission fluid as appropriate. Refer to *Transmission Fluid Level and Condition Check* in SI.
